# City of Carlsbad Wildlife Movement Analysis Final Report

Local Assistance Grant Agreement No.  
P1282107

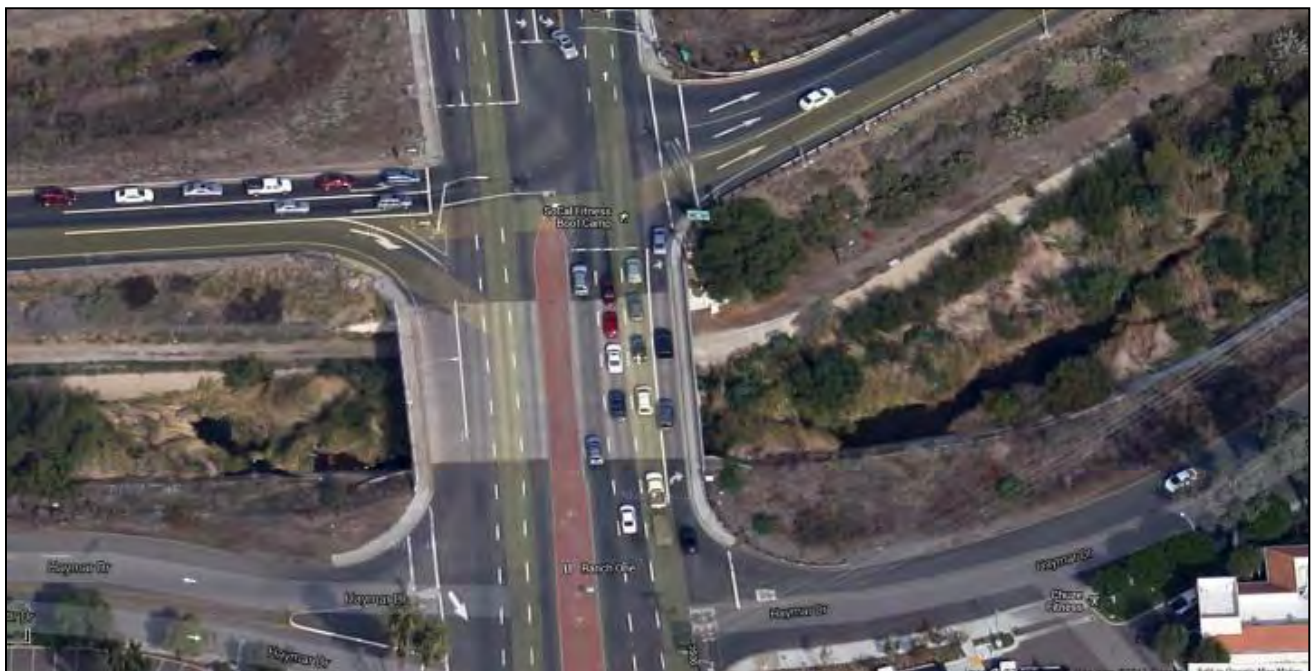
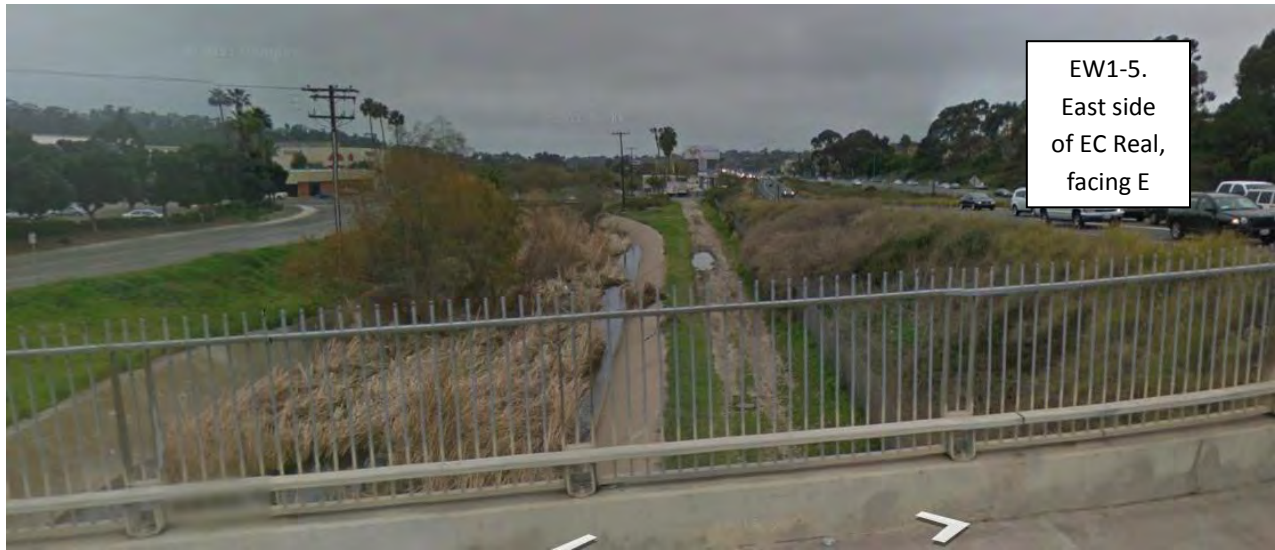
EW1-5.  
East side  
of EC Real,  
facing E

**EW1-5. High Priority.** Buena Vista Creek and El Camino Real. This location was recommended by the MHCP for monitoring.

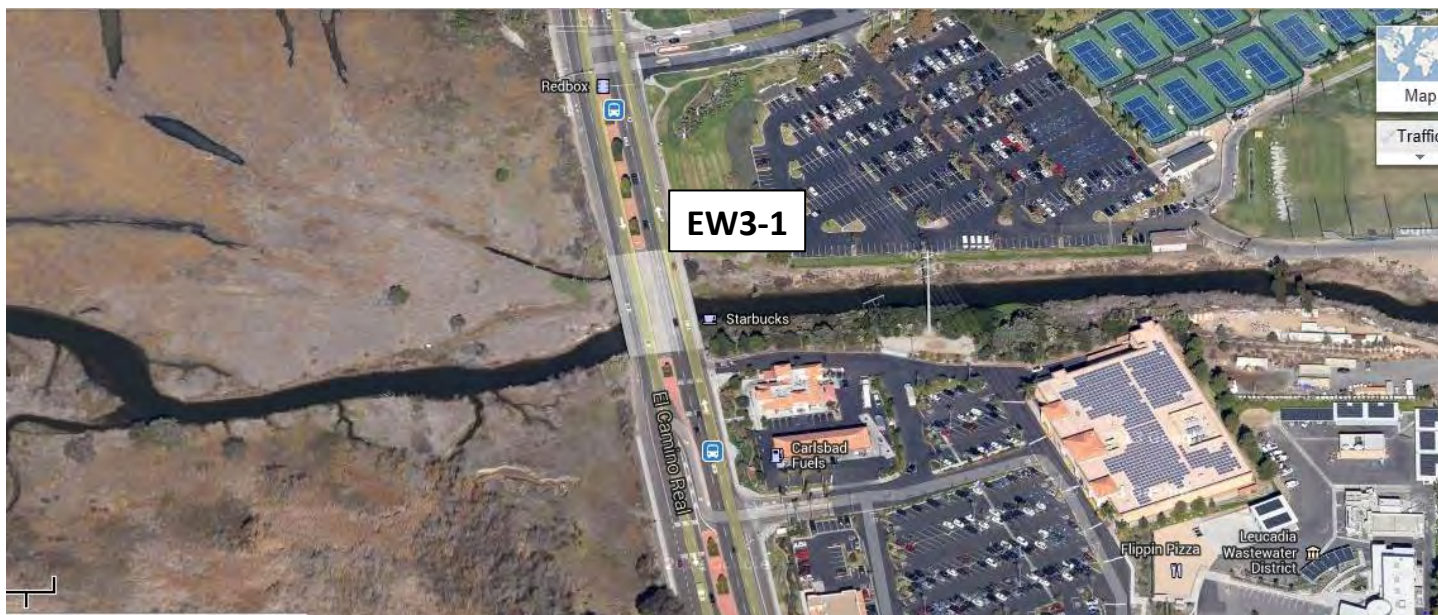
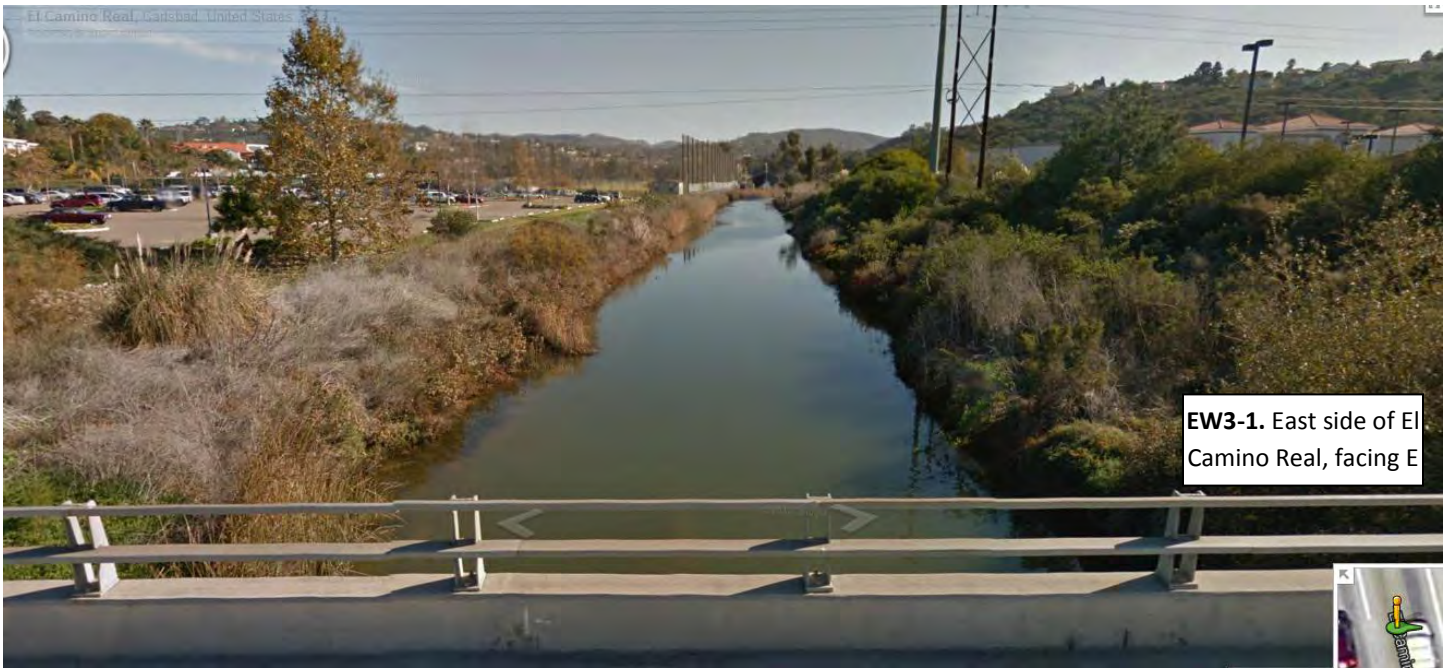
**EW3-1.** East side of El Camino Real, facing E

**EW3-1, High Priority.** Batiquitos Lagoon/San Marcos Creek and El Camino Real. MHCP-recommended monitoring location. Undercrossing may be completely inundated at times. Channelized E of ECR, but a narrow strip of upland habitat along the creek.

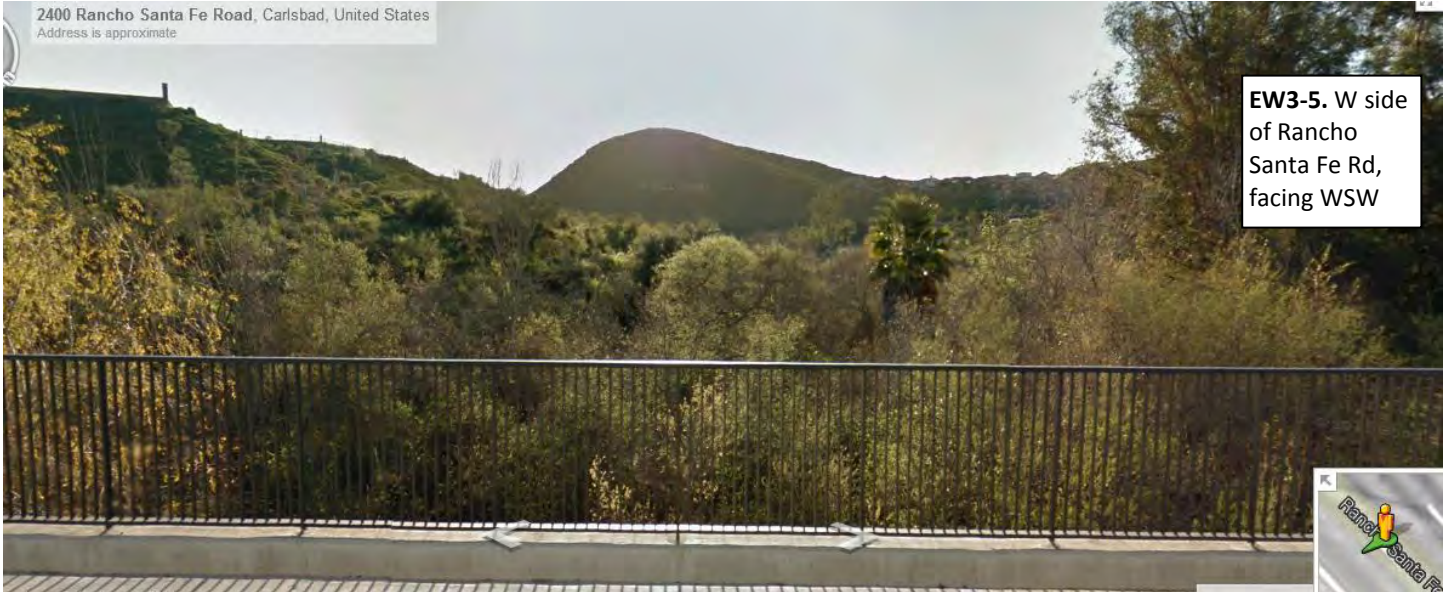
**EW3-5.** W side of Rancho Santa Fe Rd, facing WSW

**EW3-5. High Priority;** MHCP-recommended monitoring location. San Marcos Creek and Ranch Santa Fe Road.

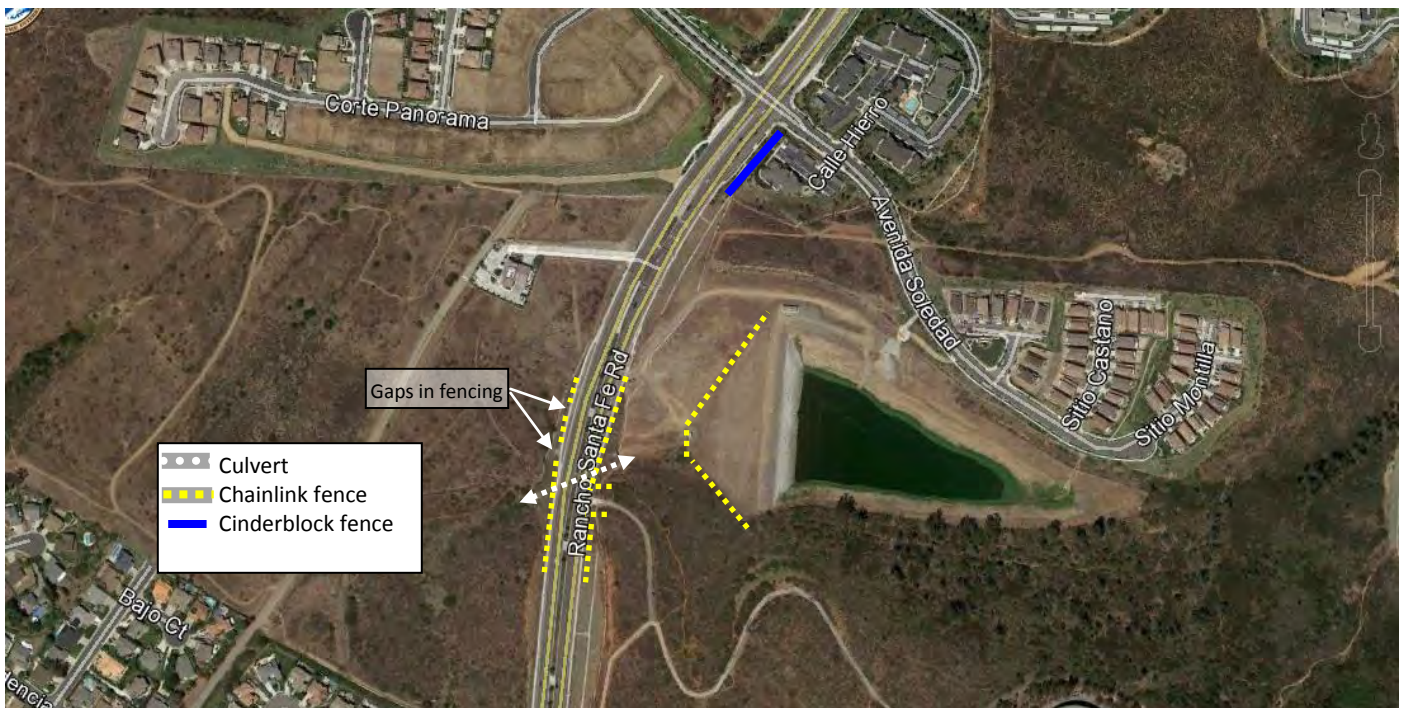
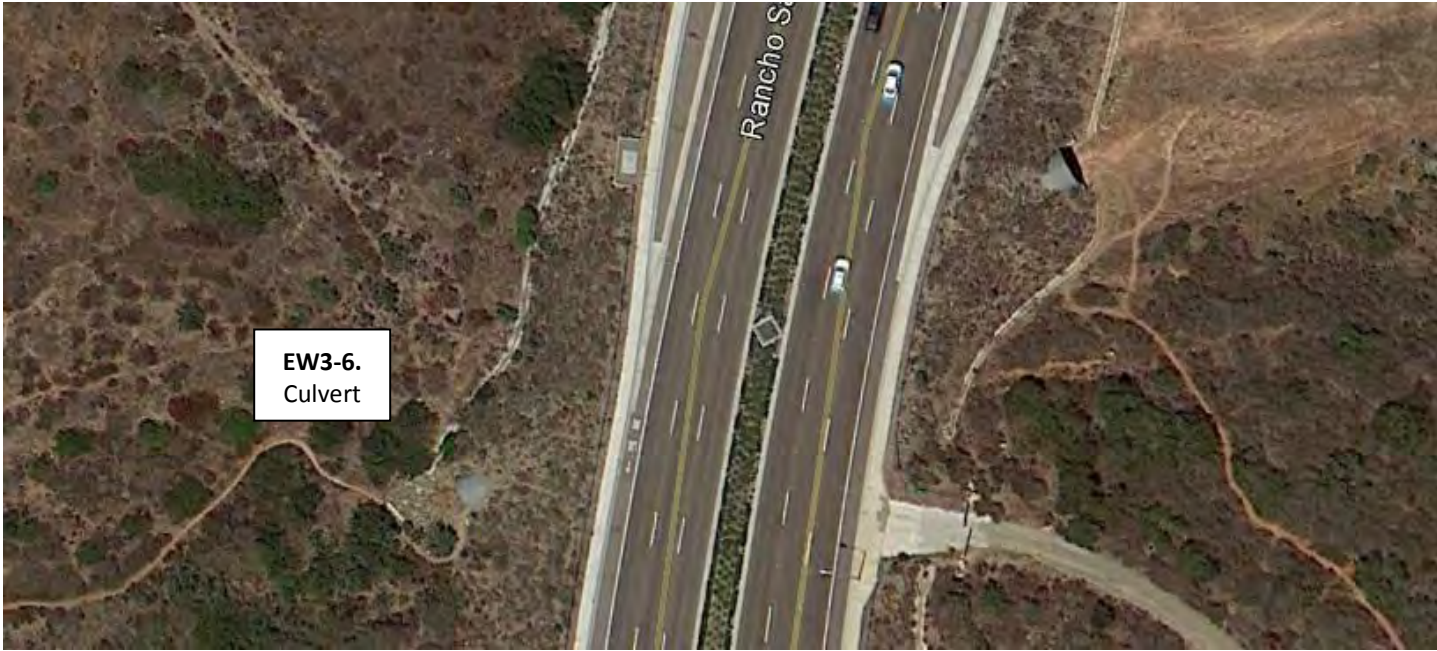
**EW3-6.**  
Culvert

**EW3-6. High Priority;** MHCP-recommended monitoring location. Rancho Santa Fe Road and Rancho La Costa Preserve. E-W movement does not follow a drainage or creek.

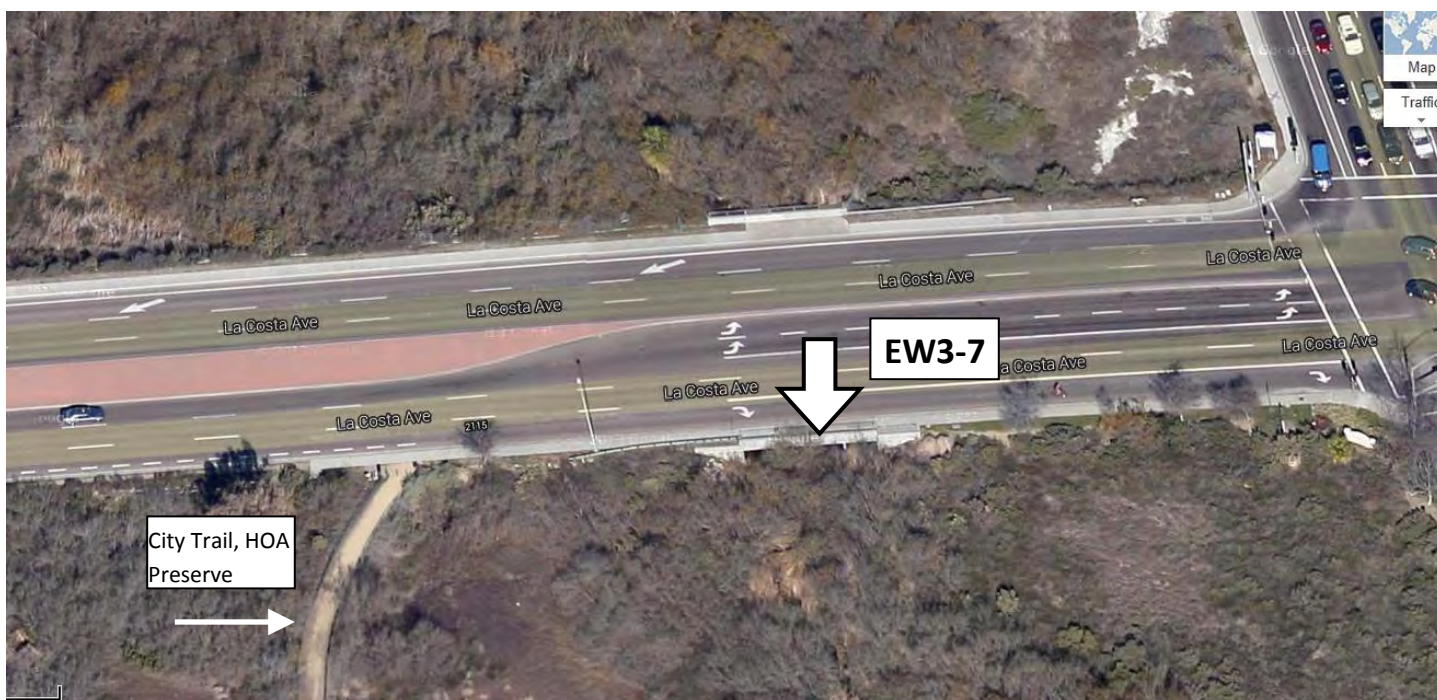
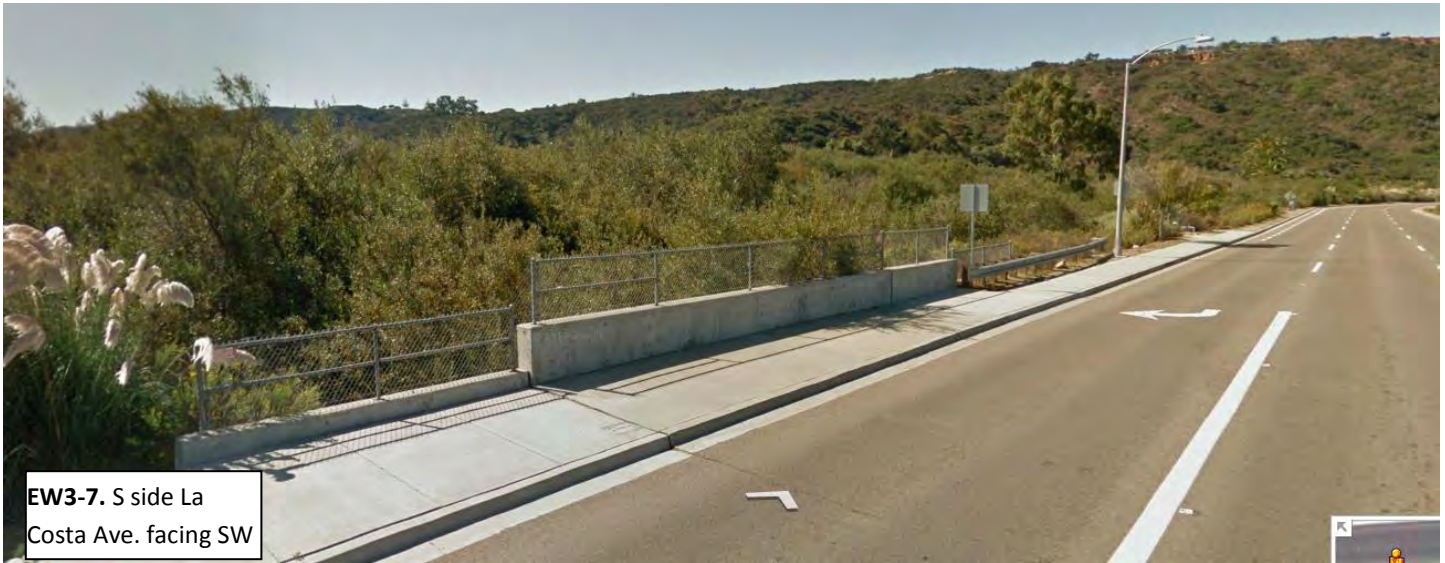
**EW3-7.** S side La  
Costa Ave. facing SW

**EW3-7. High Priority;** MHCP-recommended monitoring location. Encinitas Creek and La Costa Avenue, near intersection with El Camino Real. No obvious fencing in this area

- To gain more information about the function of EW3, replacing the camera at EW3-7 and locating a camera at EW3-1 could help understand the extent of bobcat movement in that area, since none have been observed near the southeastern portion of the Batiquitos Lagoon Ecological Reserve. As with EW1 near El Camino Real, camera monitoring at EW3-1 will require coordination with the Police Department due to heavy human occupancy. This monitoring could coincide with the placement of fencing, if that adaptive management action can be funded. A camera at EW3-11, as well as camera(s) upstream of EW3-13b, could also provide useful information.
