Sweetwater Reservoir Vernal Pool and Otay Tarplant Restoration Status Report

Performance Period

(August 2004 to August 2007)

RECON Environmental, Inc.
1927 Fifth Avenue
San Diego, CA 92101-2358
P 619.308.9333 F 619.308.9334
RECON Number 3967B

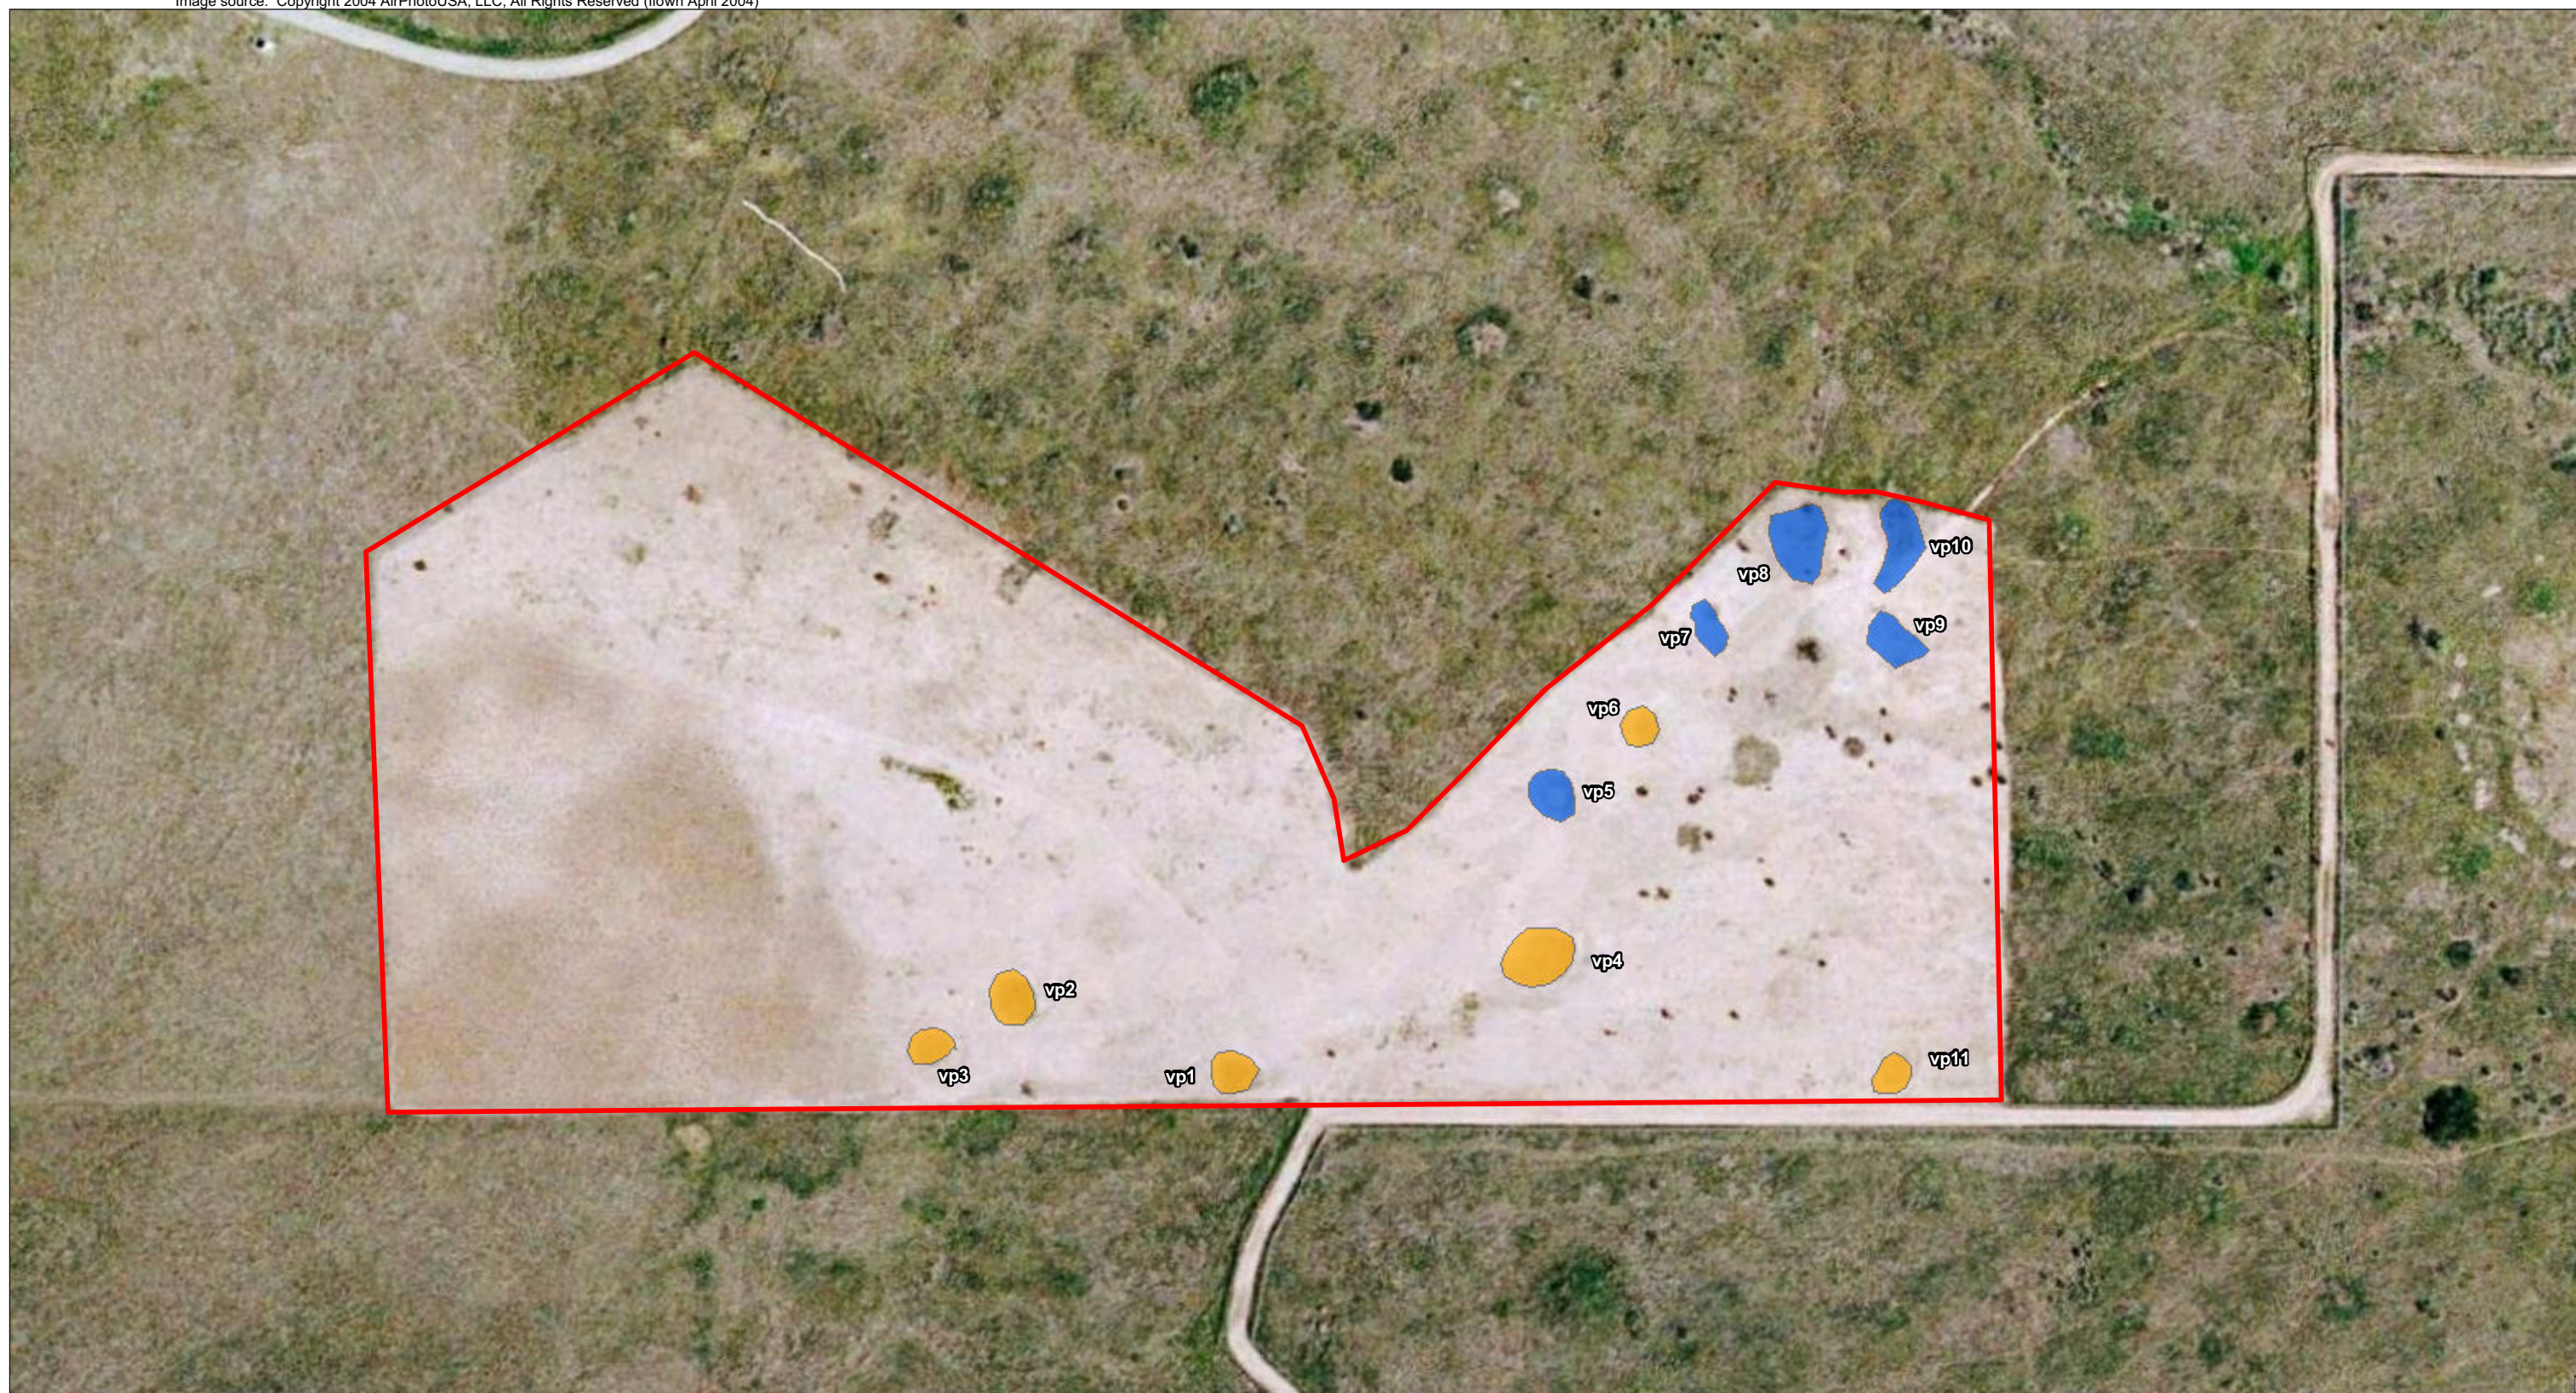
FIGURE 3

- Restoration and Enhancement Area Boundary
- Restored Vernal Pools
- Enhanced Vernal Pools

grading was conducted under the direction of a biologist (Mark Dodero) with vernal pool restoration experience. The biologist used a laser transit to help direct the grading contractor and ensure that proper topography was restored. Eleven vernal pool basins were restored, six of which were newly restored (Figure 3; Photograph 3).

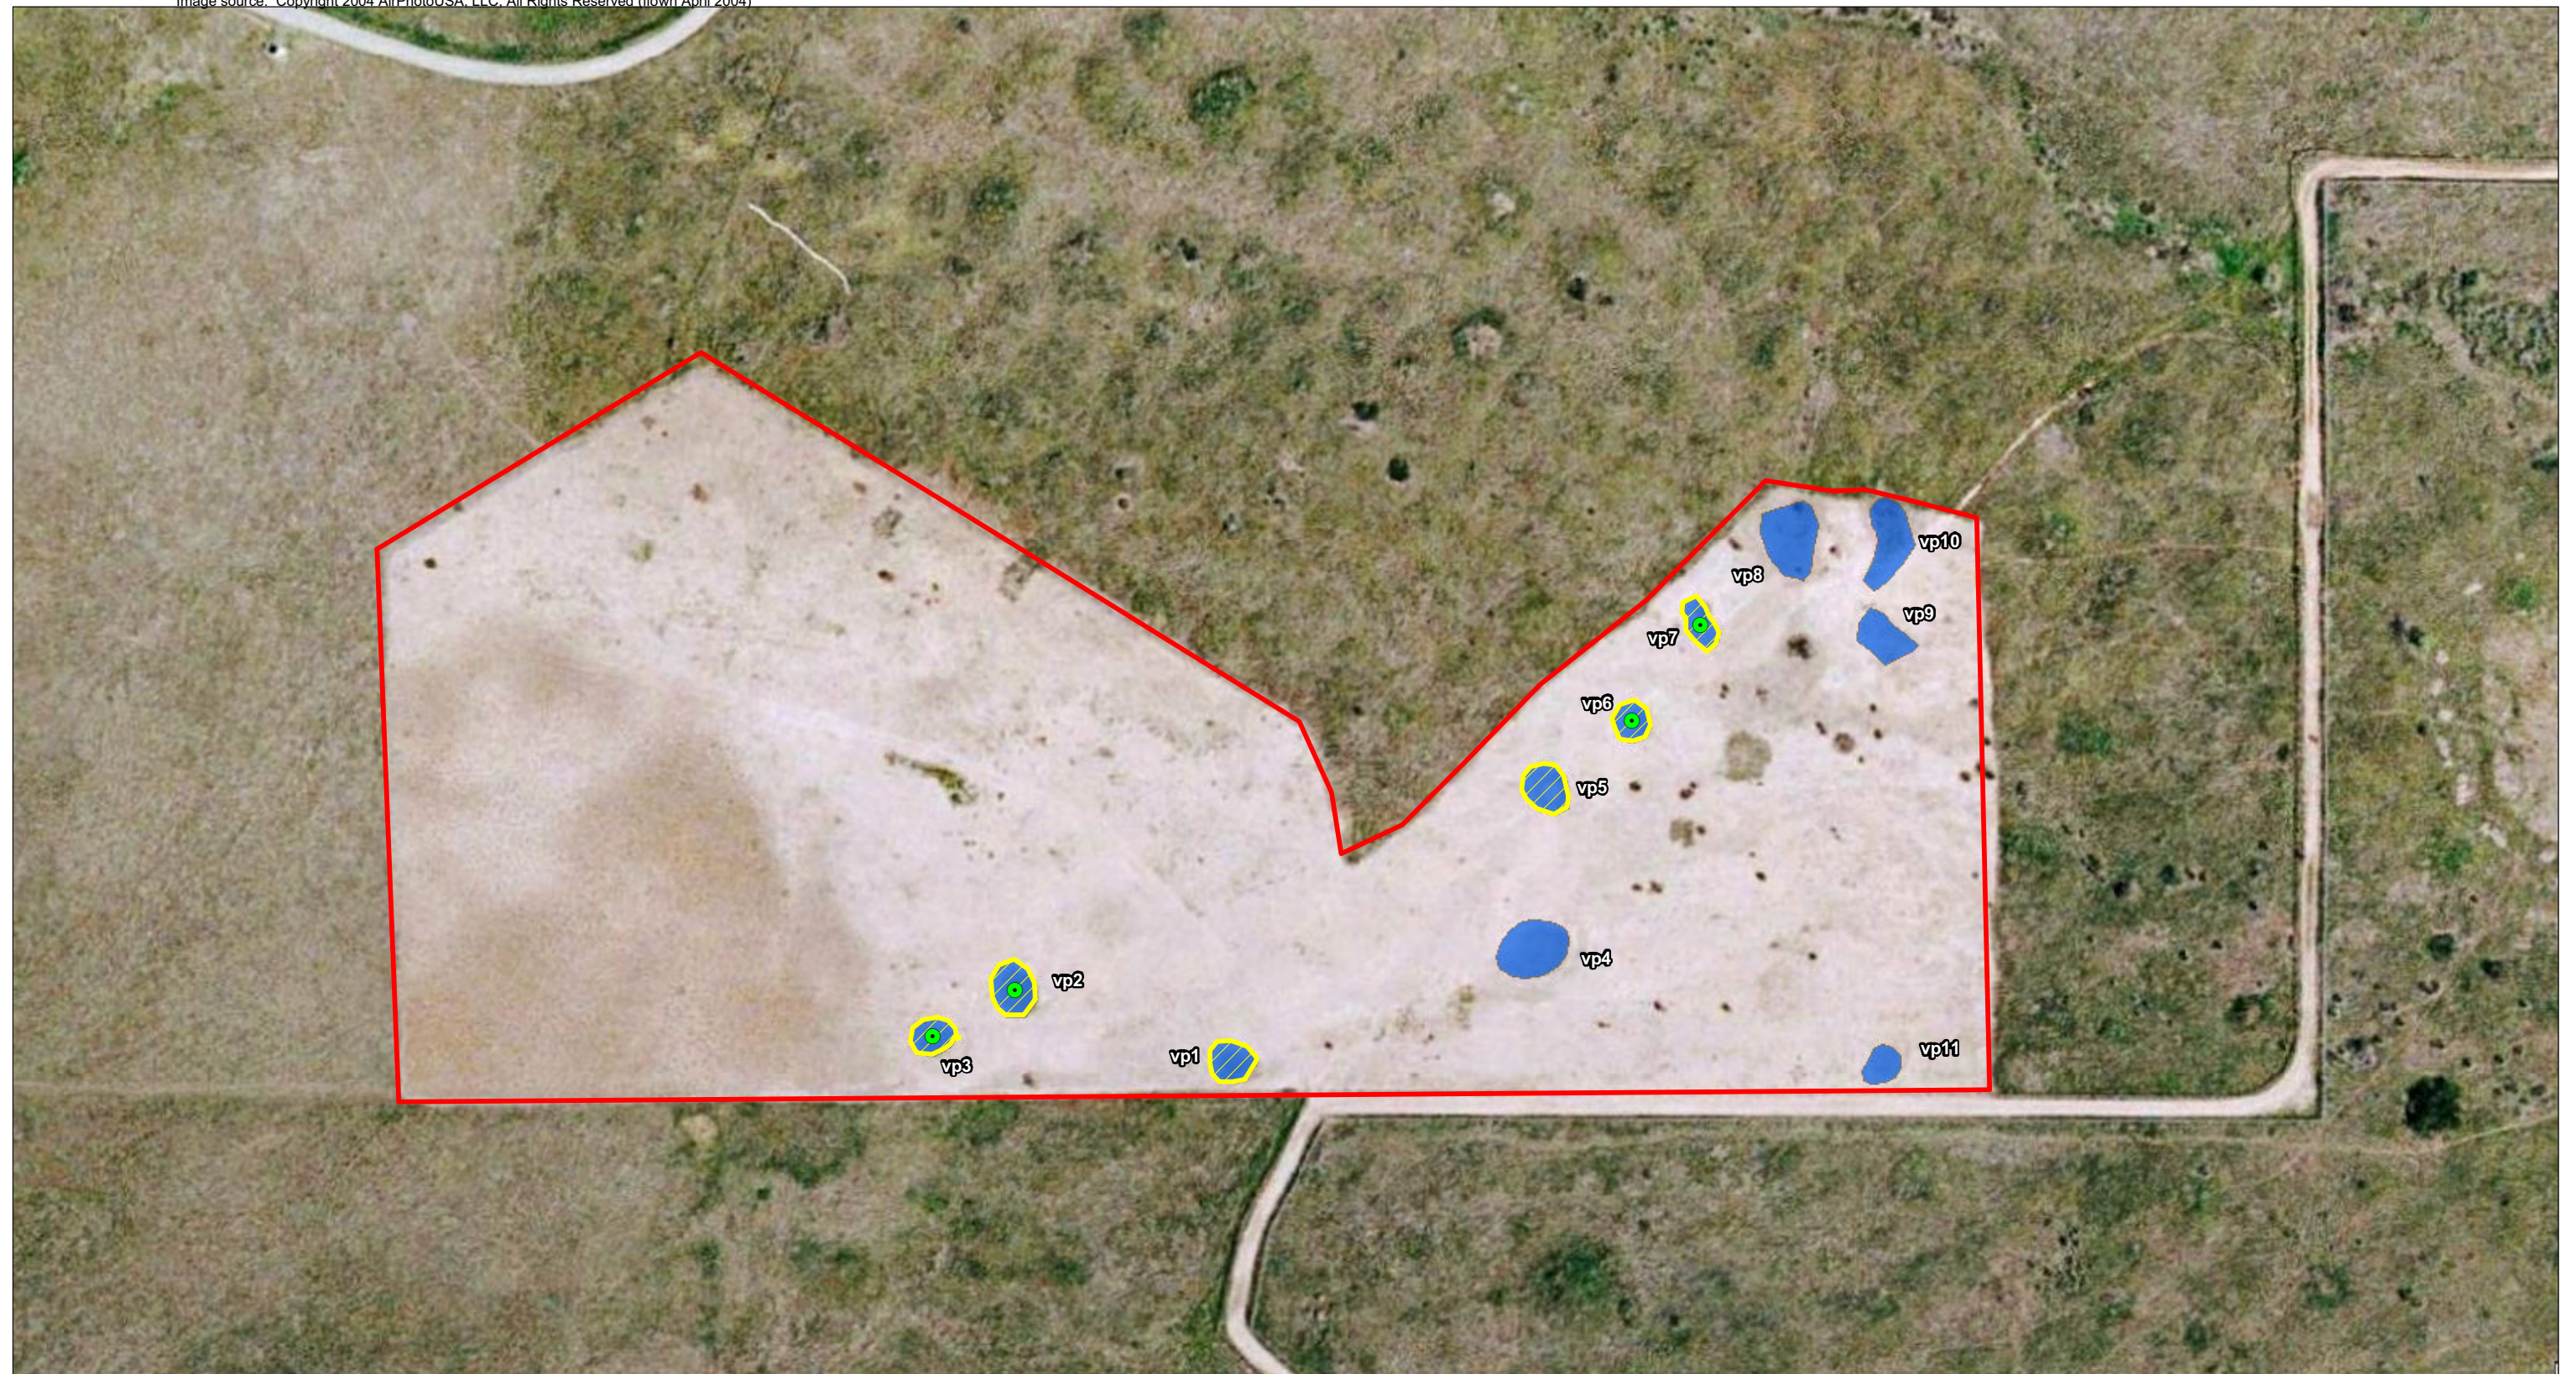
FIGURE 4
Vernal Pool Ponding
and Fairy Shrimp Results

- Restoration and Enhancement Area Boundary
- Restored/Enhanced Vernal Pools
- Ponded 2007
- San Diego Fairy Shrimp Present

During the 2006 to 2007 rainfall year, pools 1, 2, 3, 5, 6, and 7 ponded for one to three weeks (Table 2). These pools had a maximum ponding depth of between 2.0 and 5.5 inches. San Diego fairy shrimp (*Branchinecta sandiegonensis*) were observed in four of the six ponded basins (see Table 2; Figure 4). It is anticipated that during a normal rainfall year, all of the restored/restored pools will pond, and over time all of the pools should support San Diego fairy shrimp.

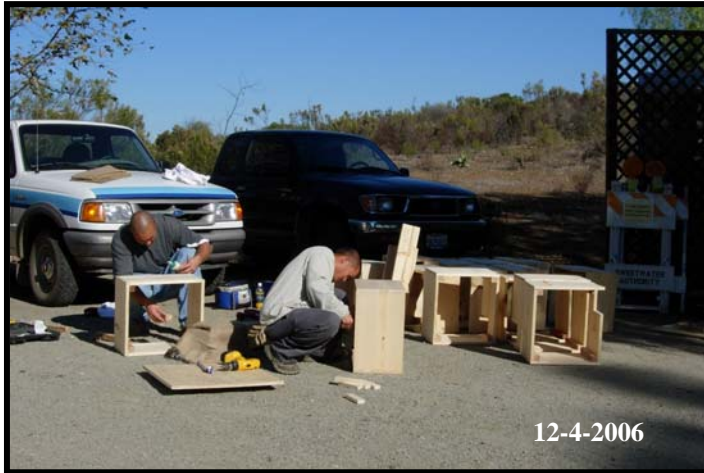
Although other materials have been used successfully, Sweetwater chose wood as the preferred building material for this project. Burrows were constructed similarly to a full scale version provided by C. Winchell (USFWS) and modeled after Collins and Landry (1977). Constructed mainly of one-inch thick solid pine, each burrow contained a 2.25

cubic foot chamber (18 inches long x 18 inches wide x 12 inches deep) with six linear feet of access tunnel. The tunnels are six inches wide and 5.5 inches high, with a 90 degree angle four feet from the tunnel entrance to minimize light entering the chamber. Chamber and tunnel lengths were prefabricated at the Perdue Water Treatment Plant facility and transported to the field for final assembly. Some

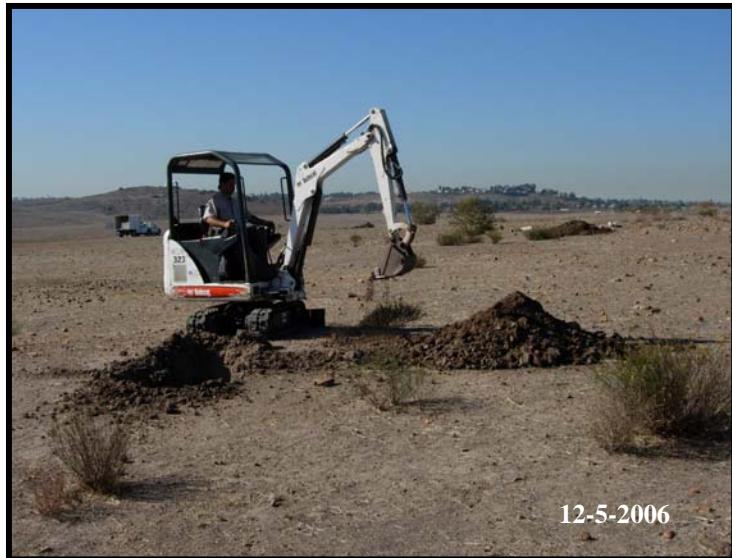
Burrow chamber sites were excavated with a compact excavator. Tunnel trenches were then hand dug with picks and shovels. Tunnel alignments were chosen and placed in a manner that would minimize erosion into the burrow. Each 90 degree tunnel angle was covered in two layers of burlap cloth to minimize soil instruction. Four burrows allowed for two tunnel entrances, and the remaining eleven were constructed with single entrances. Once in place, each artificial burrow system was buried using a tractor with bucket attachment and contoured to a natural topographical appearance with hand rakes. Chambers were covered with at least 12 inches of soil for thermoregulation purposes. Soil was placed up to the burrow entrance to camouflage the access tunnels. To further conceal the burrows by mimicking adjacent soil surface, available cobble and rock fragments were collected and placed on top of the burrow mounds.
