# **Assessment of Wildlife Crossing Sites for the Interstate 15 and Highway 101 Freeways in Southern California**

March 2018

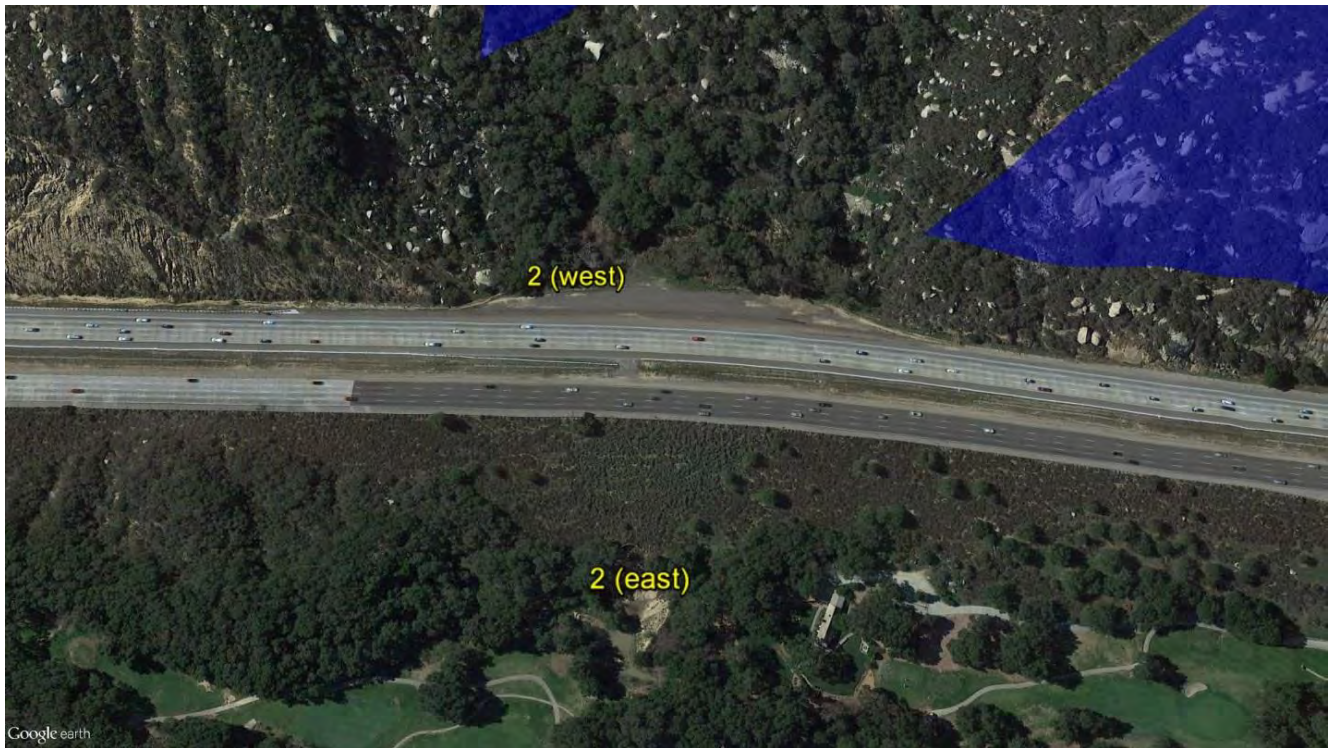
**Site 2 view from east. South end of Temecula Creek golf course is at bottom of picture.**

Design Enhancements: To improve this crossing to reduce the angle, the west side would need to be dug down below existing grade, and the east end would need to be elevated. The culvert would require a redesign or replacement that would allow visible light at each end. A light “sono tube” installed in the freeway median would allow some light to penetrate the structure. Elevation of the east end would result in its outlet being in the approximate middle of the fill slope rather than at the bottom where cover is present. Thus, modification of the vegetation on the fill slope and wildlife trail construction would likely need to be a part of this modification.

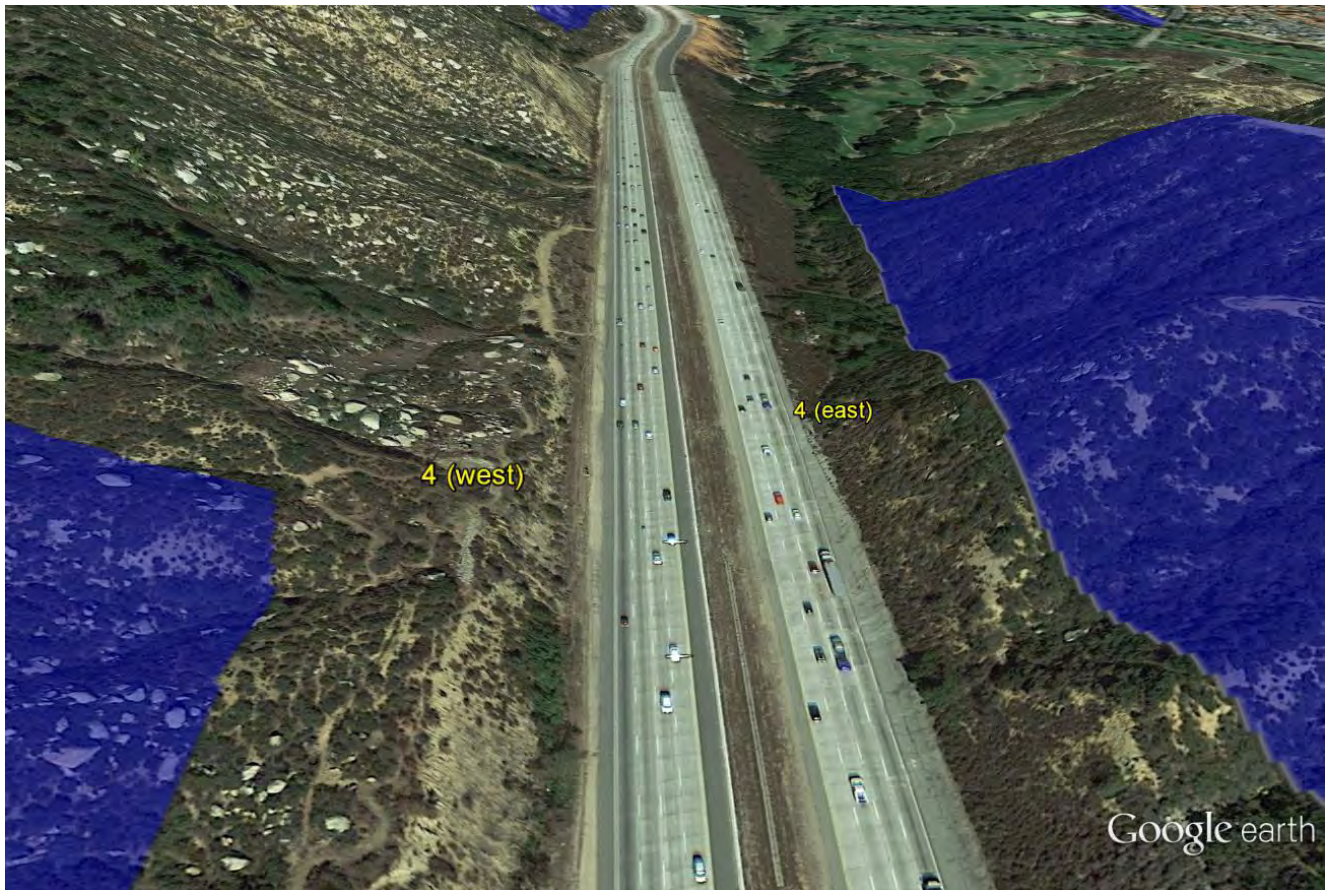
Site 4 looking north. Southern end of Temecula Creek golf course in upper right.

Design Enhancements: The existing culvert would require replacement with or the addition of a culvert that allows for light to penetrate from both ends and is of a design and size adequate to promote use by a wide range of species, including mule deer. The constructability of this crossing structure is not known but likely similar to sites 2 and 3.

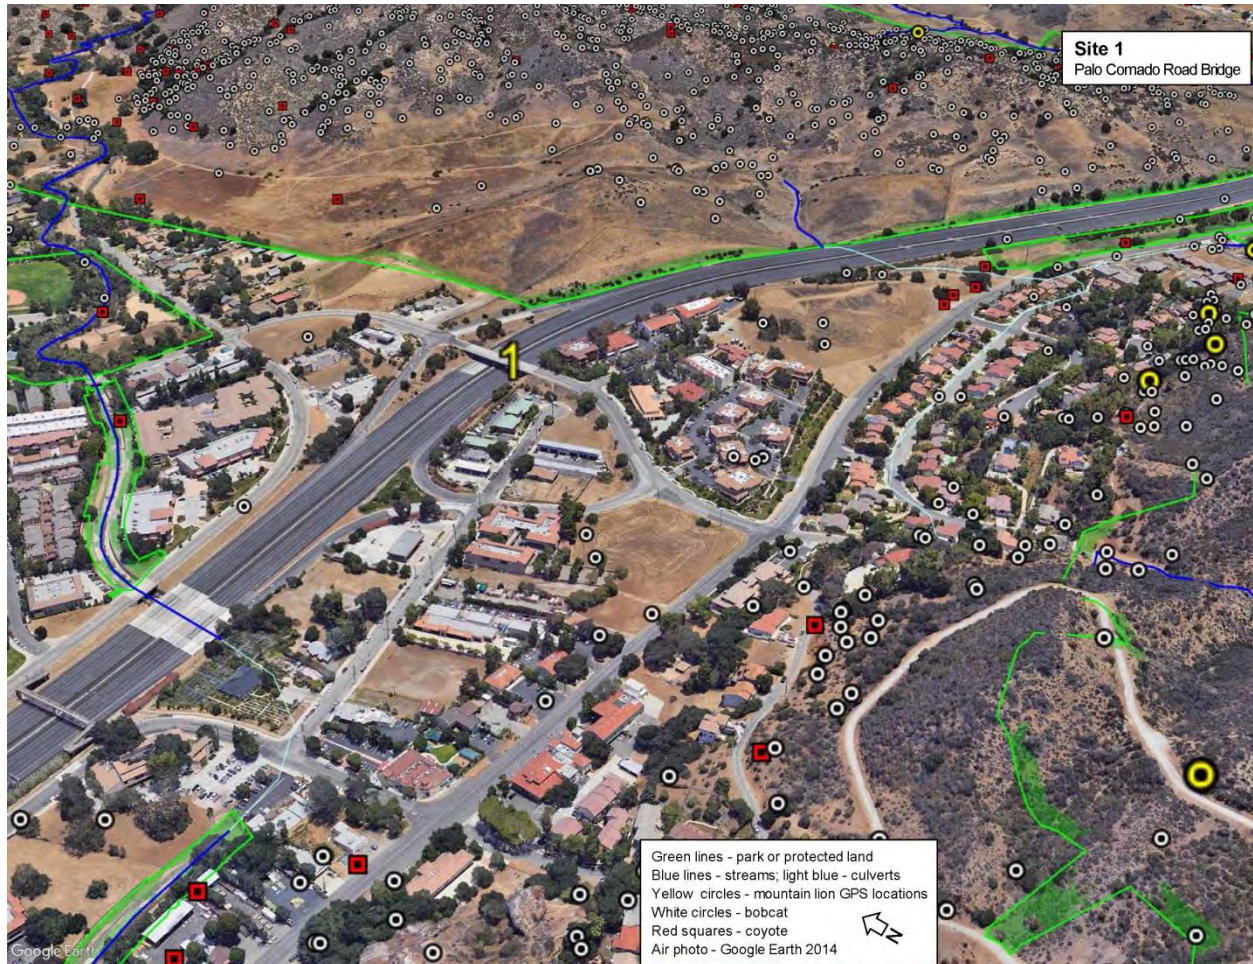
## Site 1: Palo Comado Canyon Road Bridge

Site 1, Palo Comado Canyon Road Bridge, looking northeast. Green shaded line marks edge of protected open space. White circles are bobcat locations, red squares are coyote locations, yellow circles are mountain lion locations.

This is a two-lane vehicular bridge for Palo Comado Canyon Road over US 101. There is one lane in each direction, a shoulder on the east side, and a sidewalk on the west side. There is very little vegetation and almost no cover.

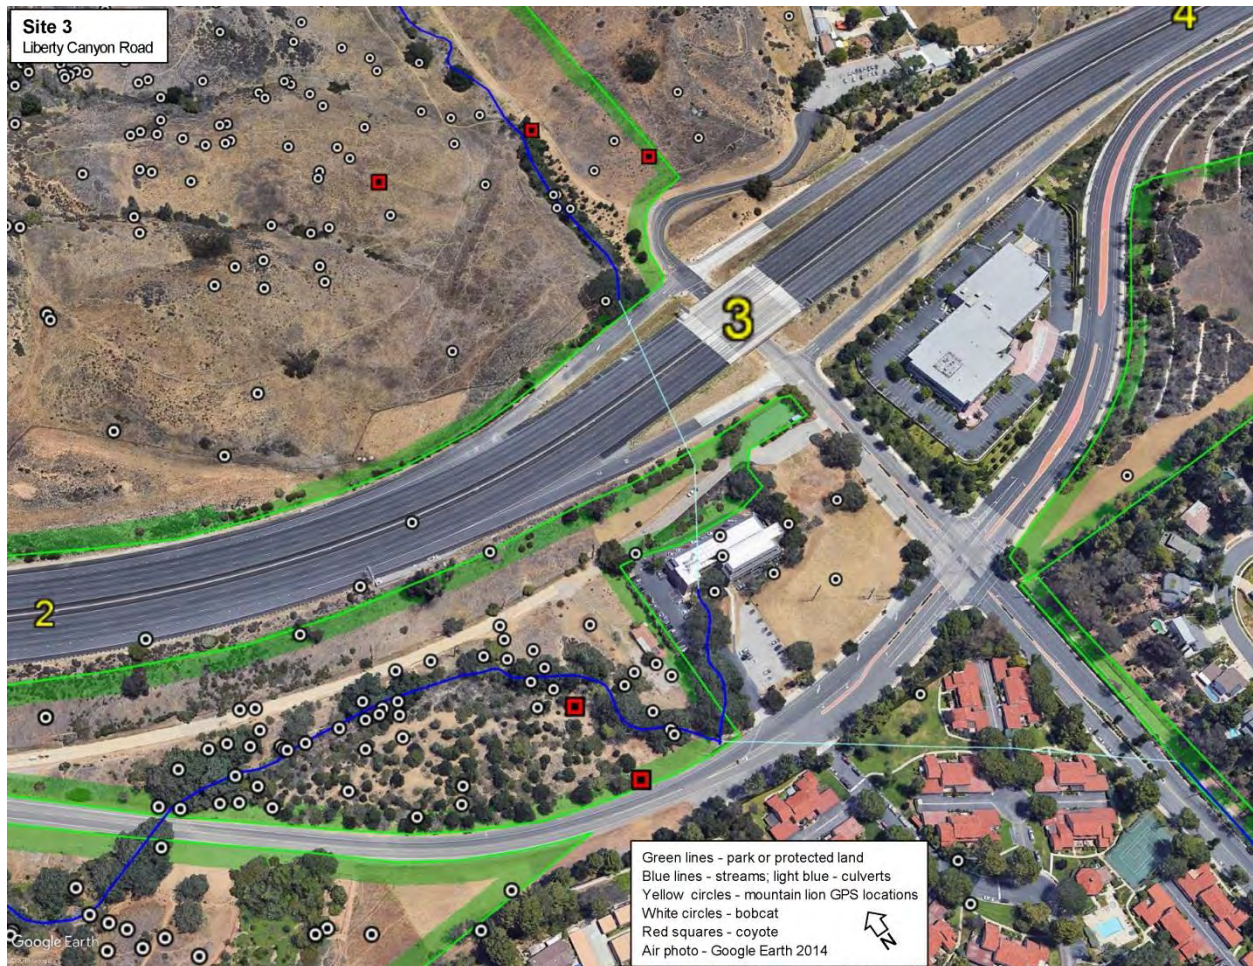
Site 3, Liberty Canyon Road, looking north. Green shaded line marks edge of protected open space. White circles are bobcat locations, red squares are coyote locations.

This is the location where Liberty Canyon Road passes underneath US 101. The road is regularly used to exit and enter the freeway. There are 3 lanes - one in each direction and a turn lane for going left to go eastbound from the north, or westbound from the south. There is also a wide dirt shoulder on either side of the road, under the freeway.

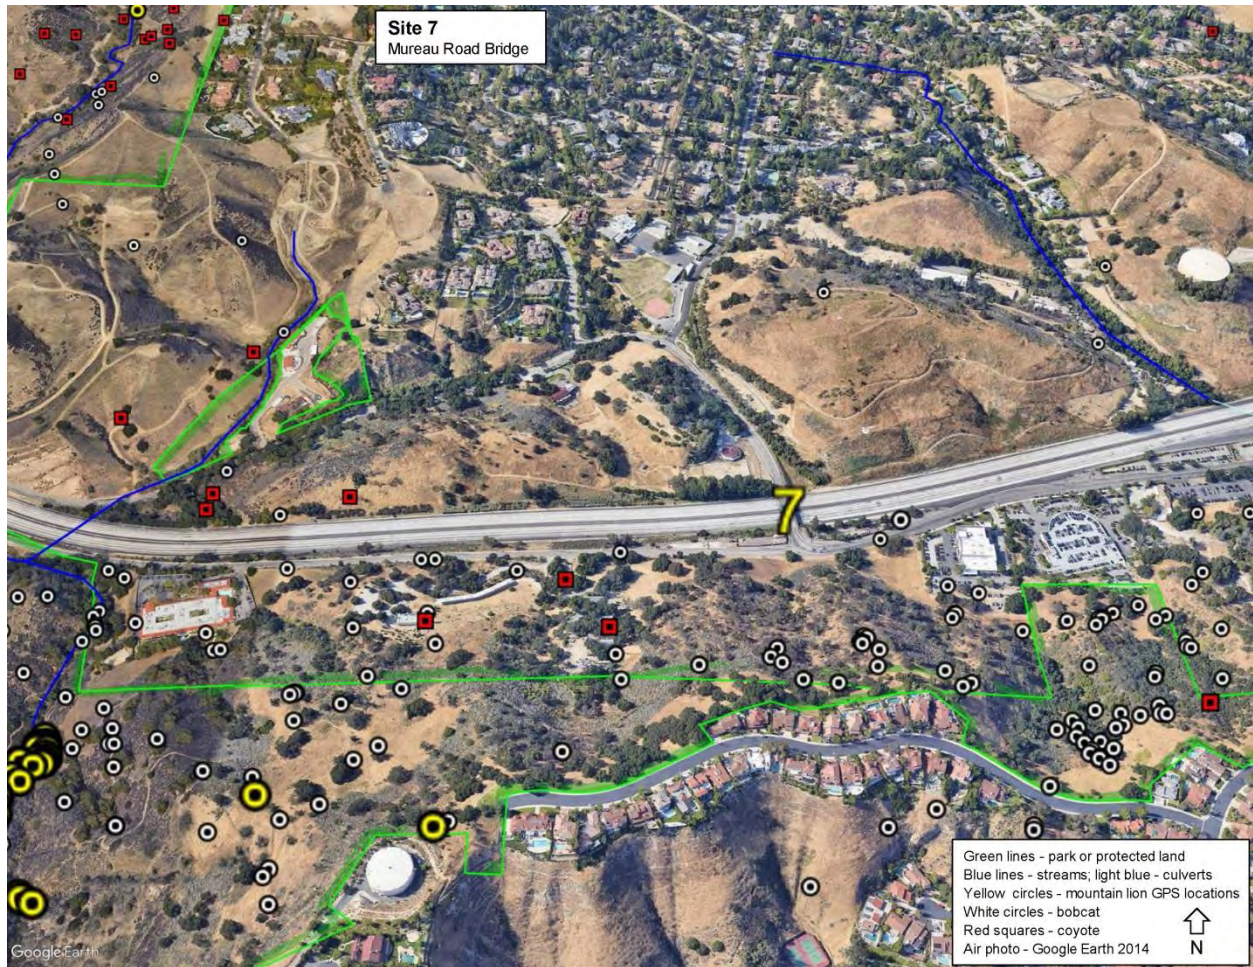
Site 7, Mureau Road Bridge, looking north. Green shaded line marks edge of protected open space. White circles are bobcat locations, red squares are coyote locations, yellow circles are mountain lion locations.

This is the road bridge where Mureau Road passes over the 101 Freeway, in Calabasas.
