Wildlife Crossings

Design for I-15

California Polytechnic State University, Pomona

Senior Project 2018-19

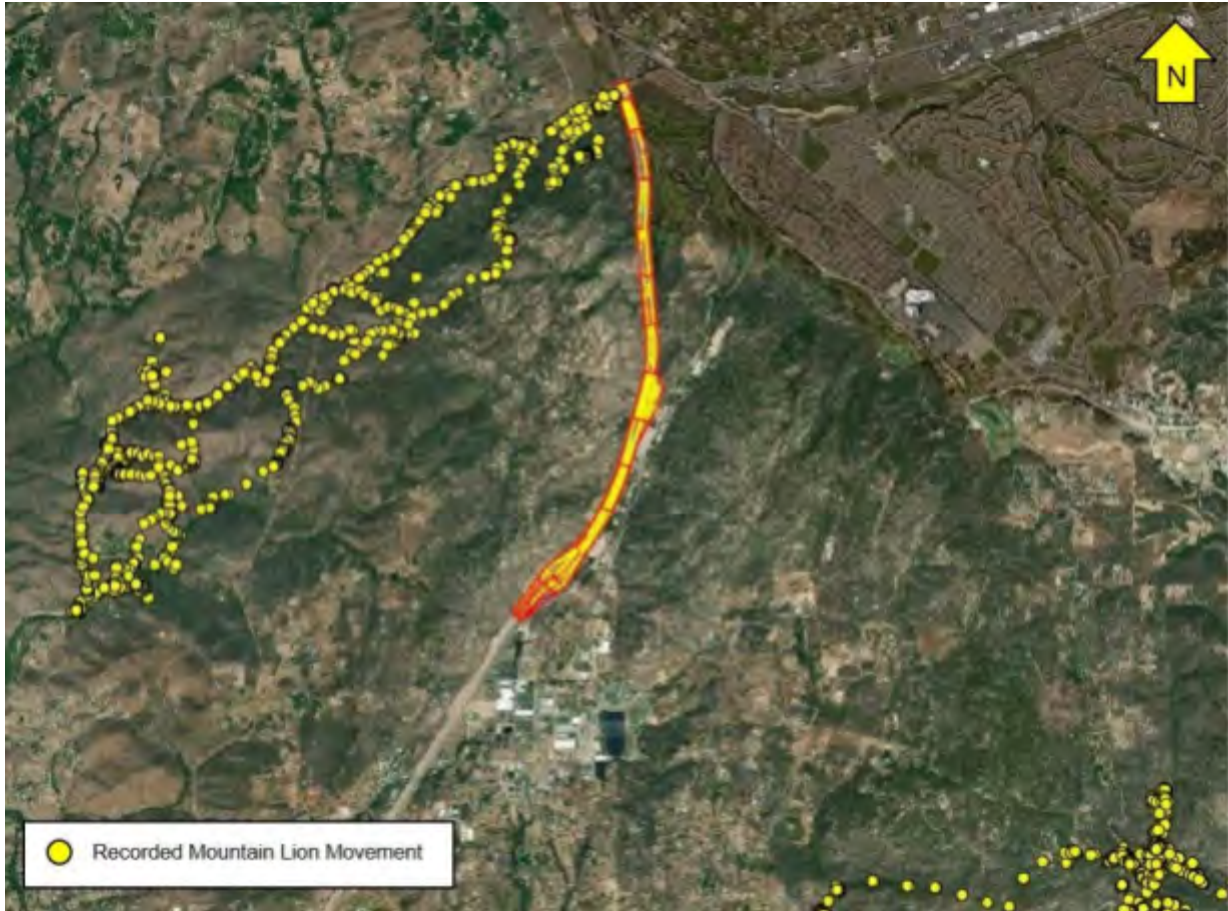
Figure 1.1. Recorded mountain lion movement through GPS collar data.

The urbanization within the city of Temecula, and the installation of Interstate 15, removes the connectivity within the species. The loss in connectivity has resulted in numerous issues such as inbreeding, vehicle to mountain lion strikes, and population isolation. Recent research conducted by UC Davis Wildlife Health Center and The Nature Conservancy, using several methods such as the use of trail cameras and global position system collars, has led to the creation of mountain lion movement corridors in the areas shown in Figure 1.1.

A 7-mile stretch along the I-15 in the Temecula, CA region is being looked at in regards to its impact on mountain lion preservation. This area of urbanization serves as a main cutoff between two populations of mountain lions: one on the east side of the freeway, and one approximately 10 miles northwest of that population. Figure 1.1 shows the GPS collar tracking data of the two aforementioned mountain lions that are separated by the I-15. The yellow dots represent the movement of the mountain lions within their respective regions.

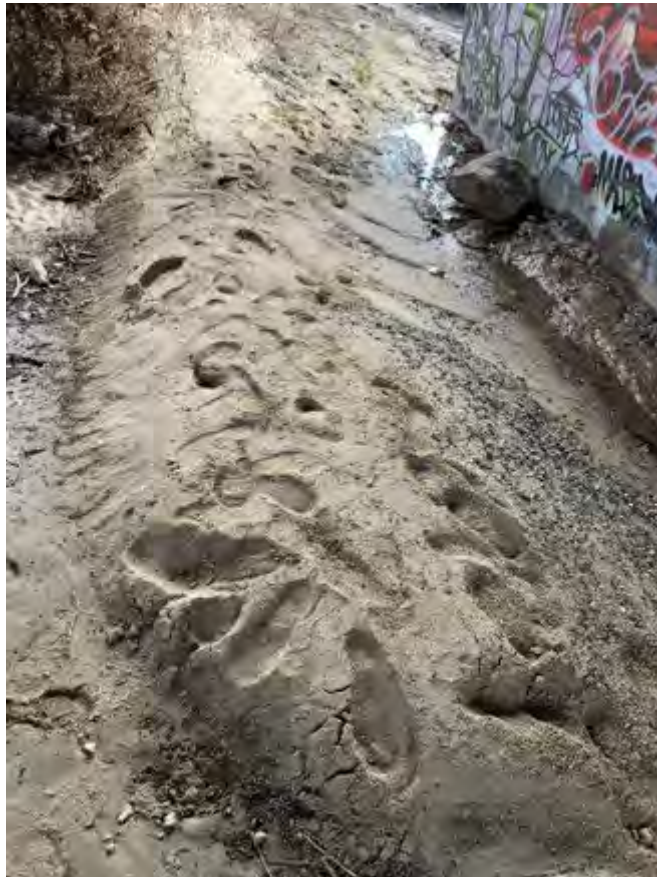
This land is protected by the ecological reserve, however from the field visits it is clear that there is consistent human presence. This was determined after the multiple human interactions during the team's field visits, as well as the presence of footprints found beneath the bridge. A visual of these footprints found on one of the field visits are shown in Figure 3.2.

Figure 3.2. Temecula Creek Site Photo.

Beyond the discovery of the footprints and the interactions with people, there was also significant presence of graffiti along the bridge columns. It was also documented that the creek located further east tends to discharge through this passageway. The site was observed before the rainy season in which the stream was narrow and slow-moving, but still with a consistent current. After the rain, the Temecula Creek Underpass experienced a heightened discharge rate underneath the bridge. However, this discharge rate did not impact the accessibility to cross the bridge. The impacting factor that was observed and prevented potential crossing was the increase in vegetation and cover that was in the area. Figure 3.3 shows the dense vegetation and presence of graffiti underneath the existing Temecula Creek Underpass. It was also observed, that after the rain, there seemed to be a controlled fire that changed the vegetation layout and decreased the density. The team researched for evidence, but found no record of how frequent this is performed in the area, nor the exact purpose of this case.

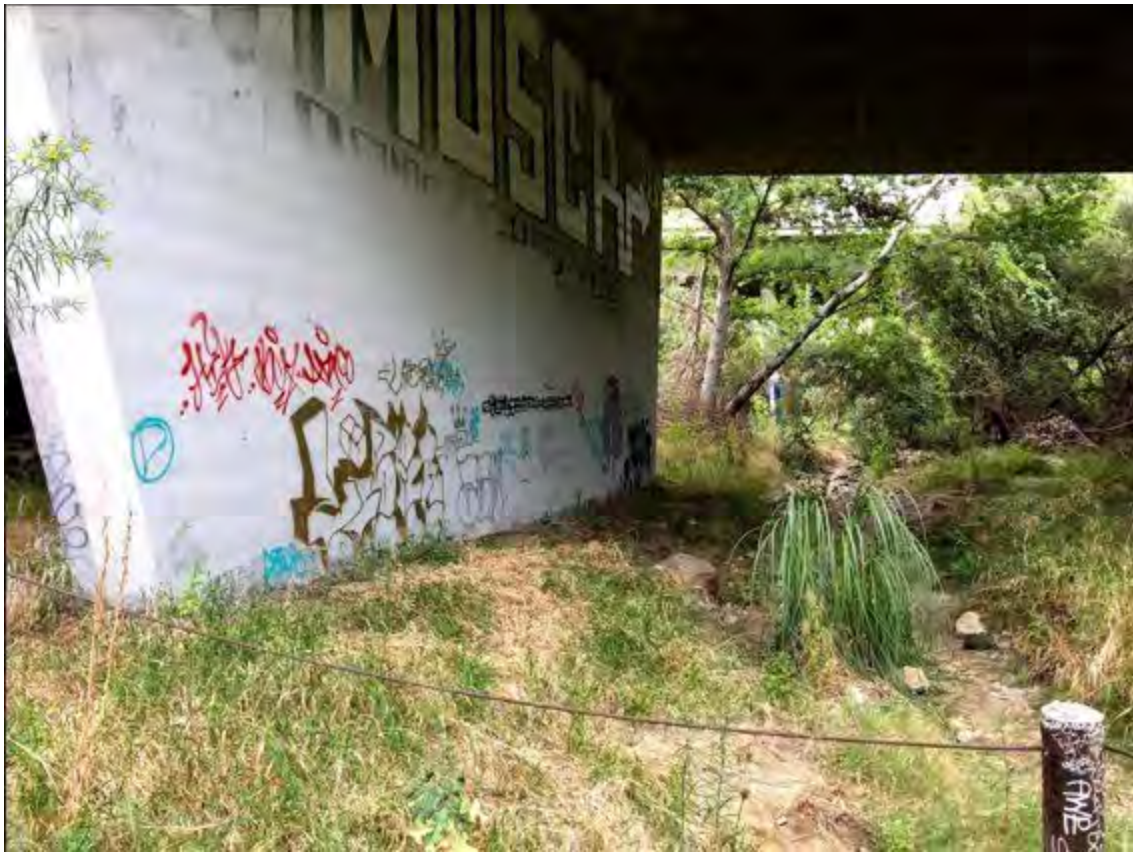
Figure 3.3. Temecula Creek Site Photo 2.

Another key factor in the investigation of the Temecula Creek Underpass was the intense noise created by the traffic overhead. The columns underneath the bridge created an observable echo which increased in volume underneath the Underpass. The initial predictions that the team made was that the riprap located on the edges of the bridge and the spacing of the columns could have increased the observable noise underneath the Underpass.

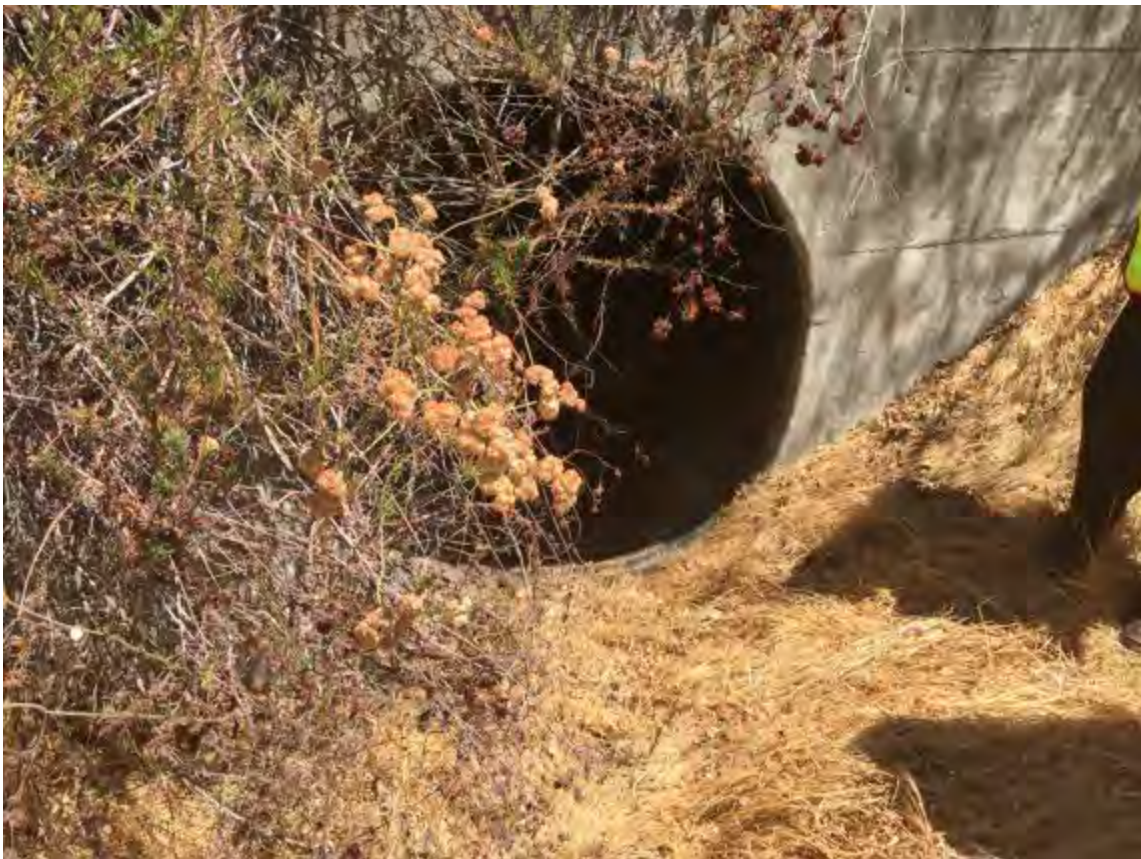
This culvert was approximately 4' in diameter and made of concrete. It is also located near canyons which, according to the report, can serve as natural funnels for a variety of wildlife. Figure 3.4 shows a visual of the existing culvert.

Figure 3.4. Existing Culvert.

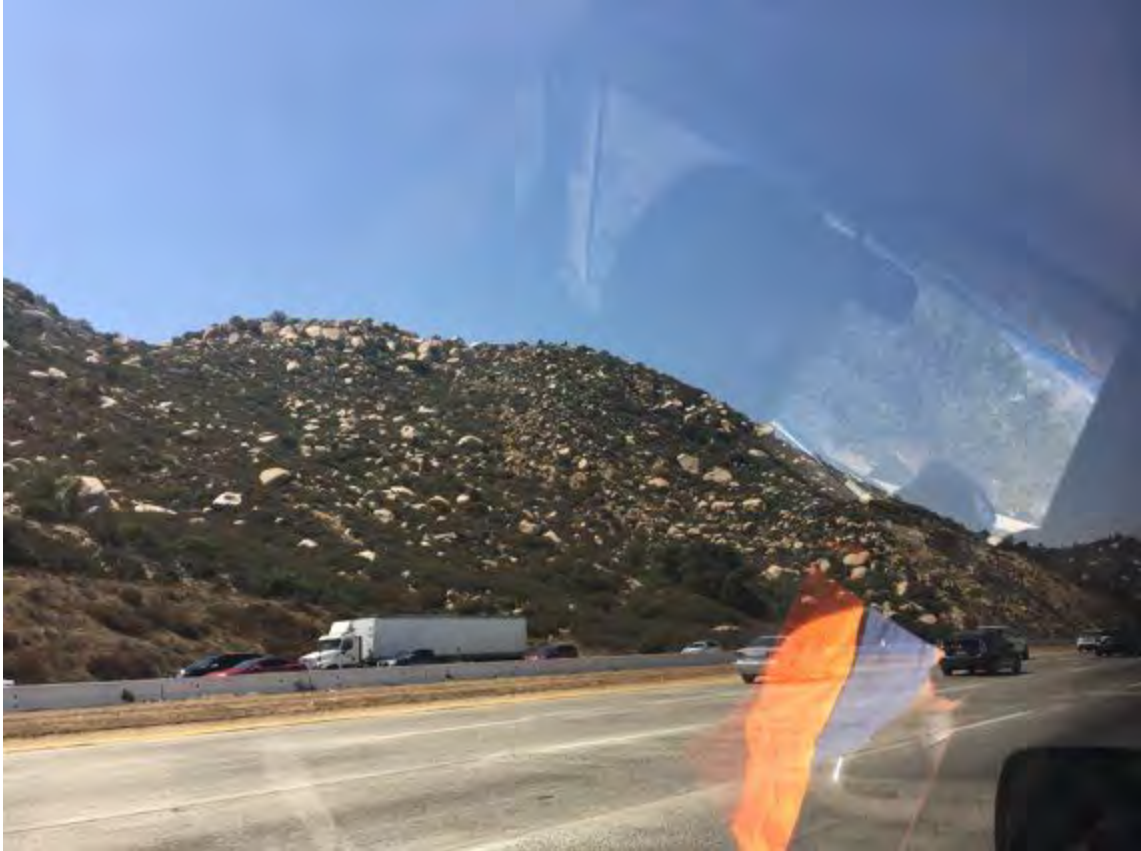
Figure 3.5. Existing Plateaus.

The team also went out to investigate the overpass site locations to gather data on the existing plateaus shown in Figure 3.5. Since the areas surrounding these plateaus are not accessible by foot without a permit, the team drove past these plateaus along the I-15 to see the surrounding area and how that might impact the effectiveness of a possible overpass.

It was observed that there was an existing golf course surrounded by chain link fence. In addition, there was a truck stop area that had many lights surrounding it and consistent traffic flow nearby. These observations were significant due to their possible impact on attractiveness of a wildlife crossing structure to animals. In this area, there were also visible canyons and natural paths that could help the mountain lions discover the overpass. The GPS data from Figure 1.1 shows that the mountain lions tend to travel along the natural canyons and pathways when moving about in their respective areas.

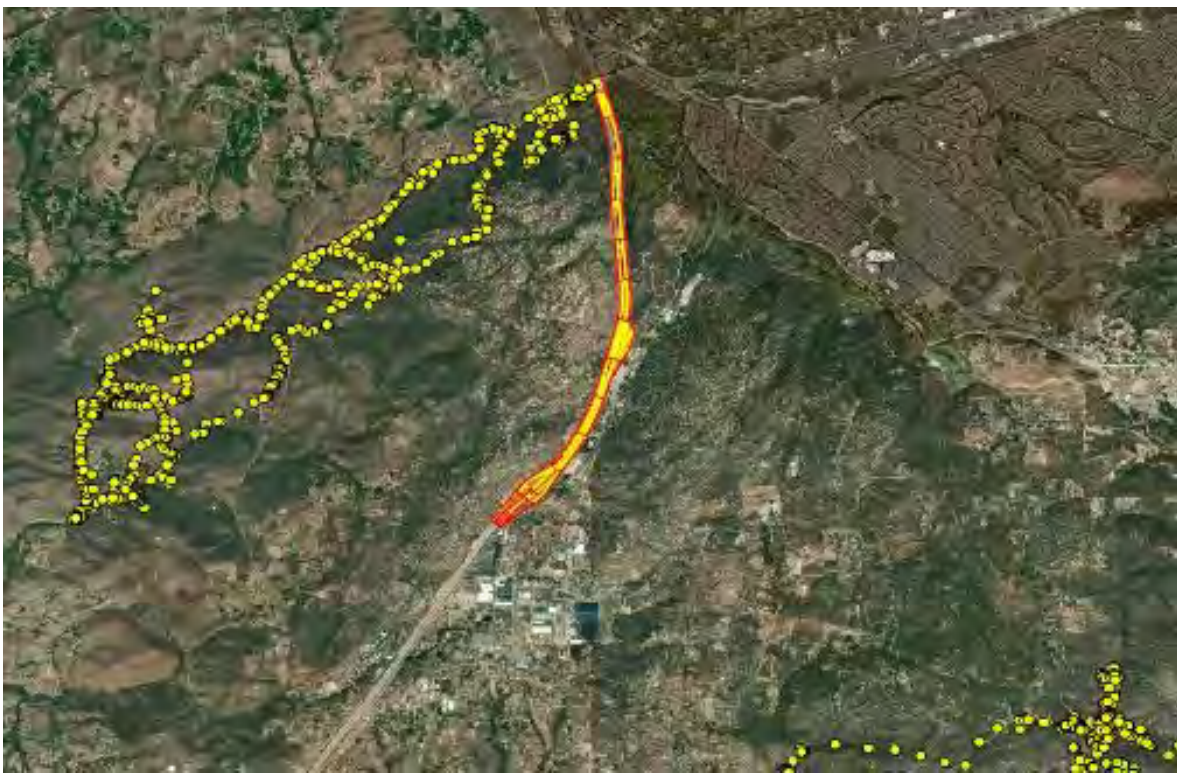
Figure 4.1. Santa Ana Mountain Lion GPS points.

Below are Figures 4.1 and 4.2 which show the separation of mountain lion population in yellow GPS position points, and another image with red triangles which represent the vehicle/mountain lion strikes along the project's focus area.

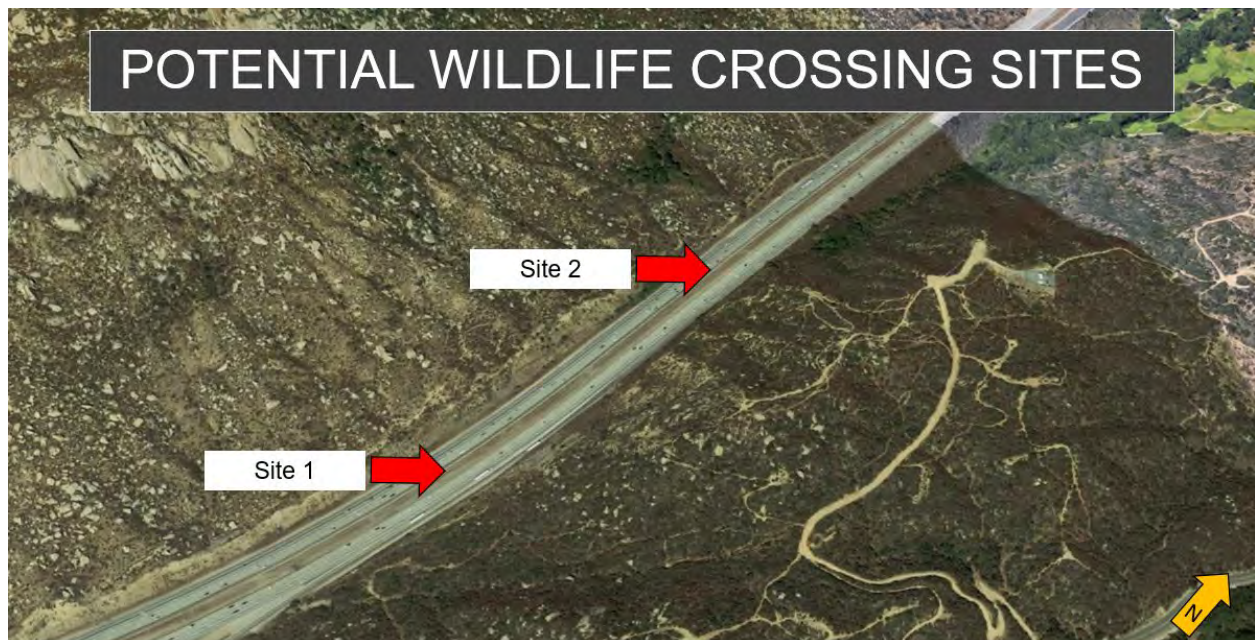
Figure 5.1. Potential Wildlife Crossings Sites.

The site selection criteria allowed the team to narrow down possible locations for the overpass. Two sites were determined to have the most potential in meeting the needs of the mountain lions. These two were compared based on the site selection criteria.

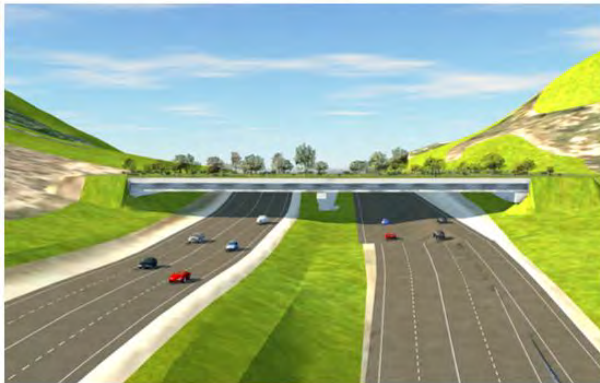
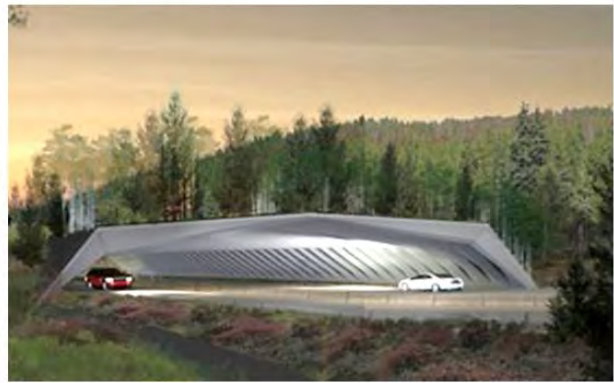
The overpass team decided to study two different design alternatives. The first alternative is a traditional beam bridges with foundations on either sides and median of

Figure 5.5. Design Alternatives.

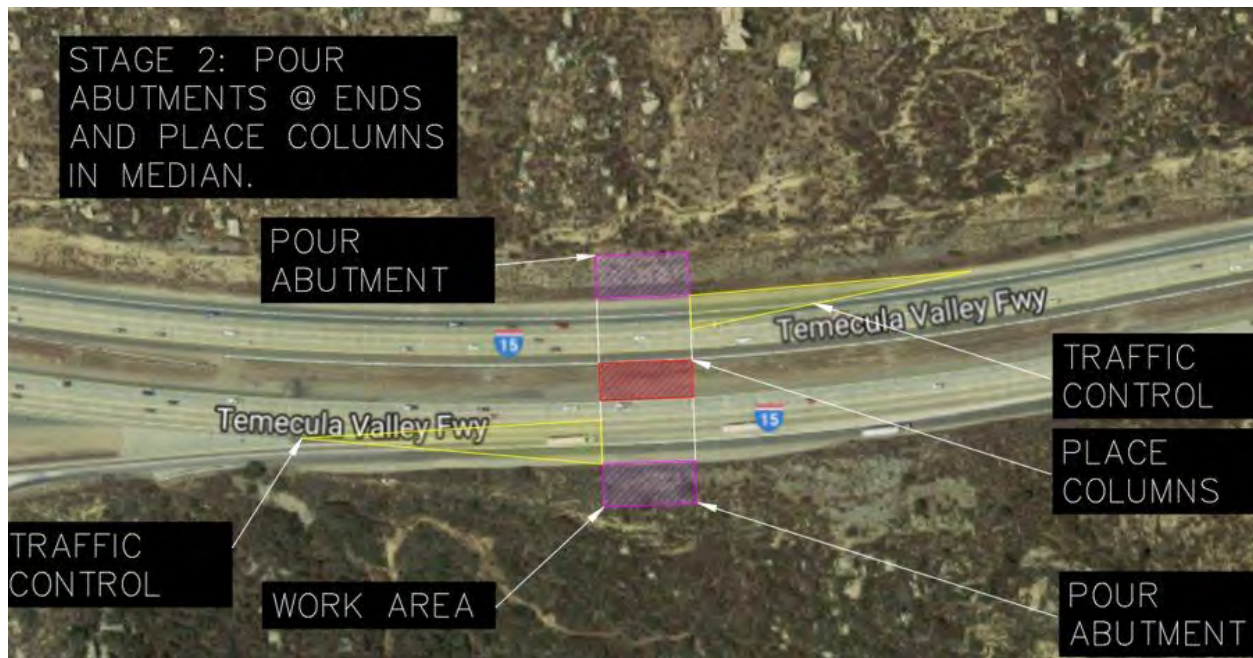
For stage two, the abutments will be poured at the ends of the overpass and the columns will be placed at the median.

Figure 5.10. Construction Stage Two.

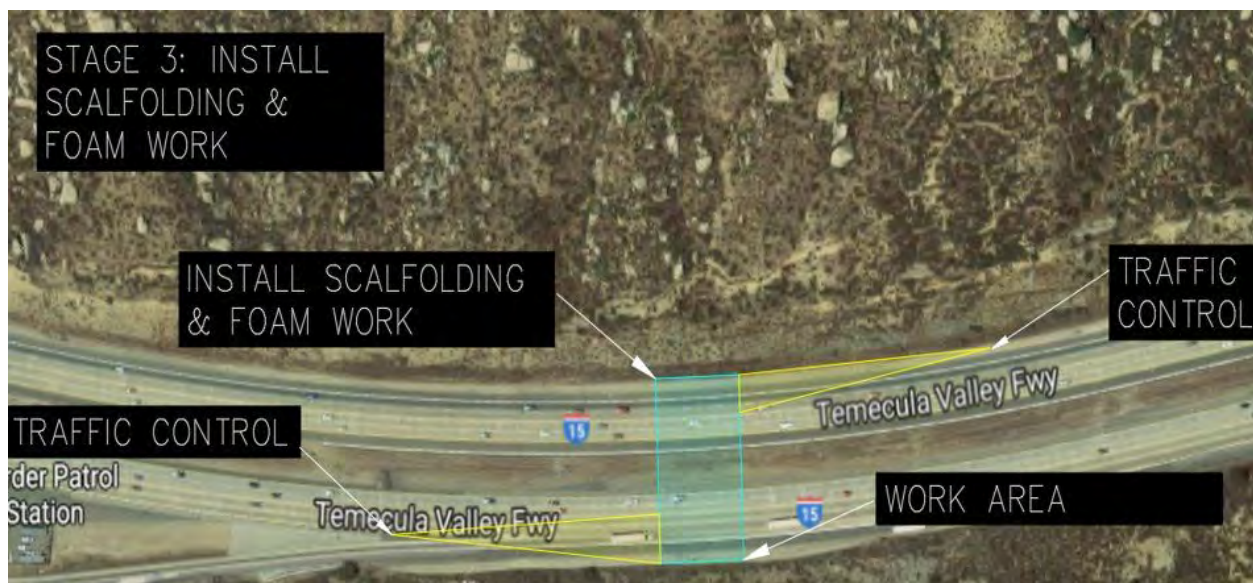
In stage three, we will install temporary scaffolding and foam work throughout the entire work area.

Figure 5.11. Construction Stage Three.

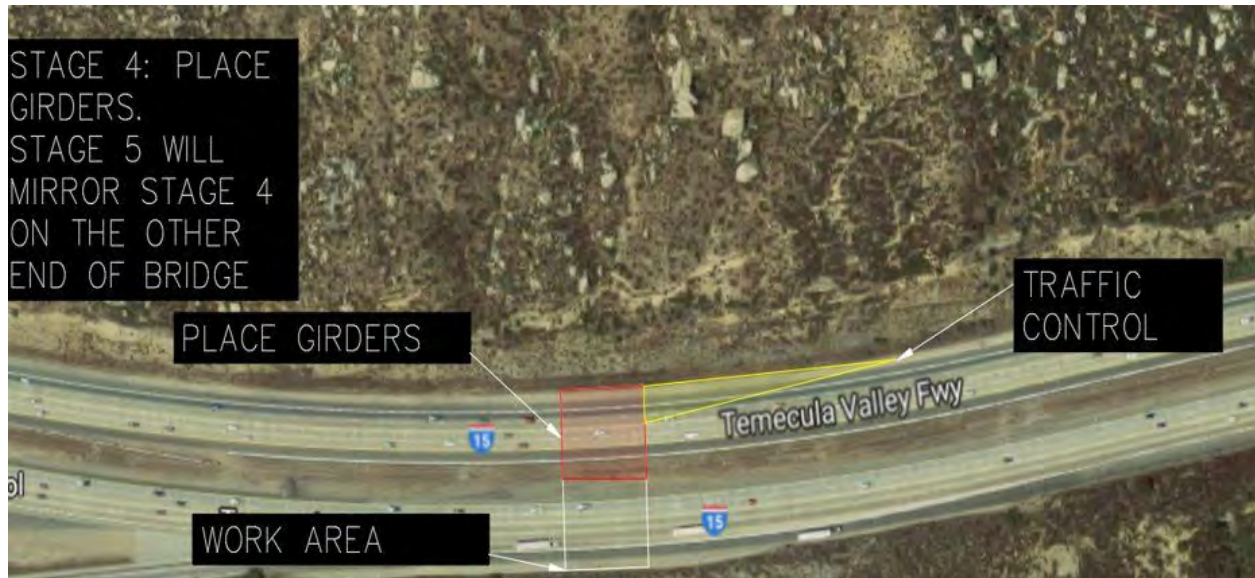
After the scaffolding and foam-work have been installed, we will move into stage four and place girders on the one side of the overpass work area at a time depending on what is more efficient to the construction crew, stage five will be a mirror of stage four.

Figure 5.12. Construction Stages Four and Five.

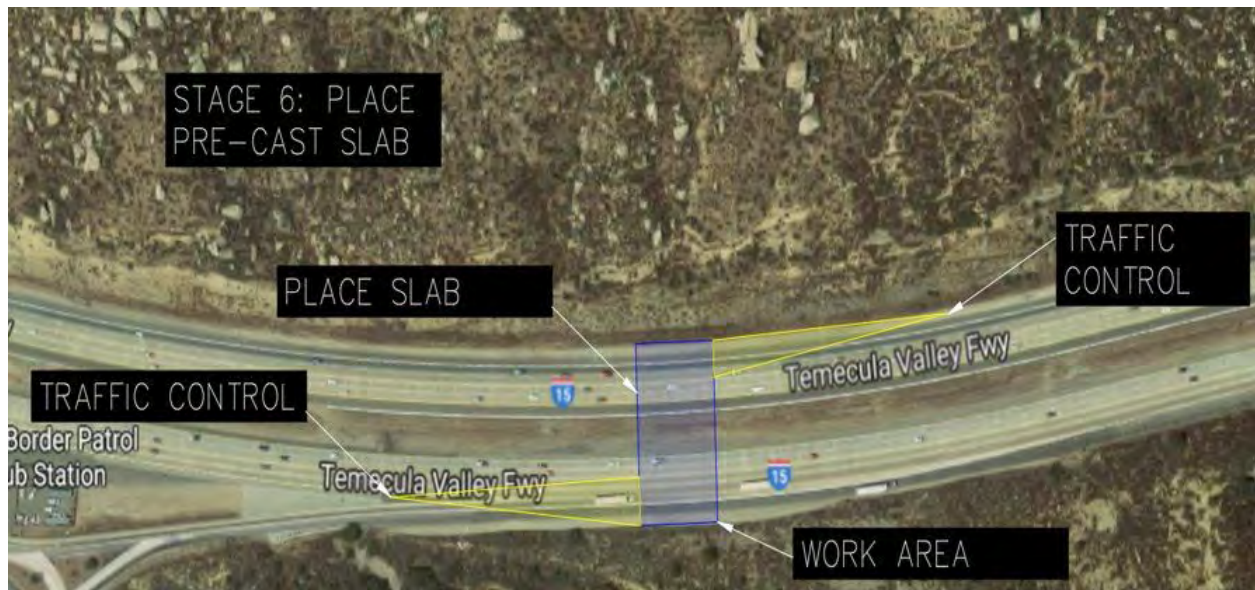
In stage six, the mobilization of the precast slab will take place and it will be placed on top of the girders.

Figure 5.13. Construction Stage Six.

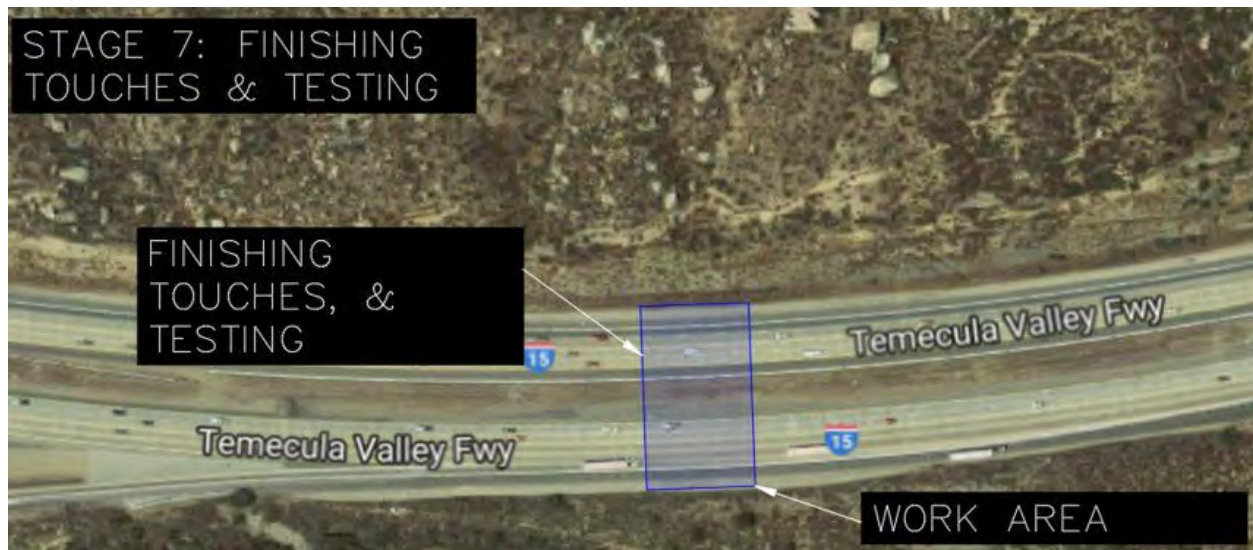
Finally, in stage seven, the finishing touches, testing, and artwork will take place. On the foundation of the foam work there will be paintings and carvings. Throughout the metal fencing, there will be metal artwork be implemented. The finishing touches includes adding soil and vegetation on top of the overpass, along with fencing and our vegetative layout. We prepared this construction staging plan to the best of our ability, but look forward to further work with professionals and get their insights and advice.

Figure 5.14. Construction Stage Seven.

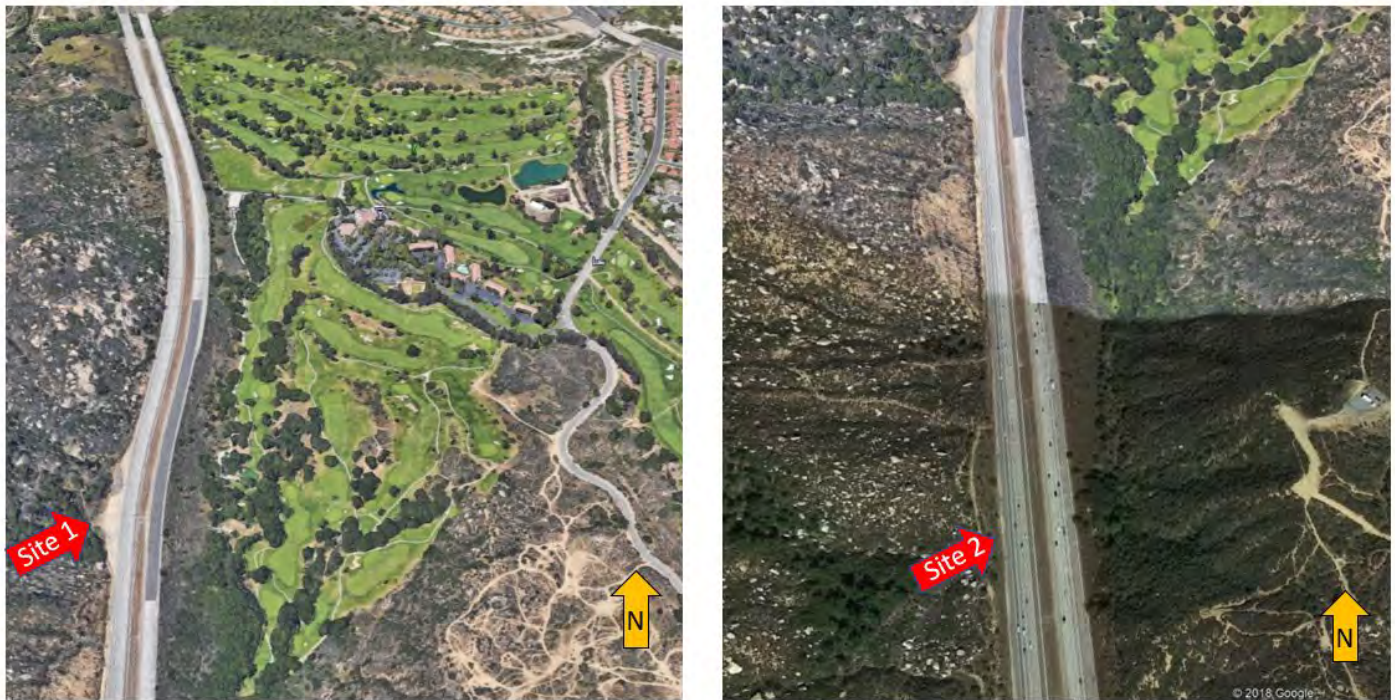
Figure 6.1. Site 1 and Site 2 location for Culvert.

First chosen location is the more northerly of the two closer to the Temecula Creek Inn and golf course. The current culvert in that location has a steep slope of 25

degrees and there is little to no light at the location. At this location there is private land to the East and conserved land to the west of the freeway. The second location is more located about 1 mile to the south of the first with a slight slope of 7 degrees for the existing culvert and little light from the eastern side of the freeway. The land on both sides of this location is conserved. Once vetted through our site selection criteria, site 2 is clearly the better choice scoring much higher than site 1 as shown in the figure below.

Within the 7 mile stretch of the focus area, site 2 is recommended as the most advantageous when looking at the criteria, the 'focus site'. This focus site was ranked based on the criteria and discussed with the UC Davis Wildlife Health Center and is consistent with their findings and needs.

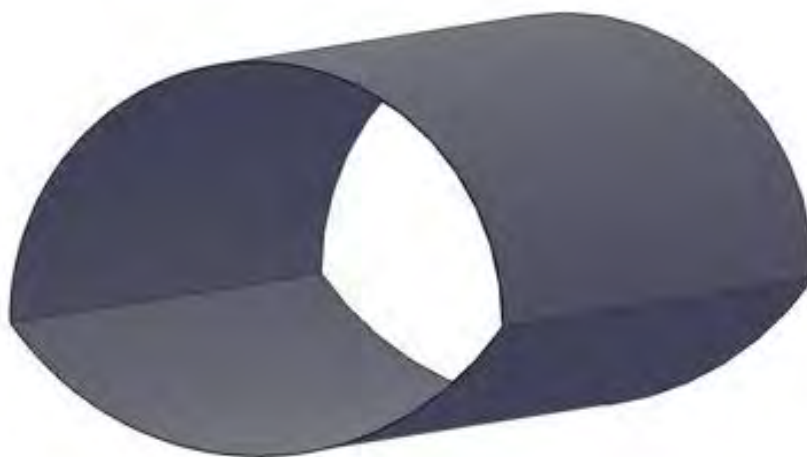
The second design alternative is a corrugated steel pipe. Corrugated steel pipes come in various sizes and shapes. For our project, we selected an arch shape with a span of 11 feet and 10 inches, and a height of 7 feet and 9 inches. In addition, these pipes come in different thicknesses depending on the needs of the project. The thickness used to meet the requirements of our project was 8 gage for steel thickness and 0.168 inches for galvanized thickness. The maximum amount of earth cover for this specific size of a steel pipe is 16 feet. Since corrugated steel pipes are not as heavy as concrete box culverts, they do not require foundation to be placed on. This factor is one of the positive attributes of the corrugated steel pipe as it will require less cost and an easier construction process. The method of construction chosen for this alternative is called pipe ramming. Pipe ramming or pipe jacking is another trenchless construction method for culvert which involves a launch shaft from which the pipe is driven through the soil in the desired direction and angle.

Figure 6.5. Corrugated Steel Pipe Culvert Design.

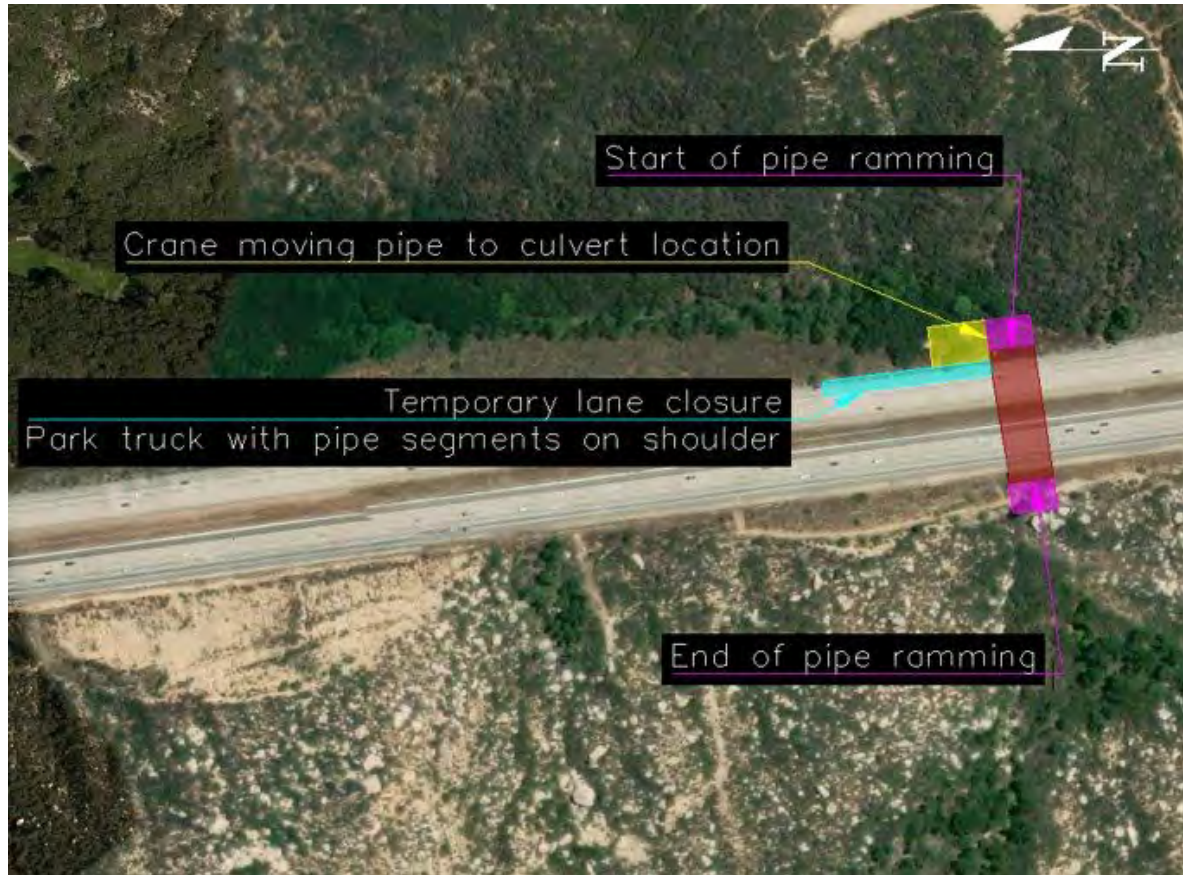
As shown in the figure below, pipe ramming will begin from the eastern side of the freeway. Some area is needed for the crane to move the corrugated steel pipe to the location and temporary lane closures on the Northbound side of interstate 15 are necessary to ensure the safety of construction crew and the public.

Figure 6.9. Construction Stage Two - Corrugated Steel Pipe.

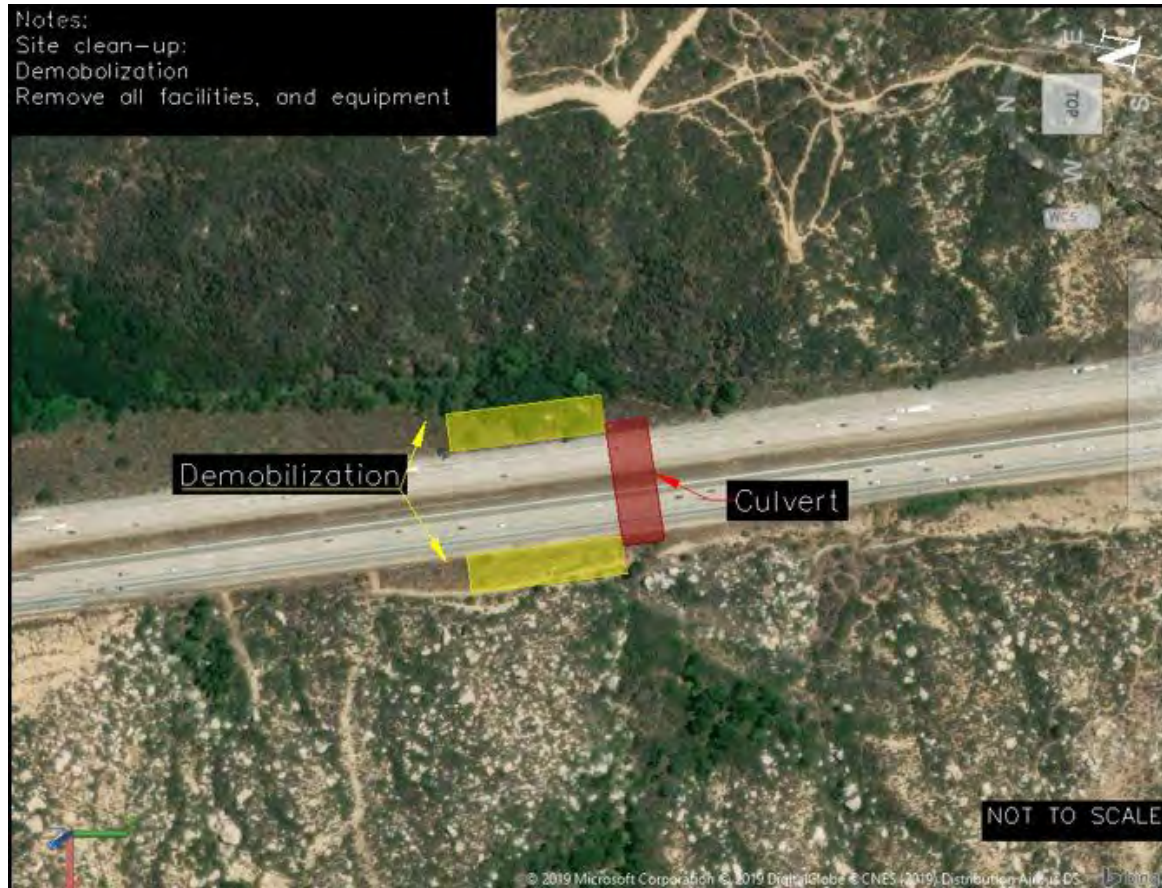
The final stage of the construction phasing is the demobilization. For this final stage clearing and grubbing will take place, along with removal of facilities and equipment.

Figure 6.10. Construction Stage Three.

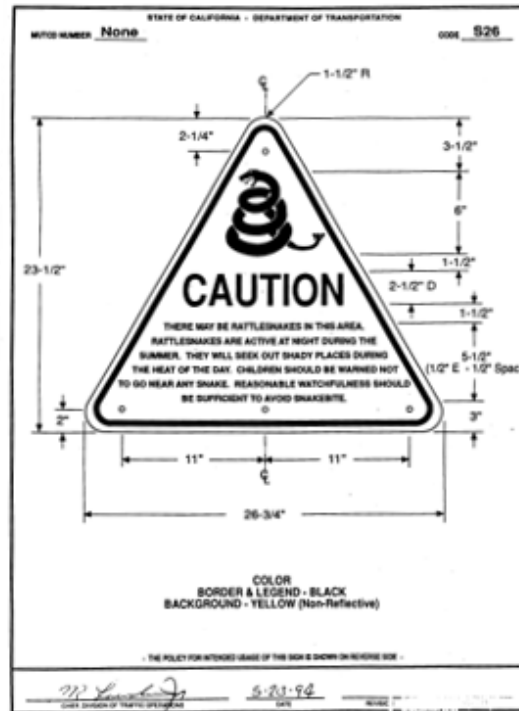
Figure 7.1. S26(CA) sign from MUTCD.

The first phase was chosen to be warning signs. The signs would display warnings for danger of rattlesnakes, which are also native to the area, as well as mountain lion signs, both shown in the figures below.

The rattlesnake sign above is a standard sign that can be purchased and placed on posts throughout the area. These signs are more familiar to the public and can be found on a variety of different hiking trails in the surrounding area. The mountain lion sign would be similar to the one pictured below. This sign would serve as a “danger” warning sign, as well as an educational sign of the presence of these animals in the area. In Phase 1 of this project, these signs would also be placed on posts throughout the underpass. The first phase would be installed and observed for 2 months before proceeding to the following phase. During this time the traffic in the underpass would be recorded with the help of the ecological reserve to determine the effectiveness of this phase. It is expected that this phase have a small effect on human traffic since it is anticipated that people inhabiting this area are already familiar with the wildlife species

For both alternatives the amount of signs that would be used will be ten, five beware of mountain lion signs and five beware of rattlesnake signs. Each sign would cost roughly \$20 and the total cost for this would come up to be \$200. Both alternatives would have the same amount of vegetation placed, and the unit cost would come out to be \$7000. The final cost that would come out the same are the sound baffles. The sound baffles are the most expensive part of the project which is why it is the final phase. There would be sixty sound baffles placed on the underpass to reduce the noise caused by the freeway.

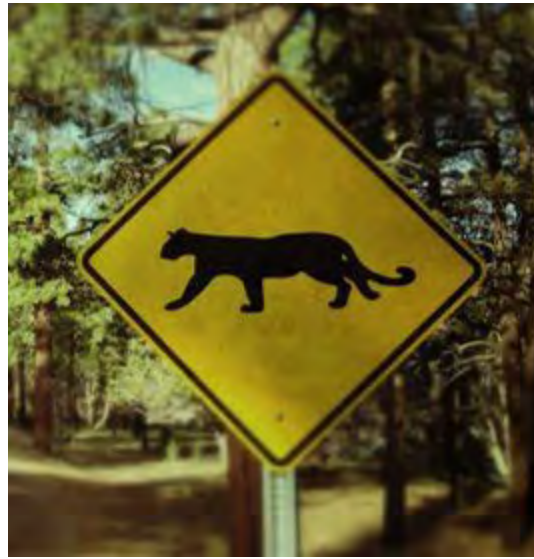
Figure 7.2. Caution Mountain Lion Sign.

present and will not be easily deterred by this. Thus, these signs are intended to be more effective at deterring new trespassers or community members who are exploring the area.

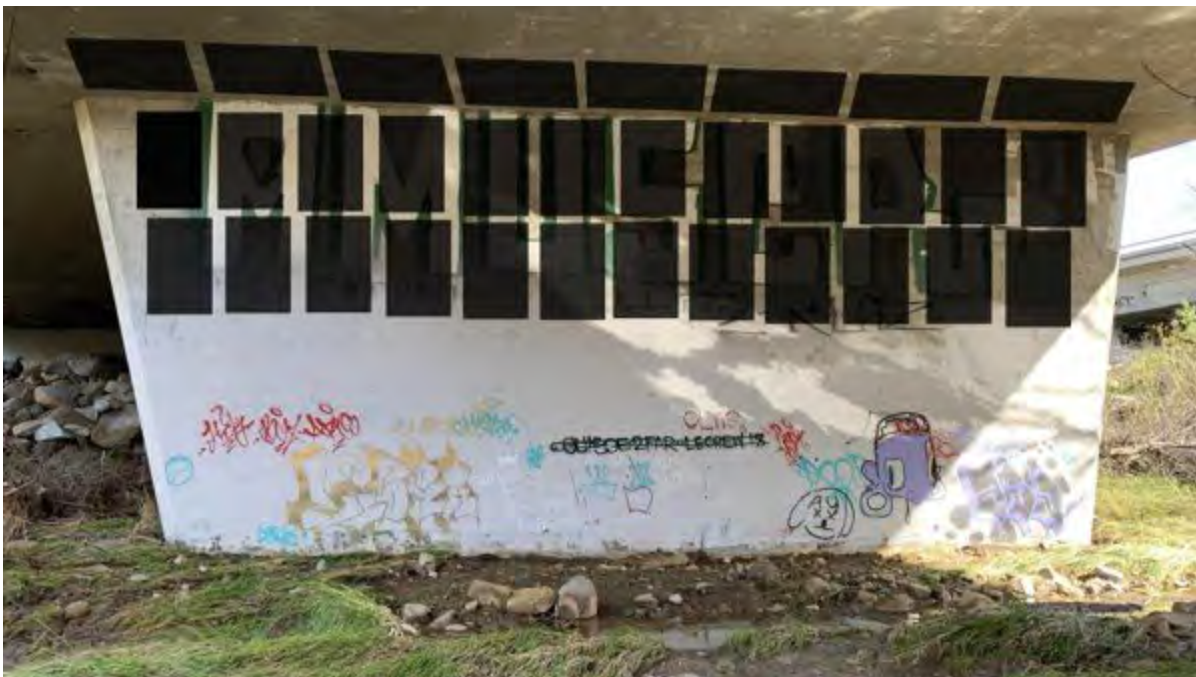
The final, and most expensive phase is the installation of sound baffles along the walls of the underpass. It was recommended by conservancy professionals to install sound baffles in the Underpass section. Various companies were contacted to give quotes and estimates of the effectiveness of their materials. It was determined that the sound baffles would provide a noticeable difference in the sound volume as well as the echoing produced and therefore a meaningful addition to the proposal. The sound baffles would be placed with a 1' offset along the walls of the underpass. This is also the last phase because it was determined that sound is the least likely deterrence for the mountain lions because of their consistent exposure to it.

Figure 7.6. Sound Baffle Layout.

Below is a visual of what the sound baffles may look like once installed on the walls of the underpass. The installation of these sound baffles is estimated to reduced the volume within this area by 10 decibels. It was also observed by a group of the professionals that the sound was varied depending on what openign you went through in the underpass. Therefore, the intention of the sound baffle phase is to reduce the presence of this echoing.
