Quarterly Status Report Overview

Work Performed this Period:

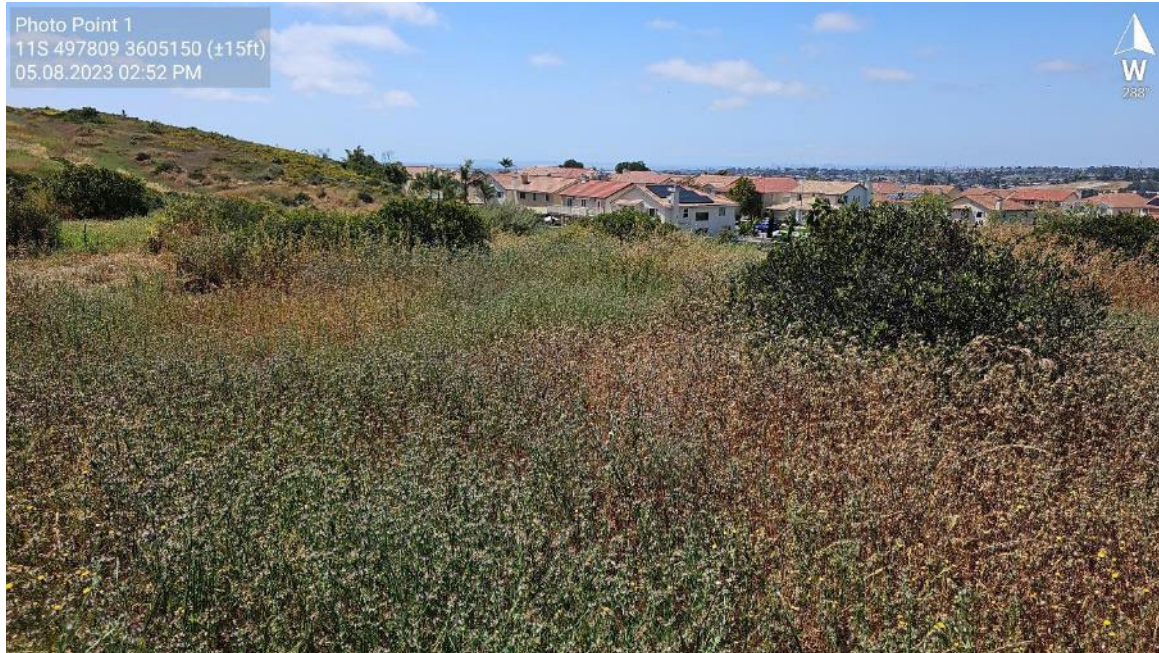
Photo 1.1: Photo point 1 shows baseline conditions for Area 1. Nonnative species cover in Area 1 is estimated at 90%. The most abundant nonnative species include Tocolote thistle (*Centaurea melitensis*), Mediterranean stork's bill (*Erodium malacoides*), Annual yellow sweetclover (*Melilotus indicus*).

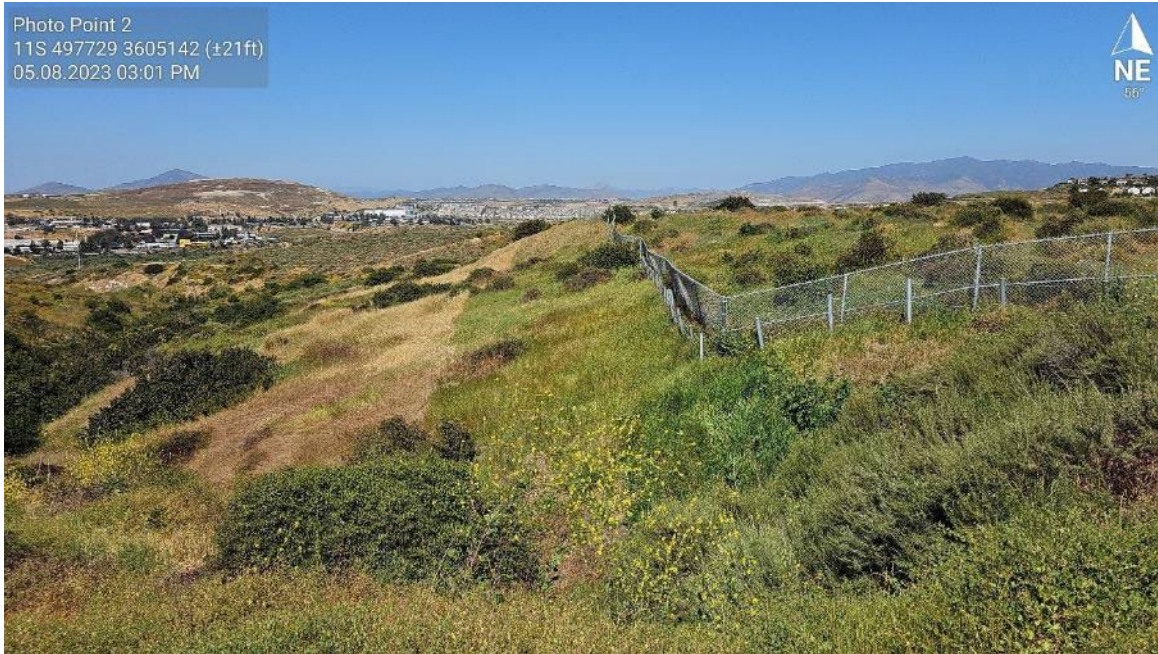
Photo 2.1: Photo point 2 shows baseline conditions for Area 2. Nonnative species cover in Area 2 is estimated at 80%. The most abundant nonnative species include Tocolote thistle, Italian ryegrass (*Festuca perennis*), slender wild oat (*Avena barbata*), and Mediterranean stork's bill.

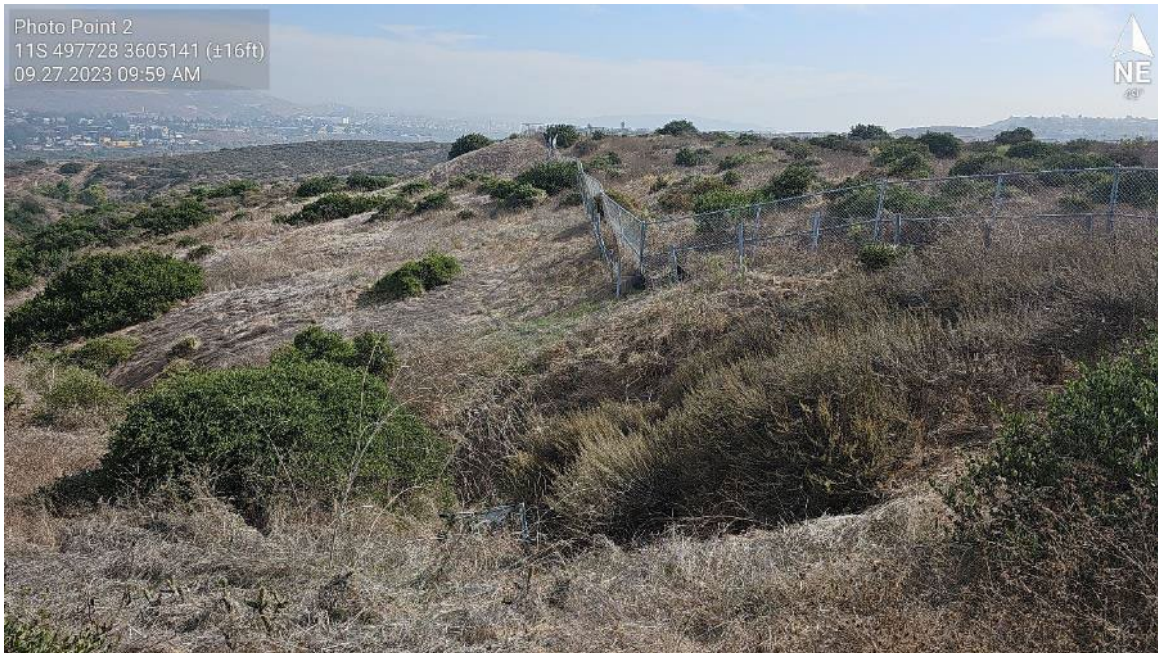
Photo 2.2: Photo point 2 on September 27, 2023. Nonnative species cover in Area 2 is estimated at 80%. Most nonnative species have senesced.

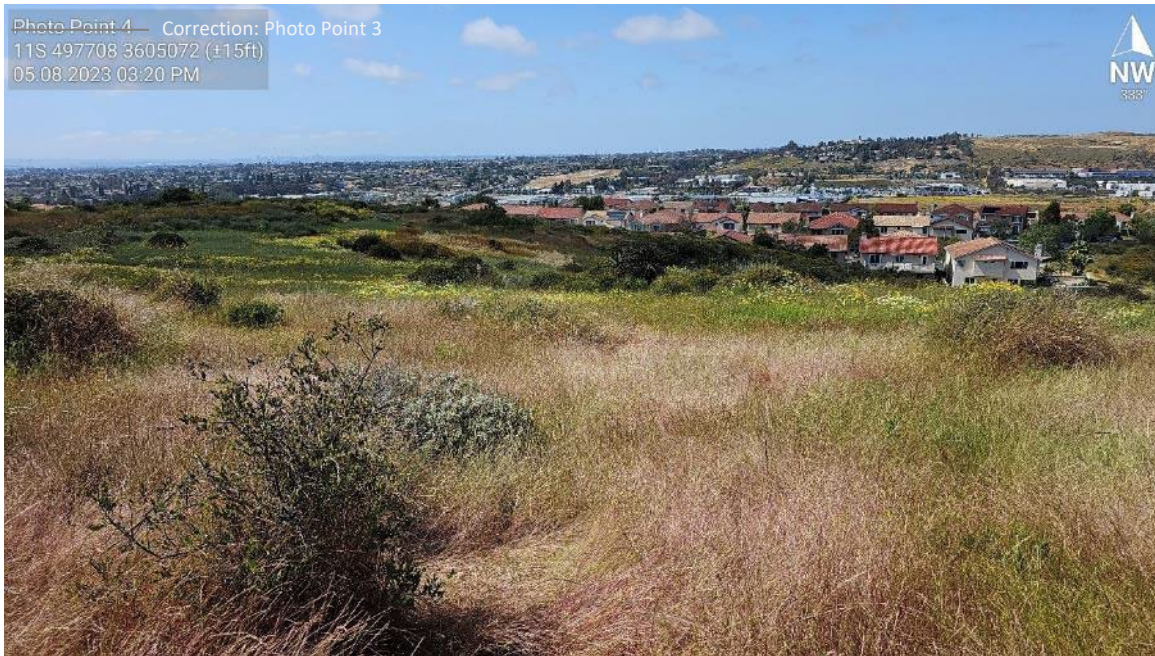
Photo 3.1: Photo point 3 shows baseline conditions for Area 3. Nonnative species cover in Area 3 is estimated at 85%. The most abundant nonnative species include Tocolote thistle, crown daisy, Italian ryegrass, and slender wild oat. *Note: previous reports incorrectly labeled this as photo point 4.*

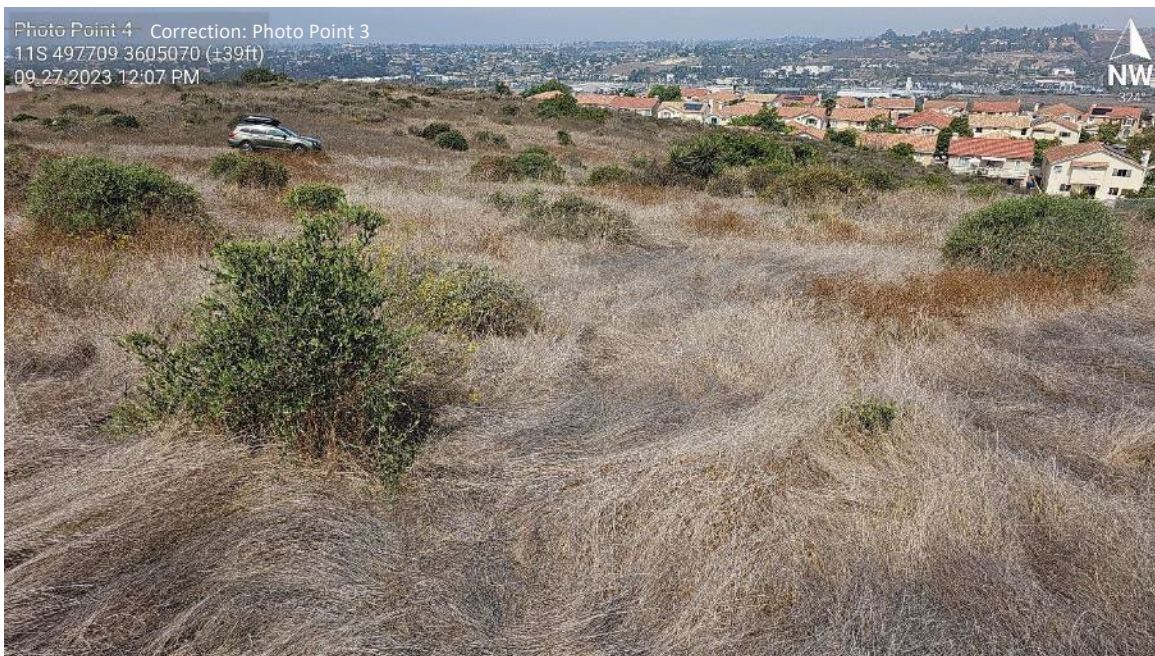
Photo 3.2: Photo point 3 on September 27, 2023. Nonnative species cover in Area 3 is estimated at 85%. Most nonnative species have senesced. *Note: previous reports incorrectly labeled this as photo point 4.*

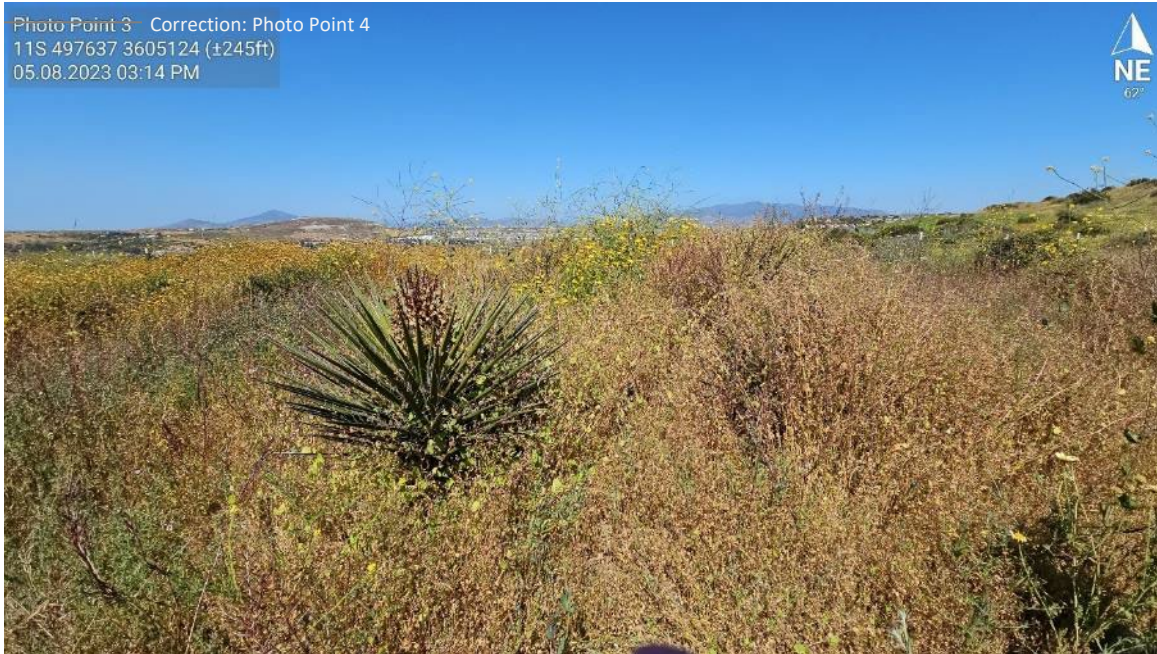
Photo 4.1: Photo point 4 shows baseline conditions for Area 4. Nonnative species cover in Area 4 is estimated at 90%. The most abundant nonnative species include Tocolote thistle, black mustard (*Brassica nigra*), crown daisy (*Glebionis coronaria*), and Mediterranean stork's bill. *Note: previous reports incorrectly labeled this as photo point 3.*

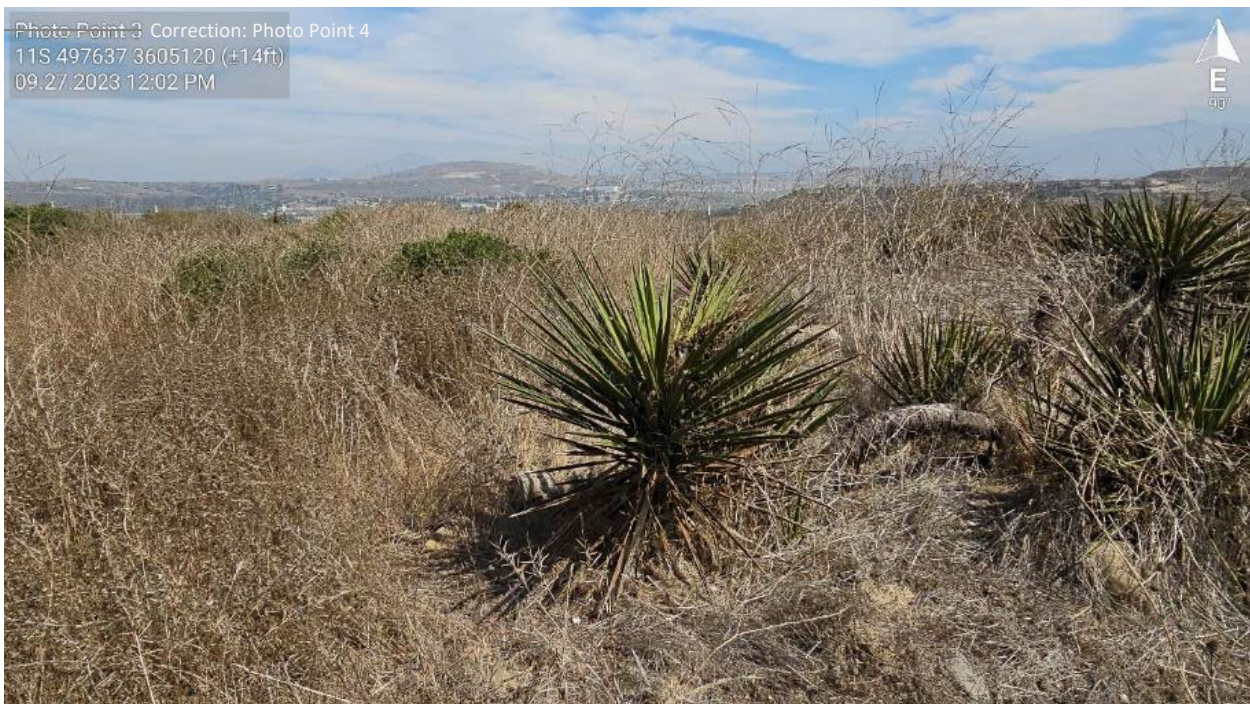
Photo 4.2: Photo point 4 on September 27, 2023. Nonnative species cover in Area 4 is estimated at 90%. Most nonnative species have senesced. *Note: previous reports incorrectly labeled this as photo point 3.*
