Quarterly Status Report Overview

Work Performed this Period:

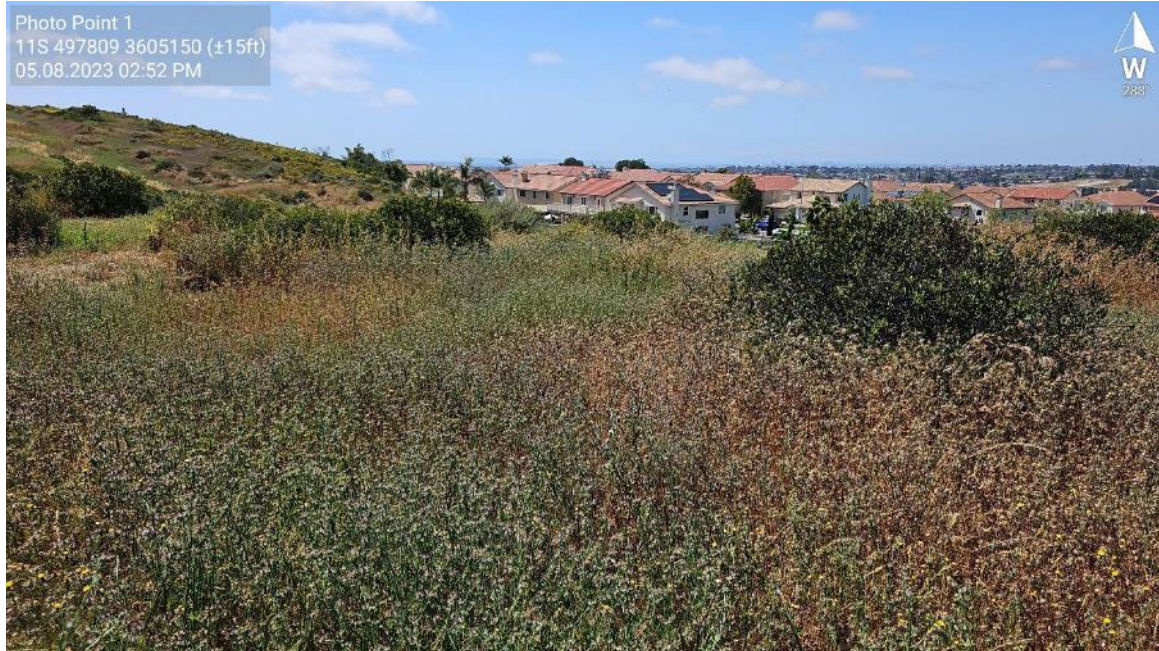
Photo 1.1: Photo point 1 shows baseline conditions for Area 1. Nonnative species cover in Area 1 is estimated at 90%. The most abundant nonnative species include Tocolote thistle (*Centaurea melitensis*), Mediterranean stork's bill (*Erodium malacoides*), Annual yellow sweetclover (*Melilotus indicus*).

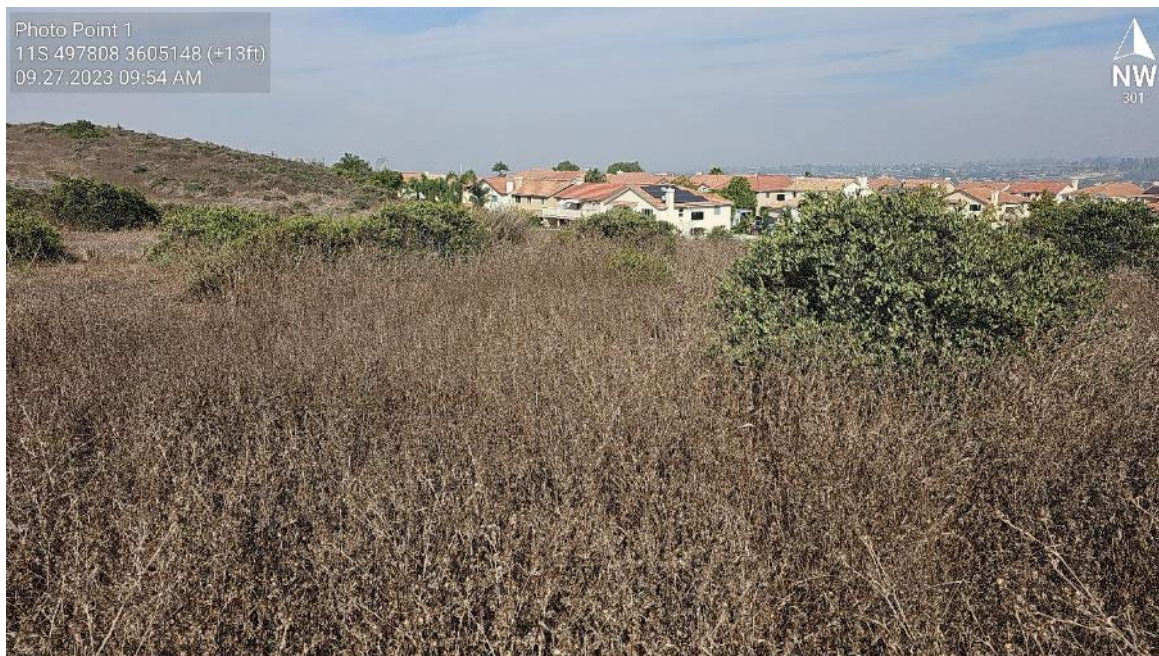
Photo 1.2: Photo point 1 on September 27, 2023. Nonnative species cover in Area 1 is estimated at 90%. Most nonnative species have senesced.

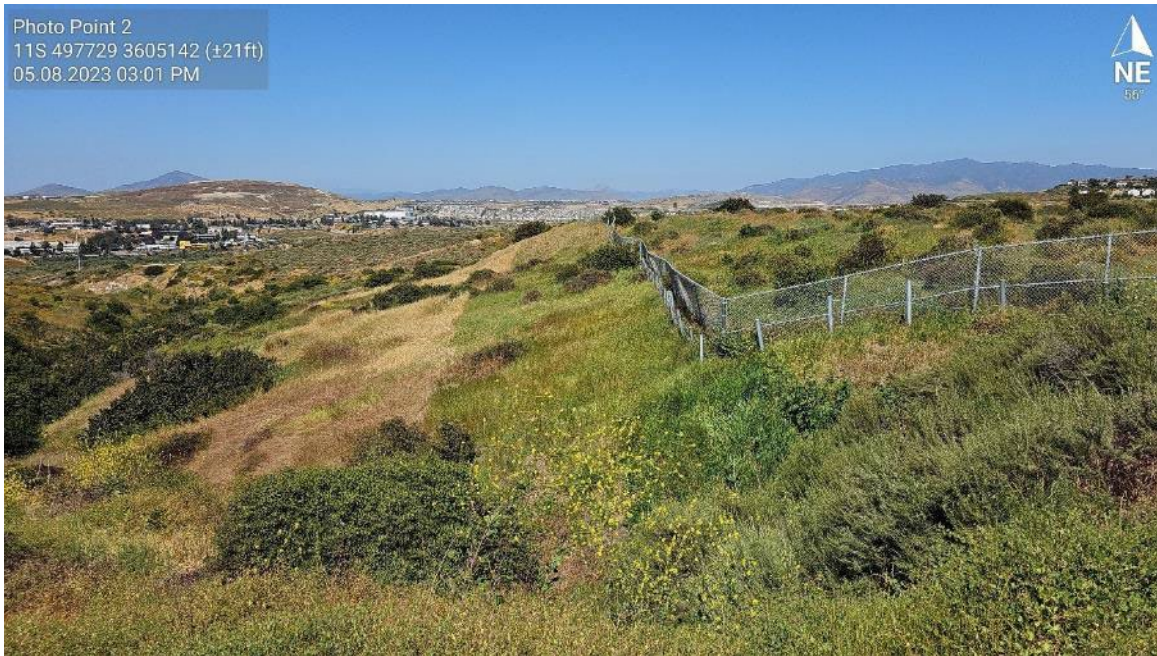
Photo 2.1: Photo point 2 shows baseline conditions for Area 2. Nonnative species cover in Area 2 is estimated at 80%. The most abundant nonnative species include Tocolote thistle, Italian ryegrass (*Festuca perennis*), slender wild oat (*Avena barbata*), and Mediterranean stork's bill.

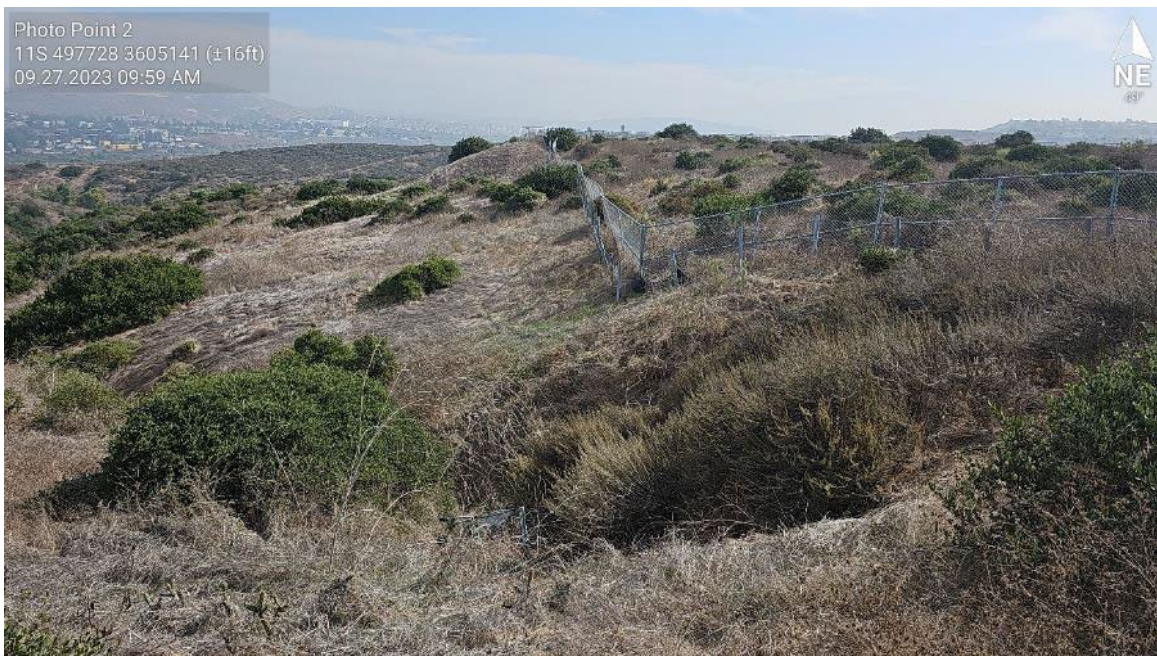
Photo 2.2: Photo point 2 on September 27, 2023. Nonnative species cover in Area 2 is estimated at 80%. Most nonnative species have senesced.

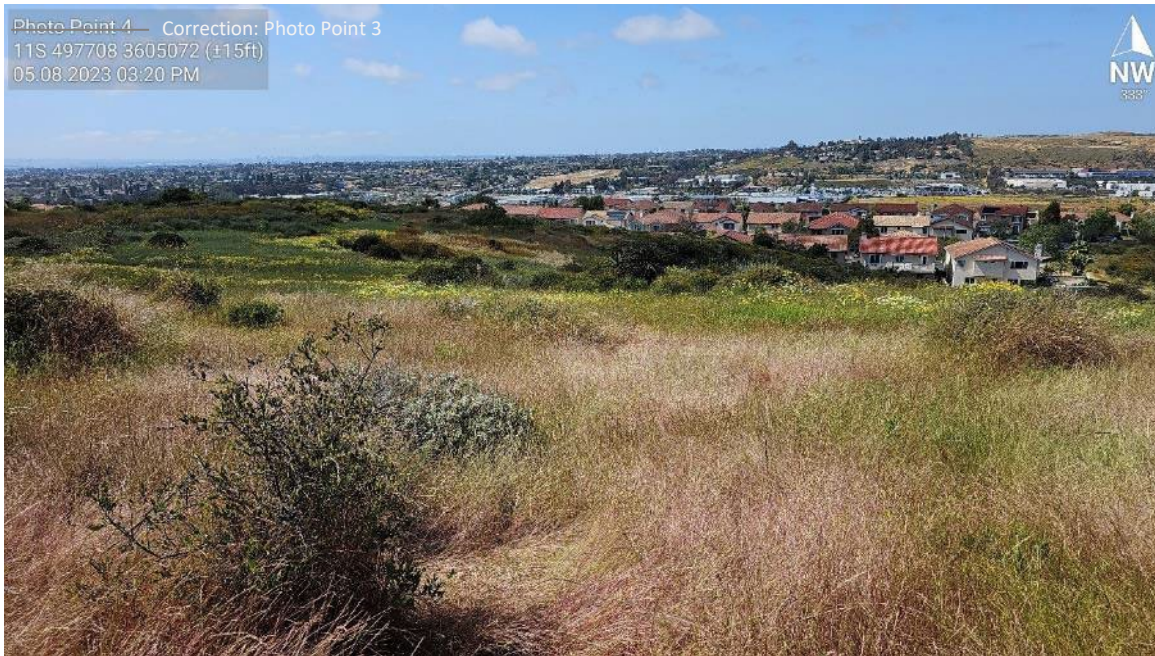
Photo 3.1: Photo point 3 shows baseline conditions for Area 3. Nonnative species cover in Area 3 is estimated at 85%. The most abundant nonnative species include Tocolote thistle, crown daisy, Italian ryegrass, and slender wild oat. *Note: previous reports incorrectly labeled this as photo point 4.*

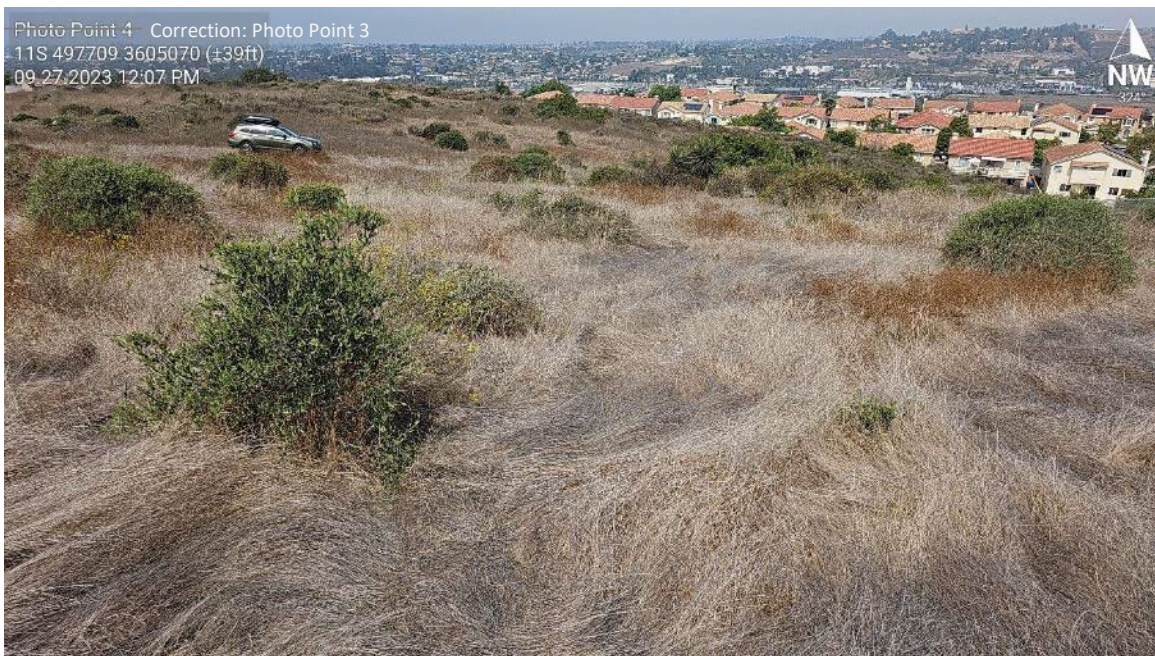
Photo 3.2: Photo point 3 on September 27, 2023. Nonnative species cover in Area 3 is estimated at 85%. Most nonnative species have senesced. *Note: previous reports incorrectly labeled this as photo point 4.*

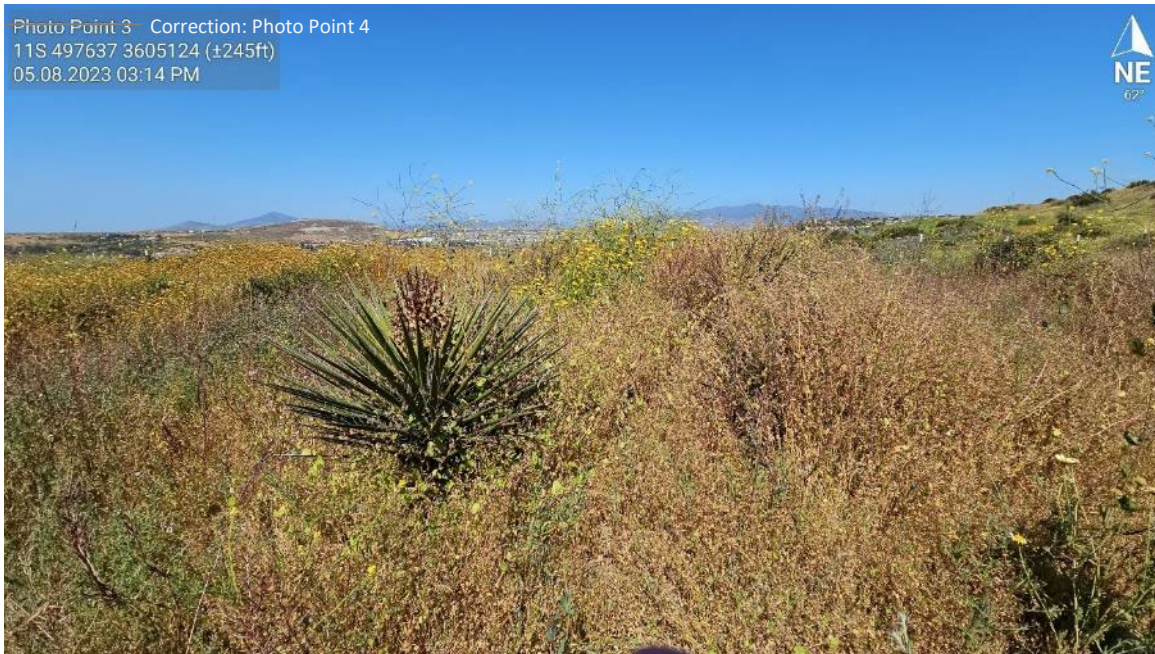
Photo 4.1: Photo point 4 shows baseline conditions for Area 4. Nonnative species cover in Area 4 is estimated at 90%. The most abundant nonnative species include Tocolote thistle, black mustard (*Brassica nigra*), crown daisy (*Glebionis coronaria*), and Mediterranean stork's bill. *Note: previous reports incorrectly labeled this as photo point 3.*

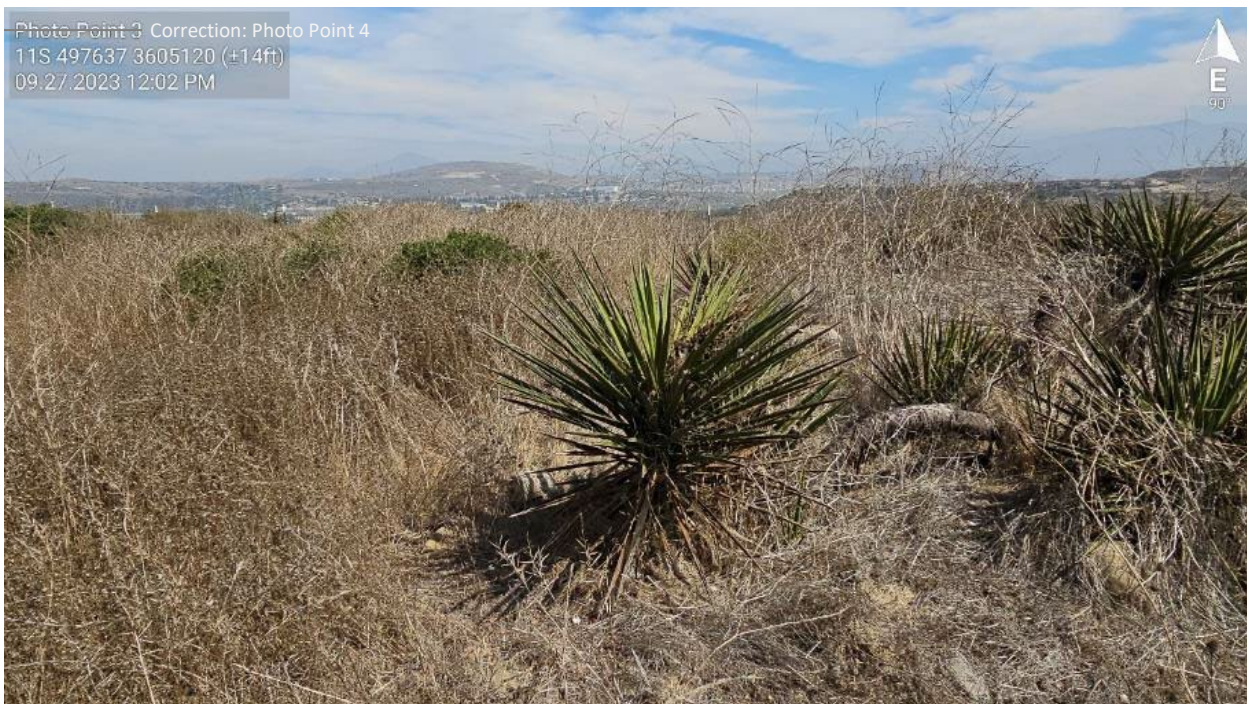
Photo 4.2: Photo point 4 on September 27, 2023. Nonnative species cover in Area 4 is estimated at 90%. Most nonnative species have senesced. *Note: previous reports incorrectly labeled this as photo point 3.*

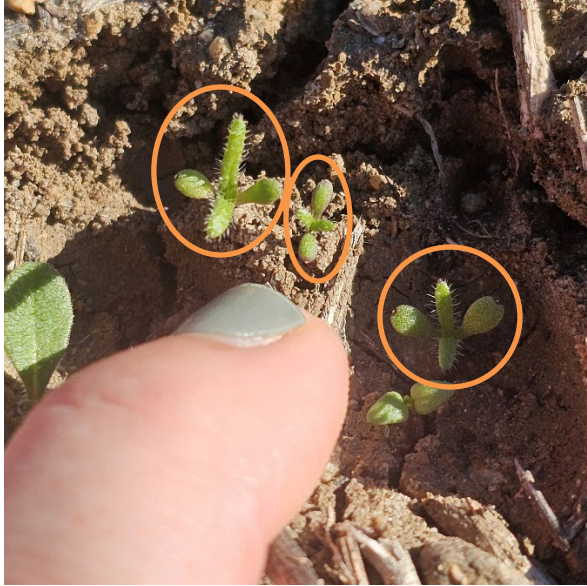
Otay tarplant seedlings observed on December 5, 2025.

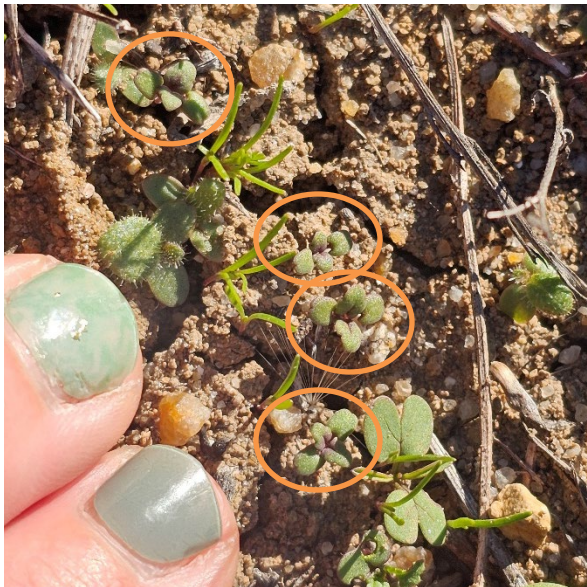
San Diego thornmint seedlings observed on December 5, 2025.
