Merkel & Associates, Inc.

March 29, 2024
M&A #96-074-12

Biological Resources Memo for the Famosa Slough Water Quality Treatment Wetland Sedimentation Basin Maintenance Project

**APPENDIX A: FAMOSA SLOUGH WATER QUALITY TREATMENT WETLAND SEDIMENTATION BASIN
MAINTENANCE PROJECT – MAINTENANCE SHEET**

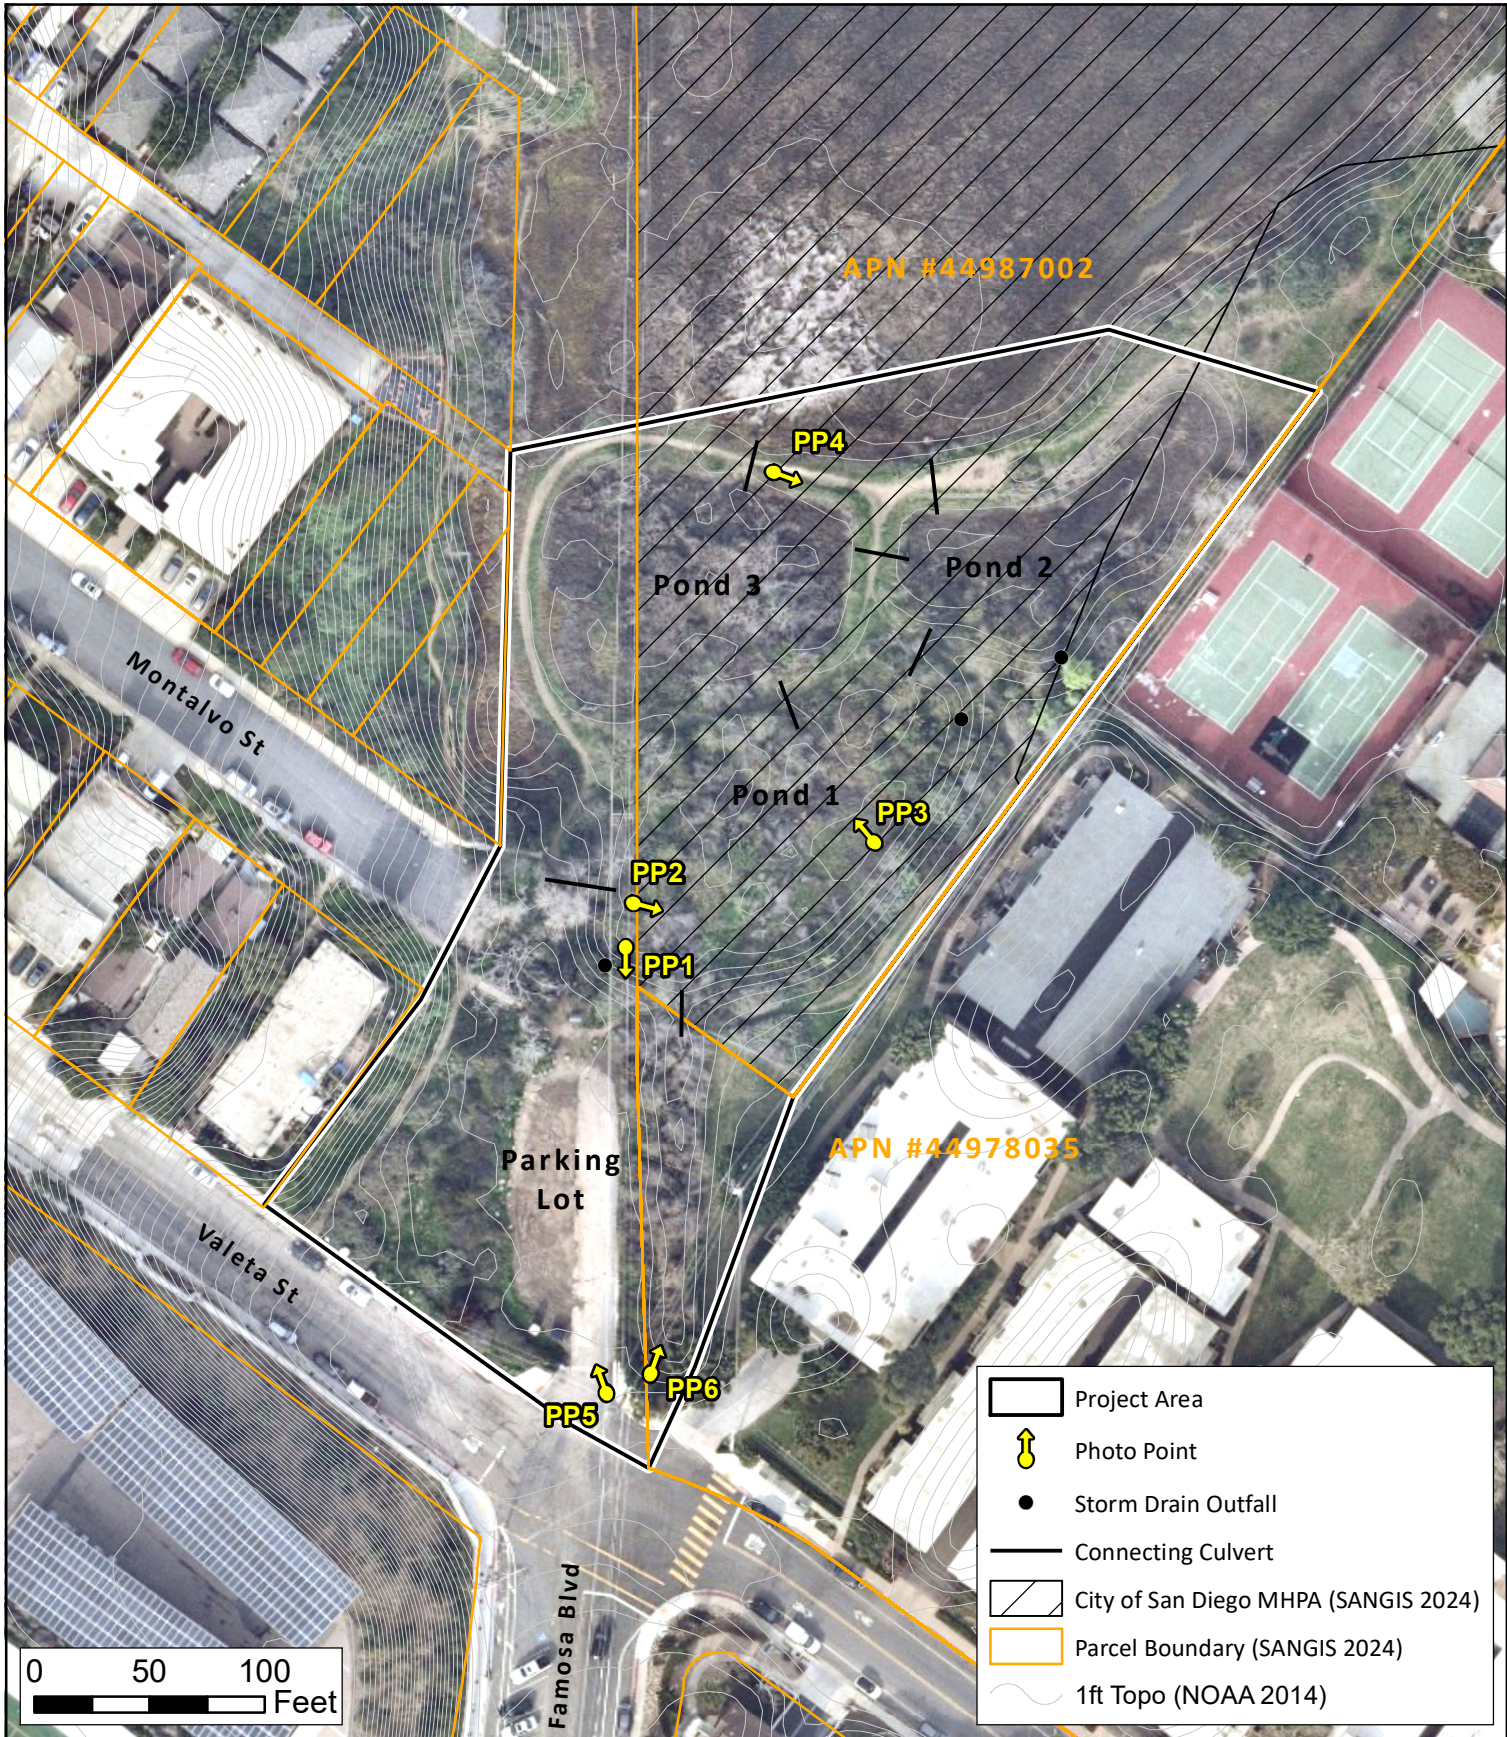
Figure 1

USGS Topography Map
Famosa Slough Water Quality Treatment
Wetlands Sedimentation Basin Maintenance Project
Source: USGS 7.5' Point Loma, CA Quadrangle

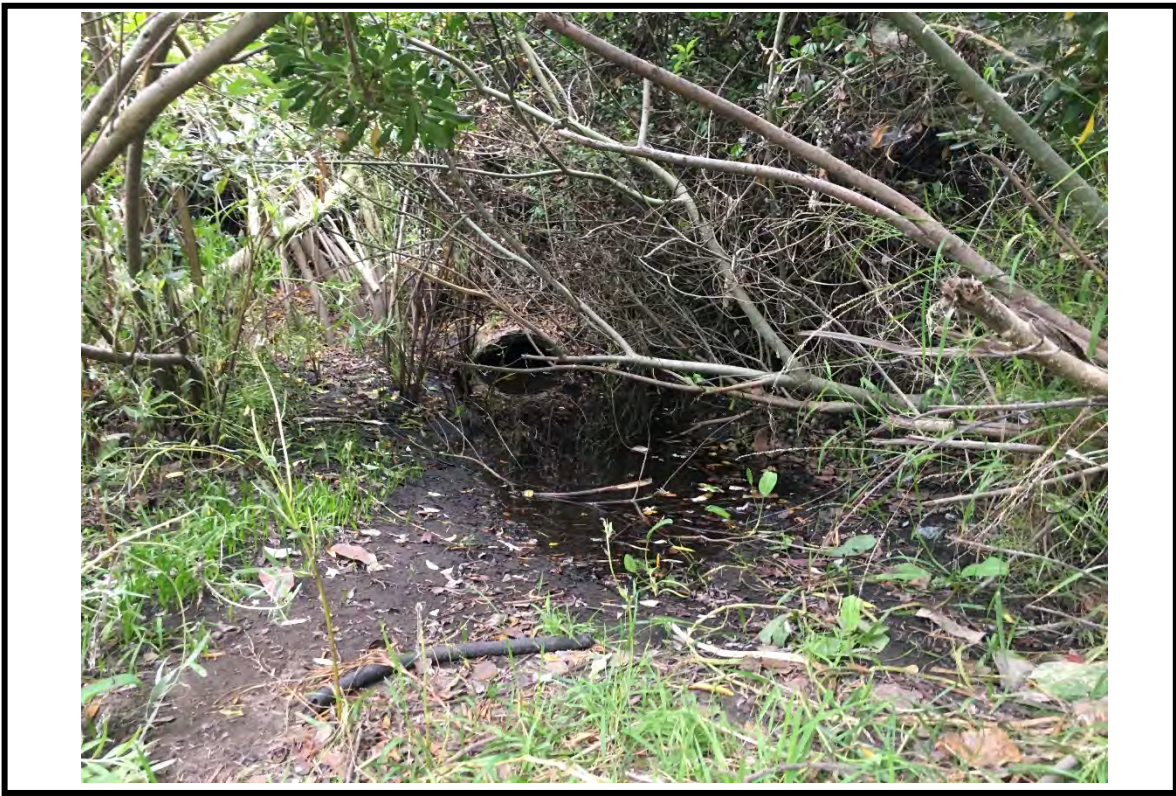
Photo Point 1. View of sediment filled culvert inlet in Pond 1. Photo date: 8/8/23. Direction: south.

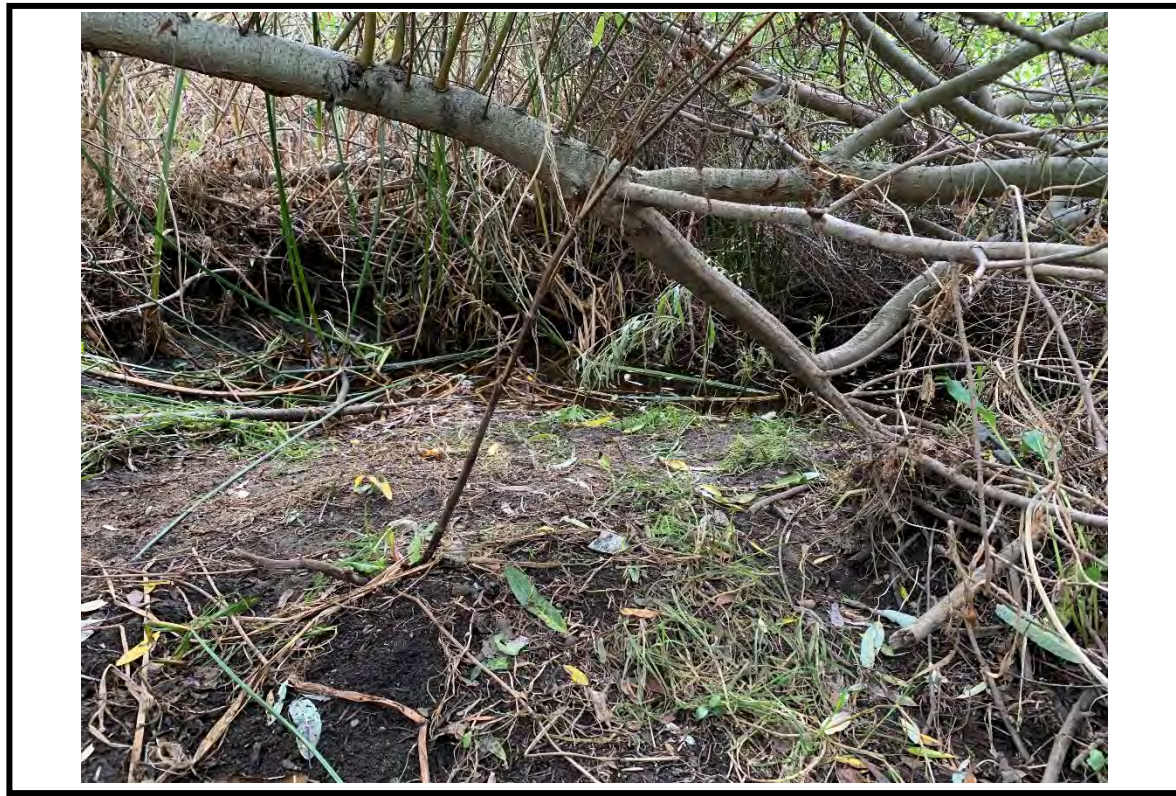
Photo Point 2. View of sediment filled basin in Pond 1. Photo date: 8/24/23. Direction: southeast.

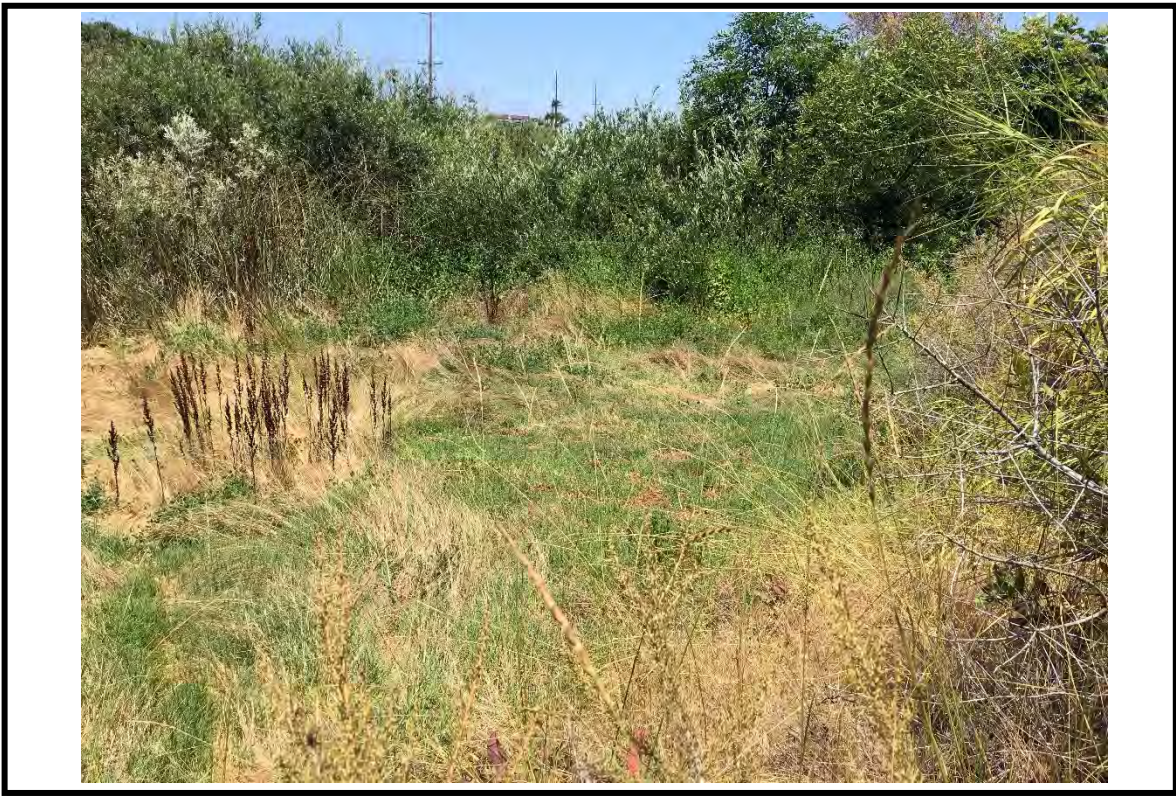
Photo Point 3. View of sediment filled basin Pond 1. Photo date: 7/27/23. Direction: northwest.

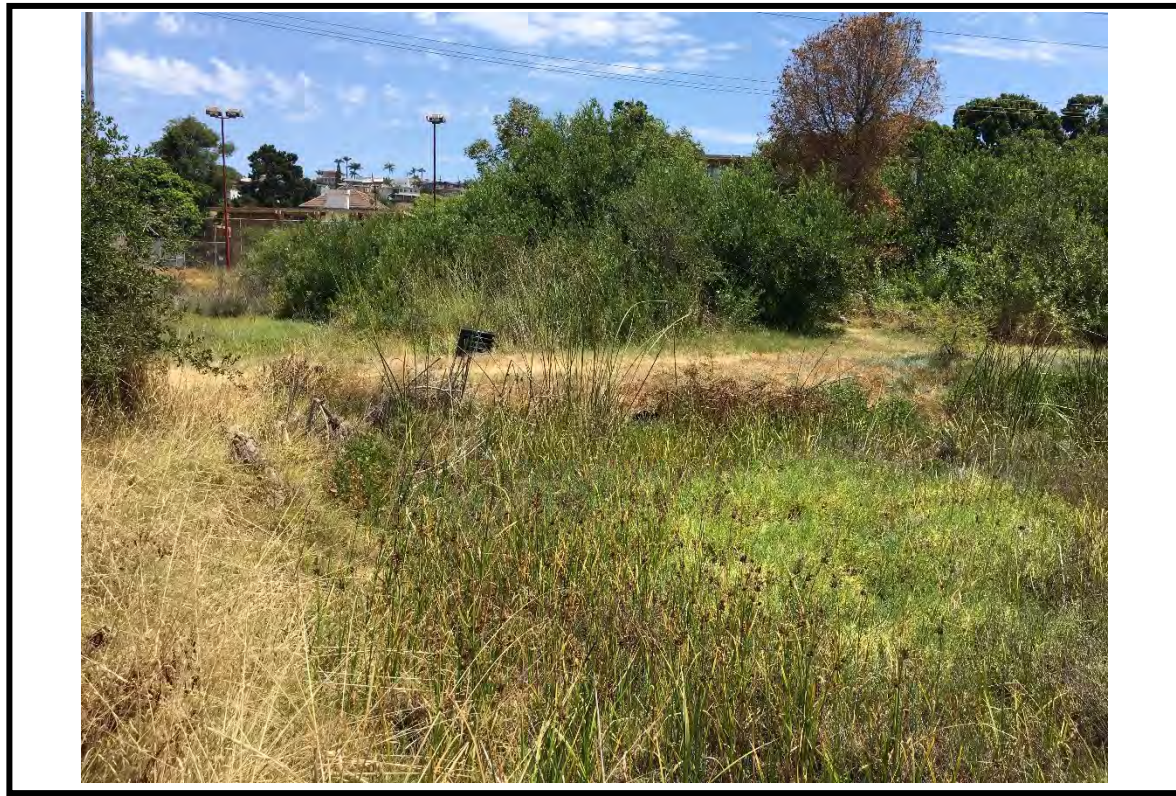
Photo Point 4. View of sediment filled basin in Pond 3 (foreground) and Pond 2 (background). Photo date: 7/27/23. Direction: east.

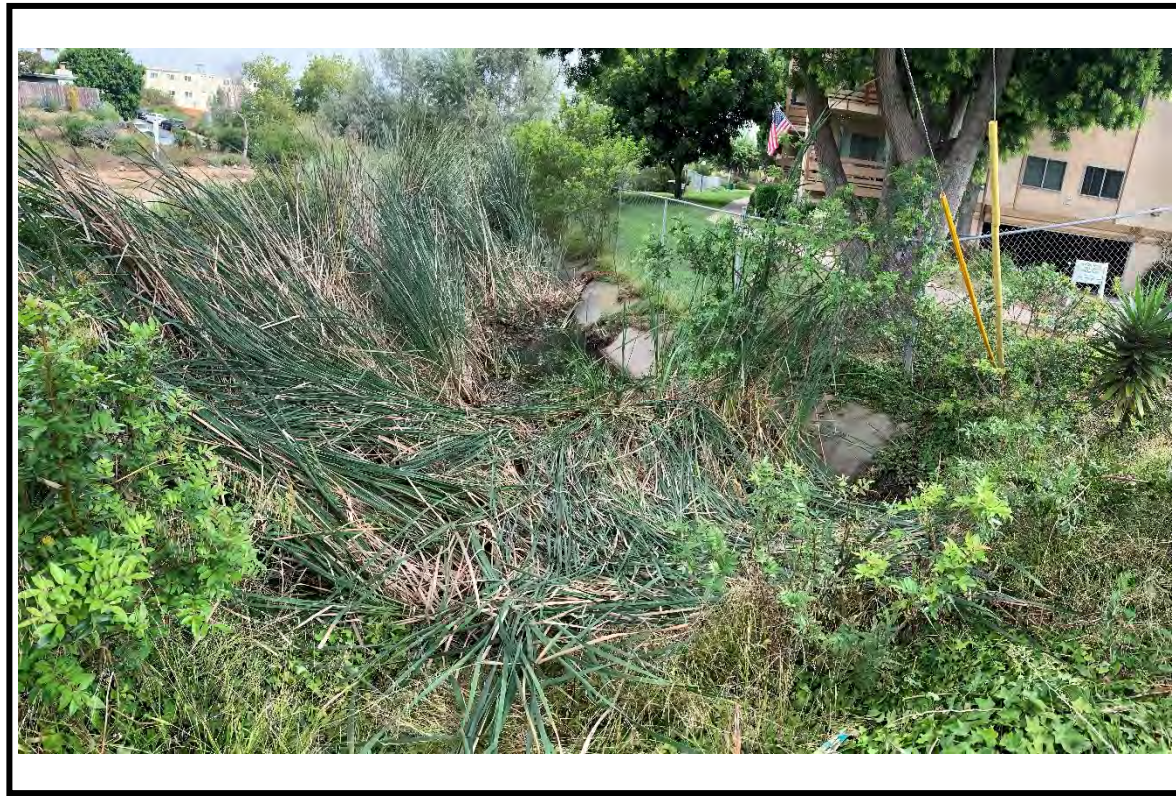
Photo Point 6. View of concrete lined channel that drains the urban watershed into Pond 1. Channel choked with sediment and vegetation. Photo date: 8/24/23. Direction: north.

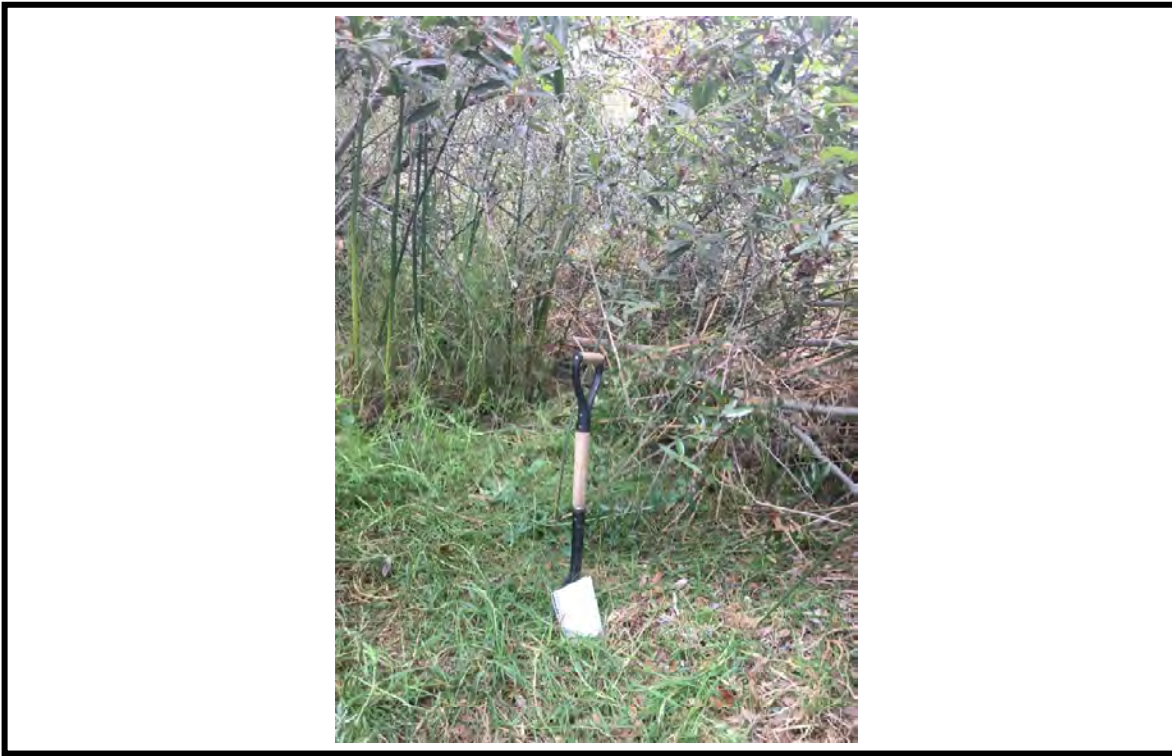
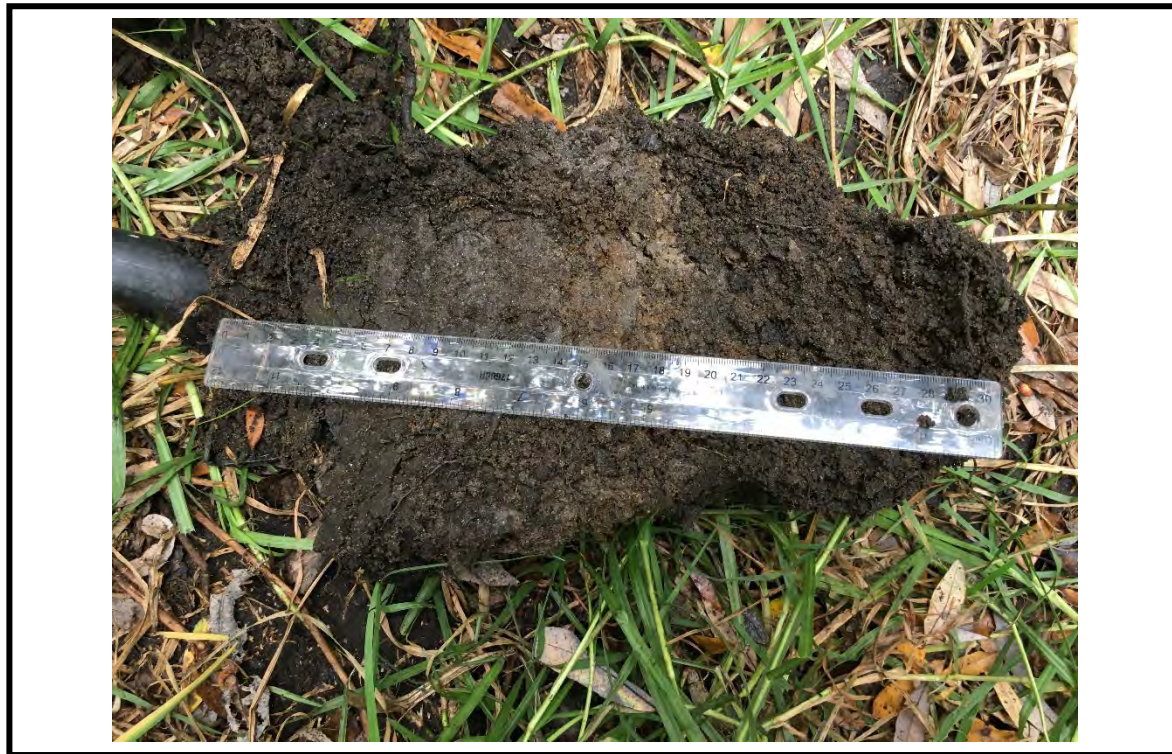
Remarks:
Overall, the basin bottom is uneven, with low spots near the culvert outfall pipes and northward (evidence of previous sediment removal maintenance). Pockets of water in the low spots, near the culvert outfall structures (just outside of the DP plot size but depth of about 4") . Some drift line is also present in the low areas but not necessarily throughout the basin. The soil was moist but not saturated. M&A conducted the delineation on 8/18/23 prior to the arrival of Tropical Storm Hilary which made land fall in San Diego on 8/20/23. M&A revisited the survey area on 8/24/23 to reassess conditions; during the follow-up survey the water table was encountered at about 6".

Photo Point 1a. Wetland Determination Sampling Point 1 (shovel) located in the basin floor of Pond 1. Photo date: 8/18/2023. Direction: west. Lat/Long: 32.74826, -117.22930.

Photo Point 1b. Wetland Determination Sampling Point 1. Photo of soil. Photo date: 8/18/2023.

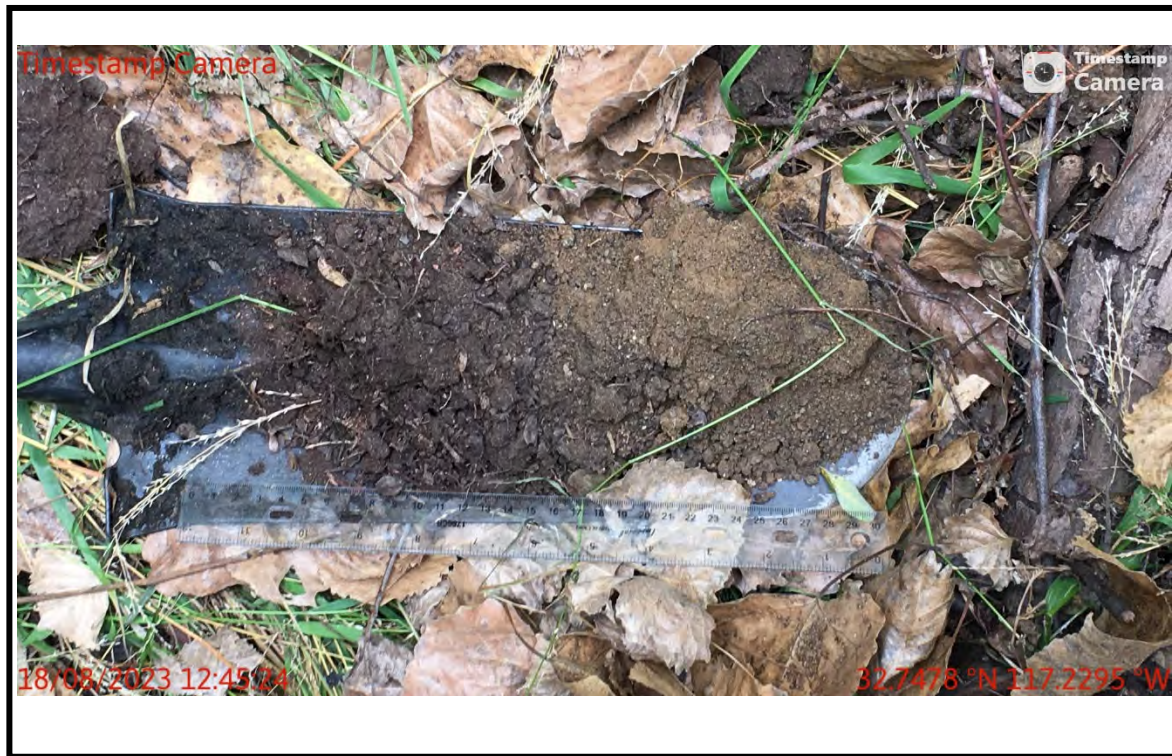
Photo Point 2a. Wetland Determination Sampling Point 2 (shovel) located just above the toe of the basin floor of Pond 1. Photo date: 8/18/2023. Direction: west. Lat/Long: 32.74827, -117.22936.

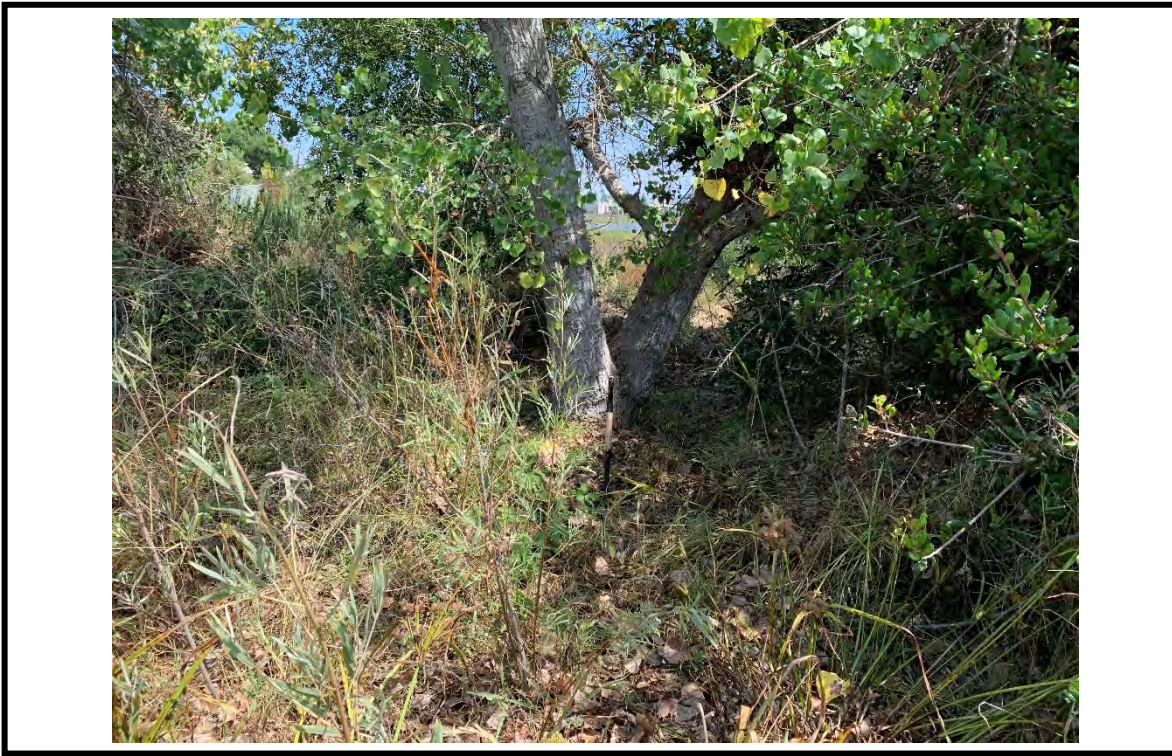
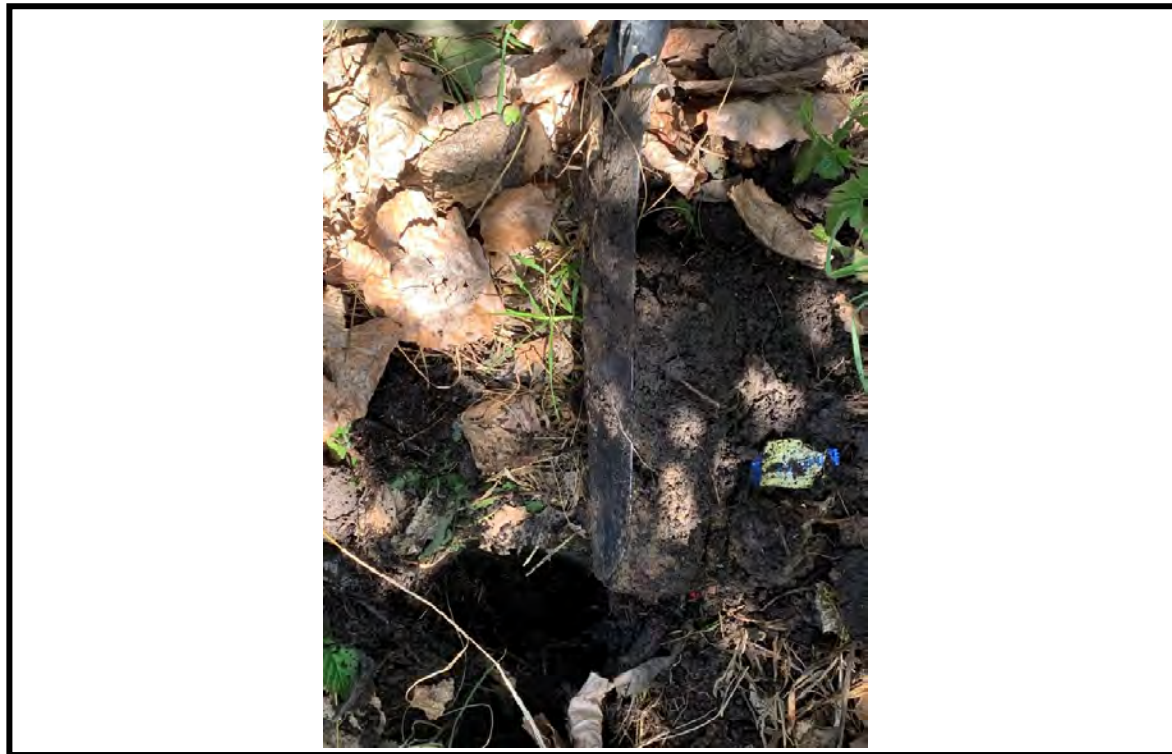
Wetland hydrology not present. Data point located within a swale but defined drainage patterns or evidence of flow not evident. Soils cool but not saturated. M&A conducted the delineation on 8/18/23 prior to the arrival of Tropical Storm Hilary which made land fall in San Diego on 8/20/23. M&A revisited the survey area on 8/24/23 to re-assess conditions; there were no changes to the soil or hydrology conditions.

Photo Point 3a. Wetland Determination Sampling Point 3 (shovel) located within the swale west of Pond 1. Photo date: 8/24/2023. Direction: north. Lat/Long: 32.74825, -117.22947.

Photo Point 3b. Wetland Determination Sampling Point 3. Photo of soil. Photo date: 8/24/2023.

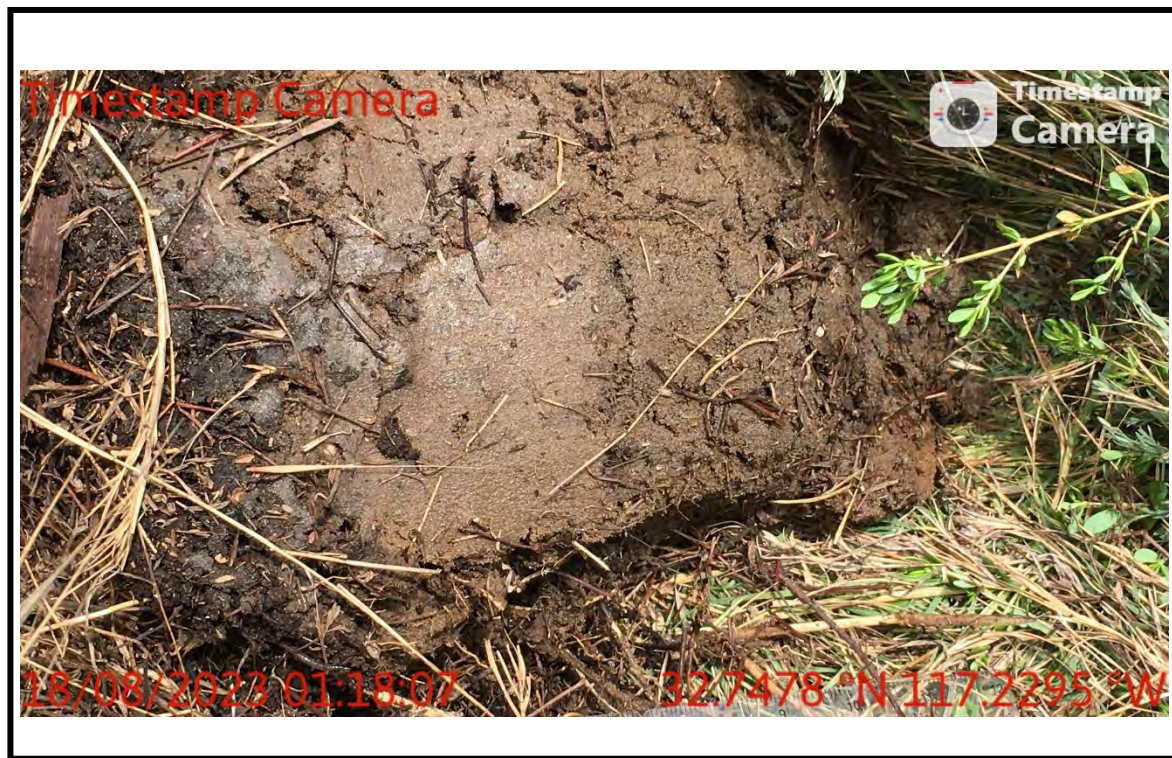
Photo Point 4a. Wetland Determination Sampling Point 4 (shovel) located within the upper elevational limit of Famosa Slough. Photo date: 8/18/2023. Direction: south. Lat/Long: 32.74852, -117.22952.

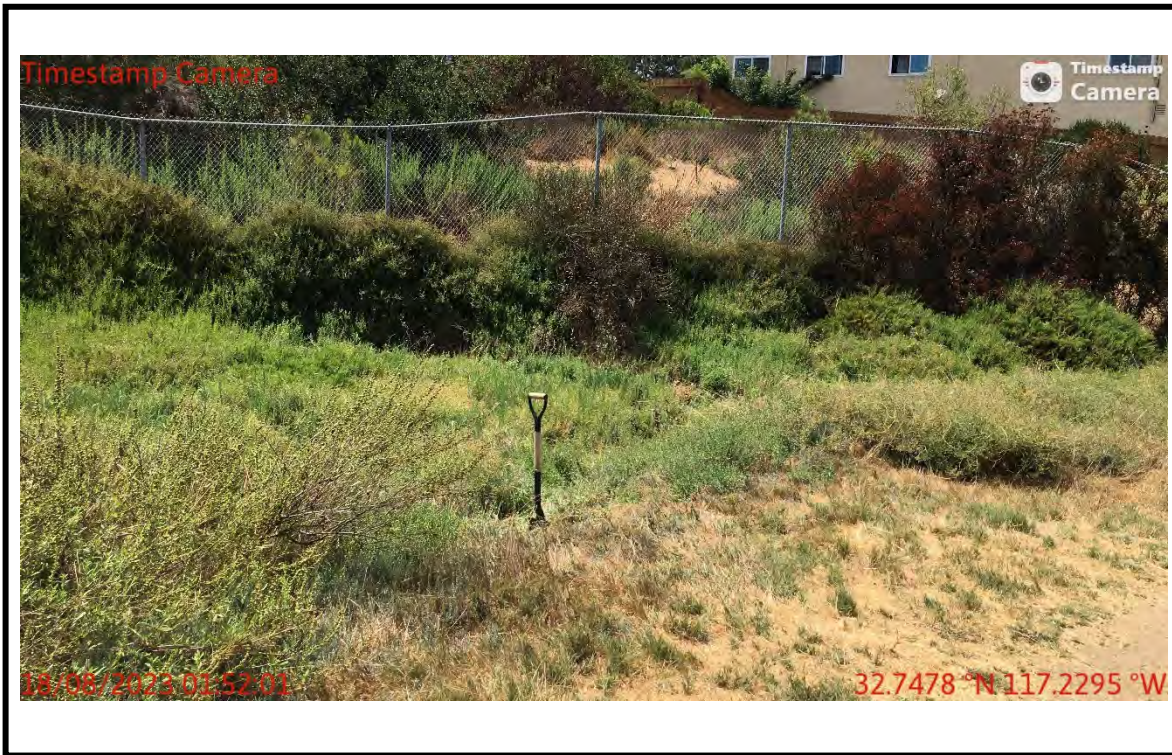
Photo Point 4b. Wetland Determination Sampling Point 4. Photo of soil. Photo date: 8/18/2023.

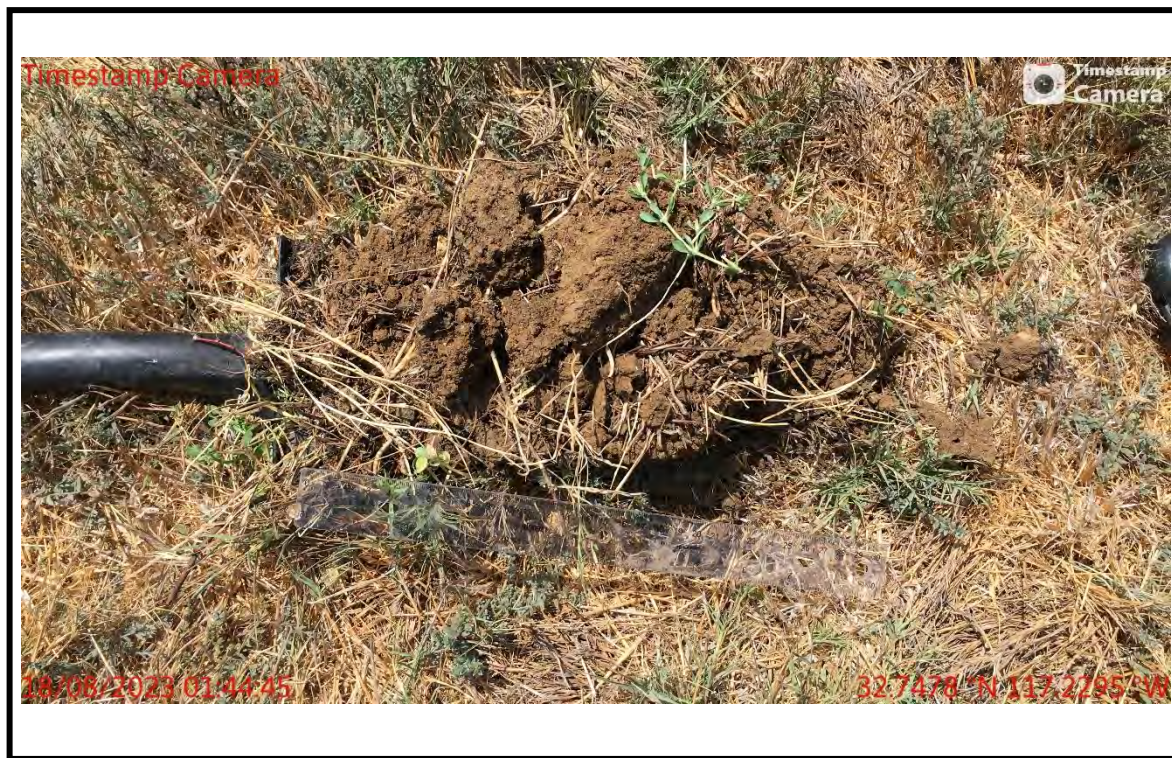
Photo Point 5a. Wetland Determination Sampling Point 5 (shovel) located on the slope, between the basin floor of Famosa Slough and the trail system/Treatment Basin to the south and east. Photo date: 8/18/2023. Direction: west. Lat/Long: 32.74849, -117.22944.

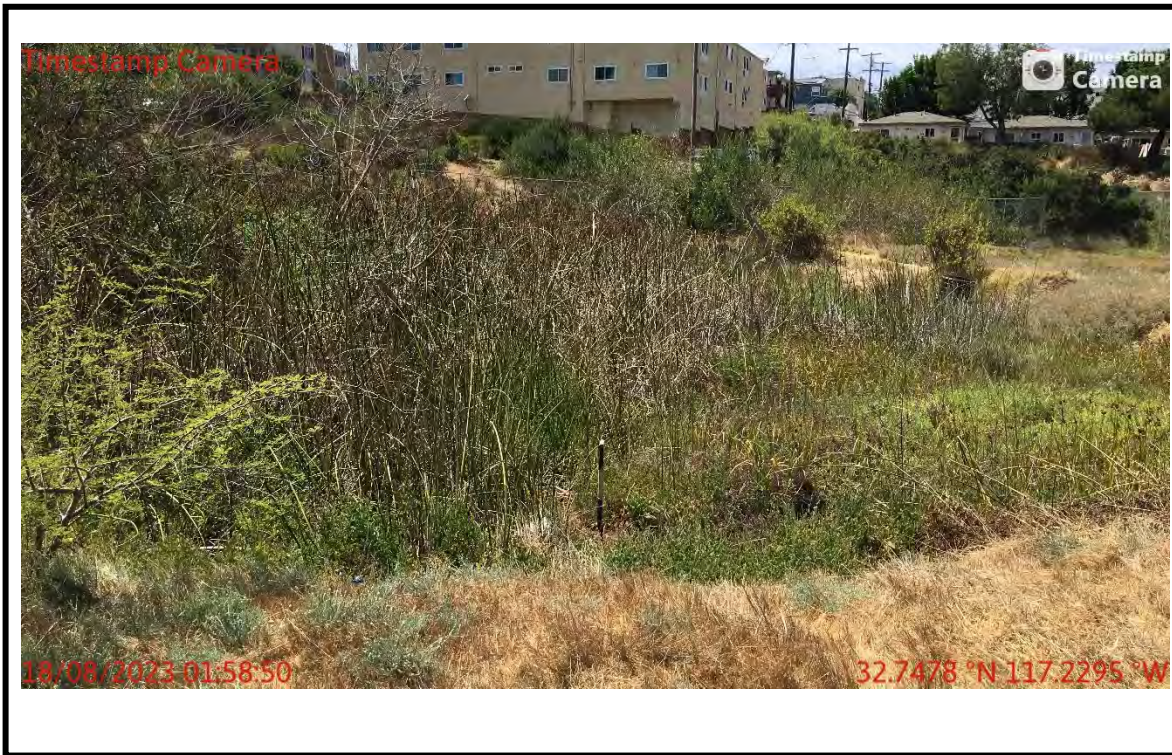
Photo Point 5b. Wetland Determination Sampling Point 5. Photo of soil. Photo date: 8/18/2023.

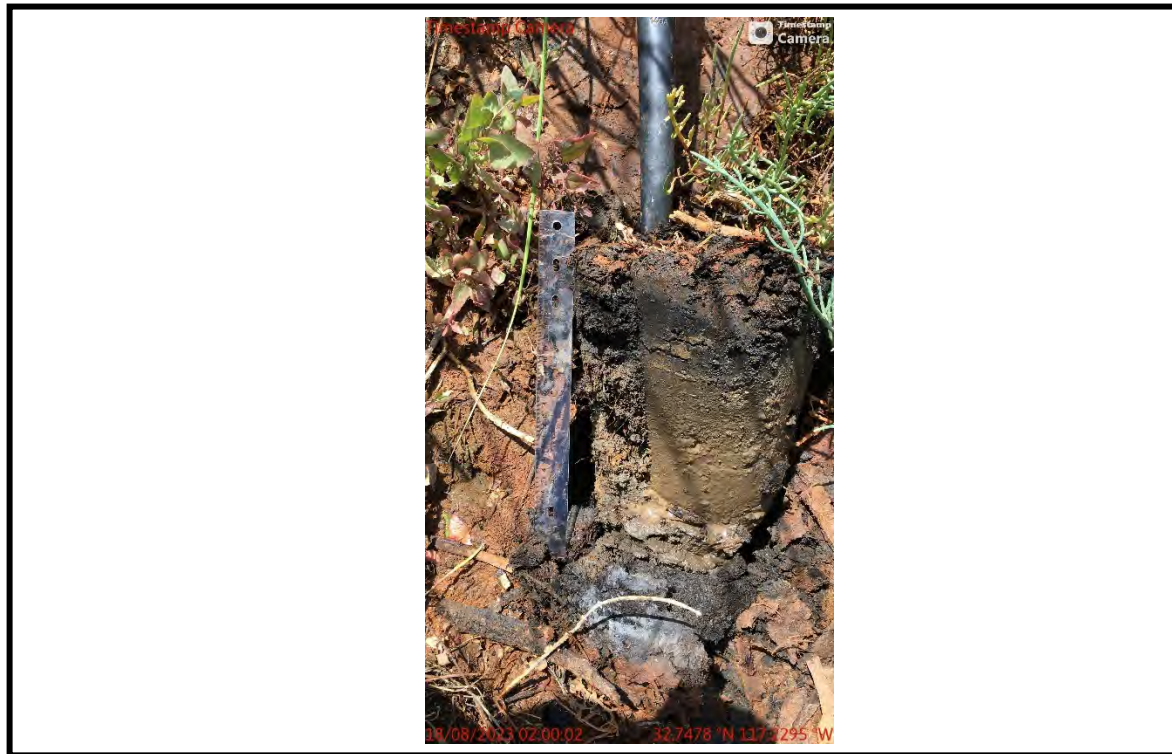
Photo Point 6a. Wetland Determination Sampling Point 6 (shovel) located within Pond 3. Photo date: 8/18/2023. Direction: west. Lat/Long: 32.74866, -117.22902.
