# City of Carlsbad Wildlife Movement Analysis Final Report

Local Assistance Grant Agreement No.  
P1282107

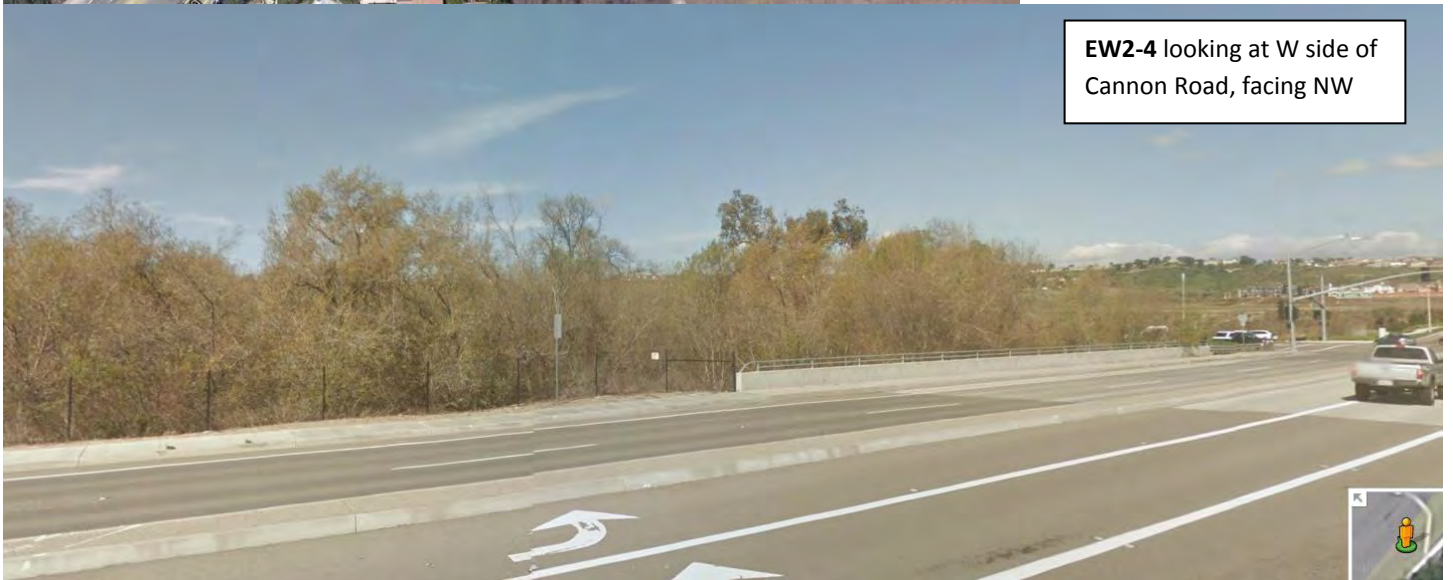
**EW2-4** looking at W side of Cannon Road, facing NW

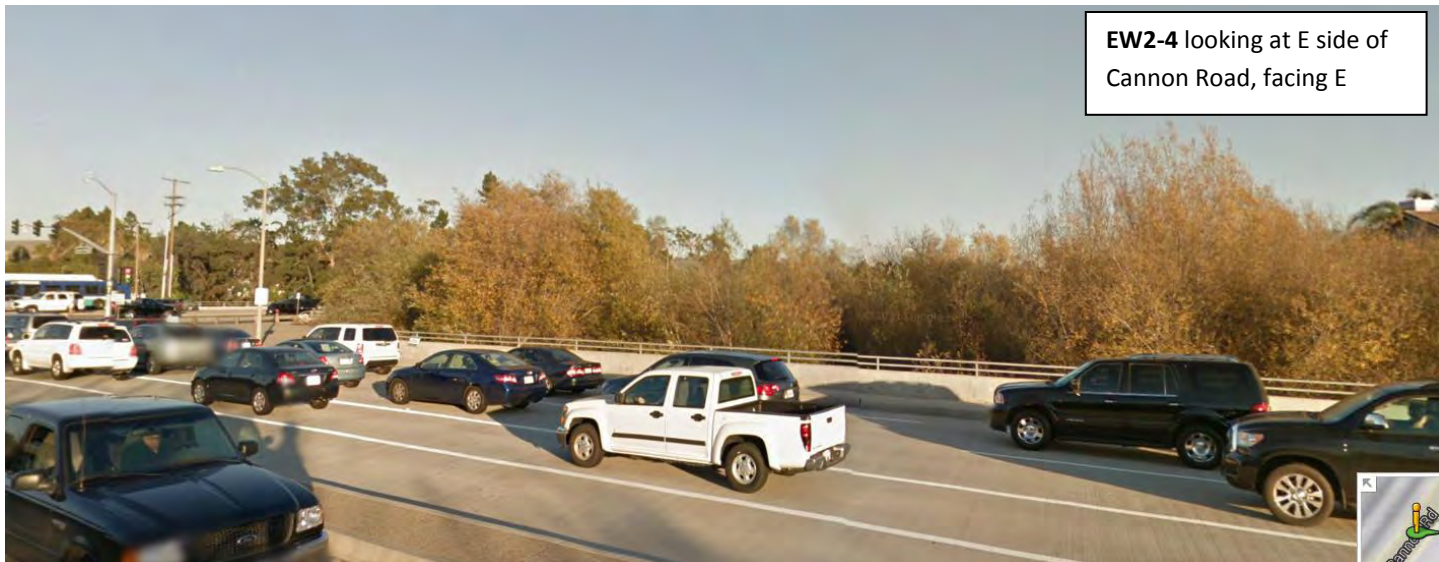
**EW2-4** looking at E side of Cannon Road, facing E

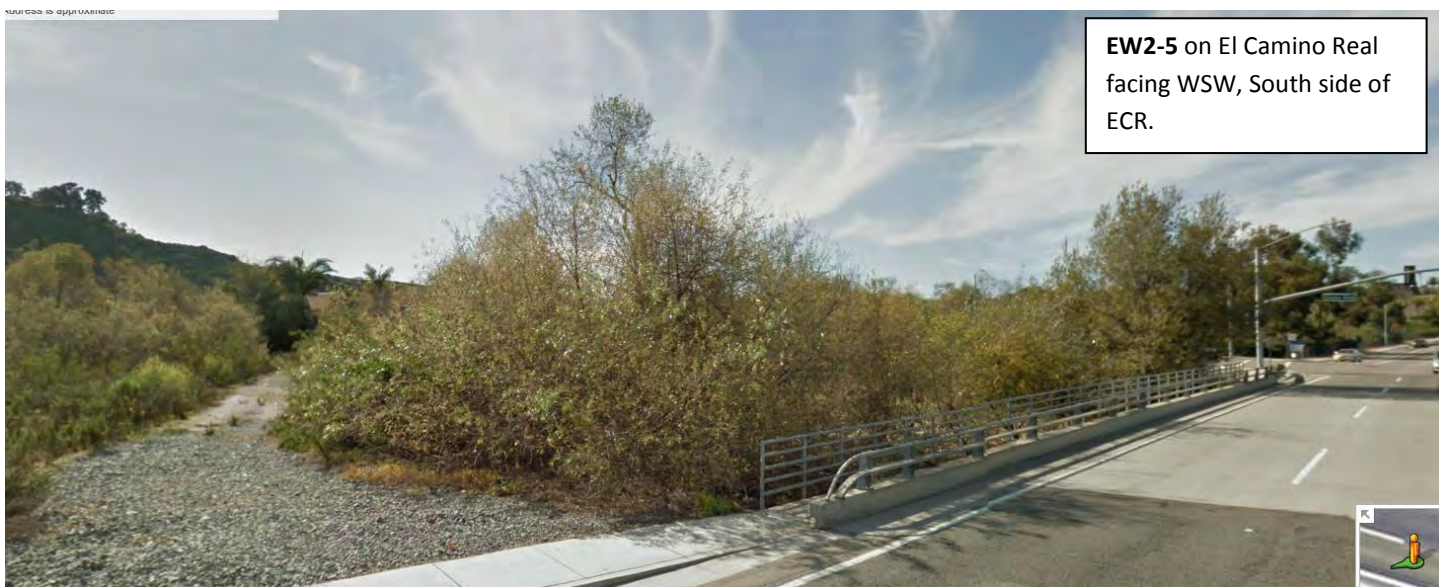
**EW2-5** on El Camino Real facing WSW, South side of ECR.

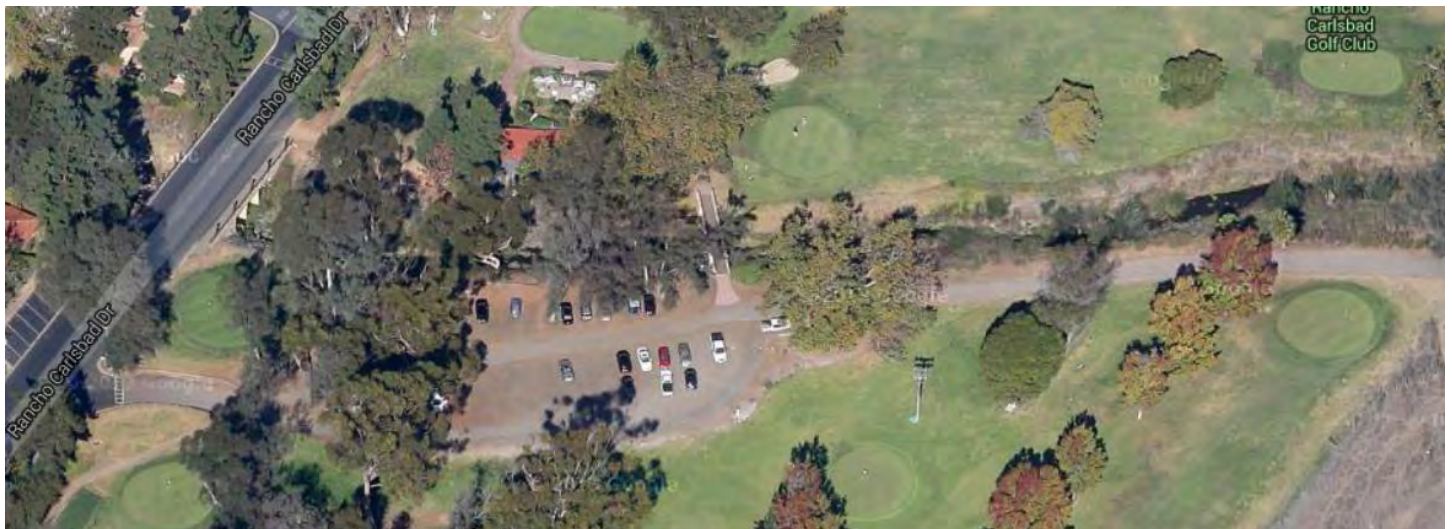
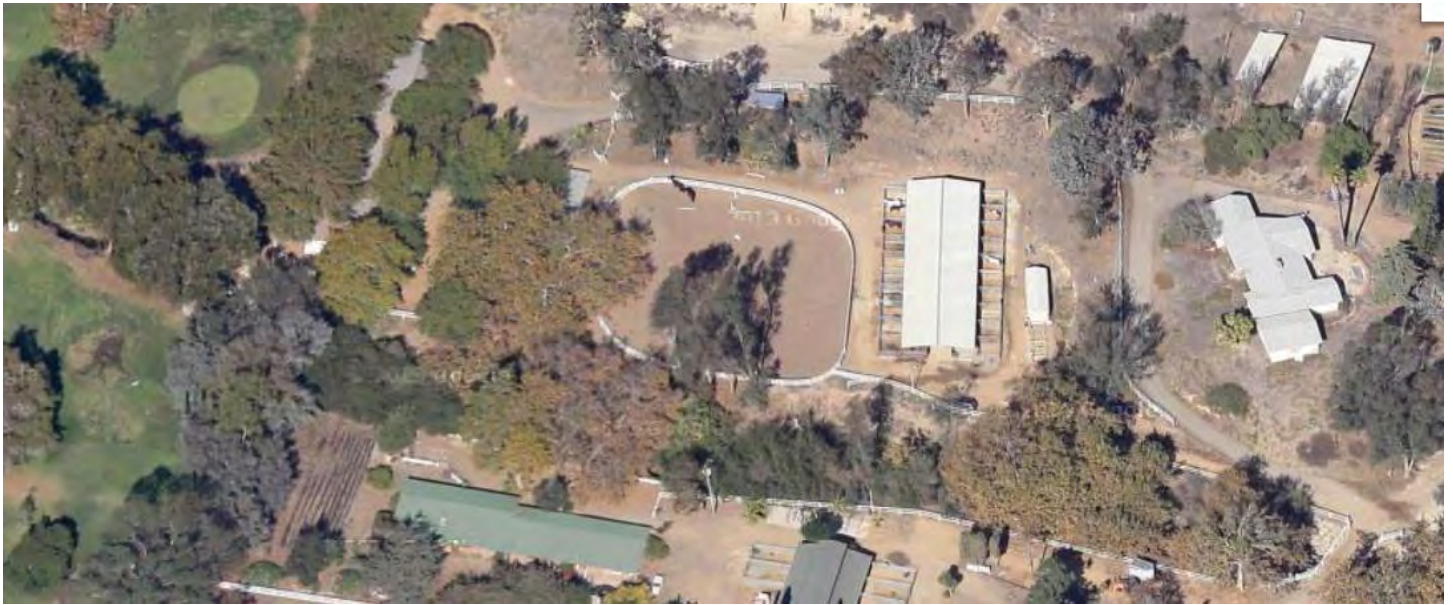
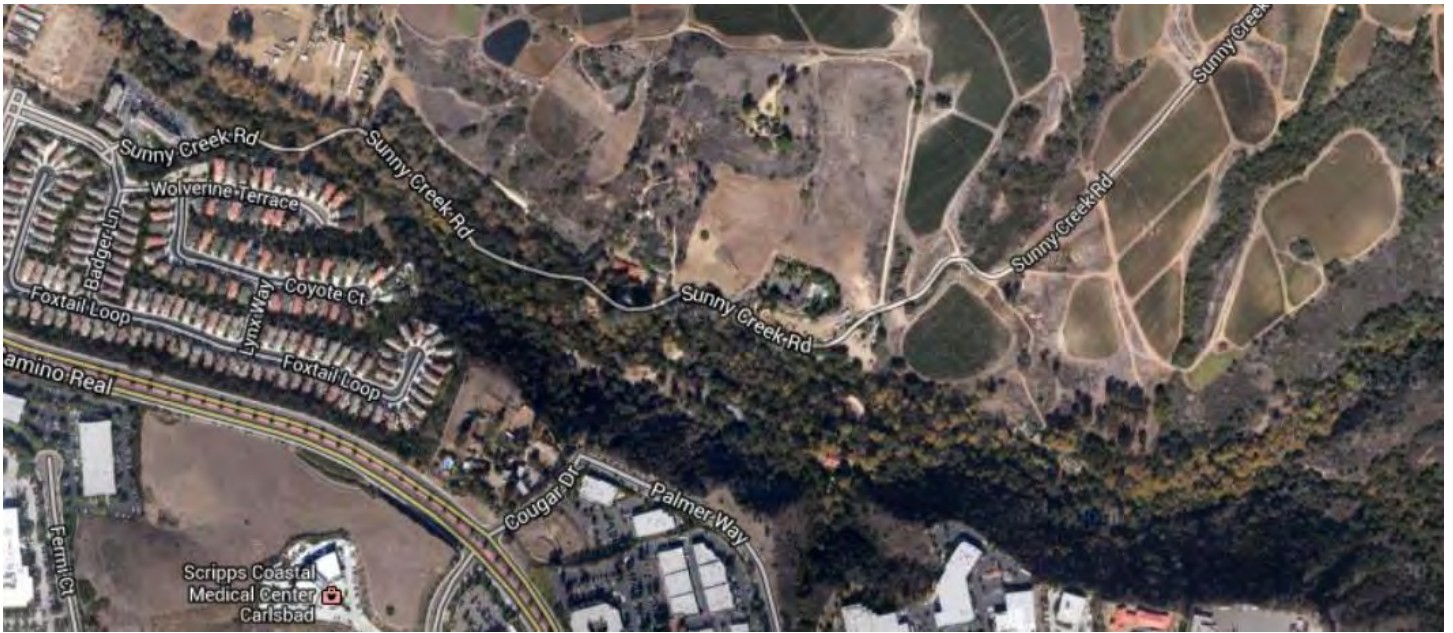
**EW2-8.** Rancho Carlsbad Golf Course and equestrian area to the east. The entire golf course needs to be walked along the riparian drainage to look for signs of obstructions to movement, such as fences. Like EW3-3, this area has a lot of small bridges across the drainage, which probably does not impede movement, but should be confirmed. There are also areas that are narrow with very dense vegetation surrounded by development. The area probably has access control during the night, so may not be a problem to wildlife unless there are wildlife proof fences. Note that the riparian area is protected (classified as open space but not part of HMP). Photos:

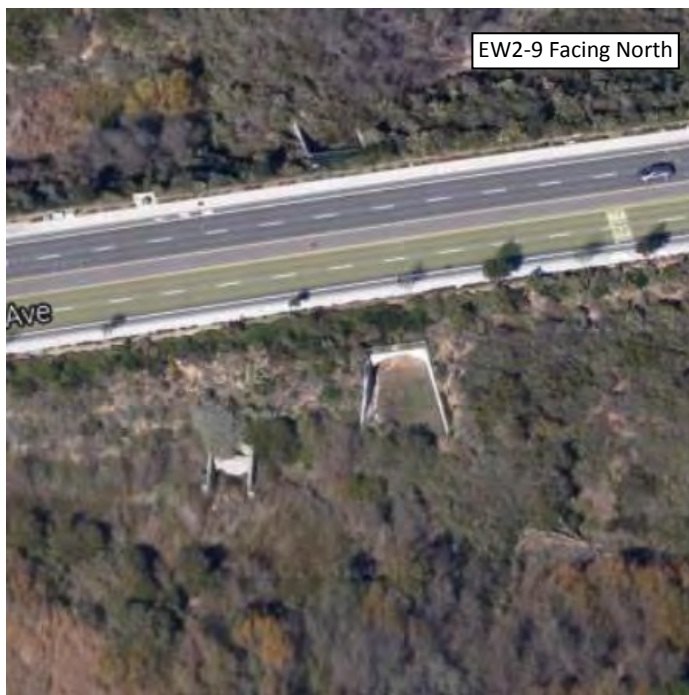
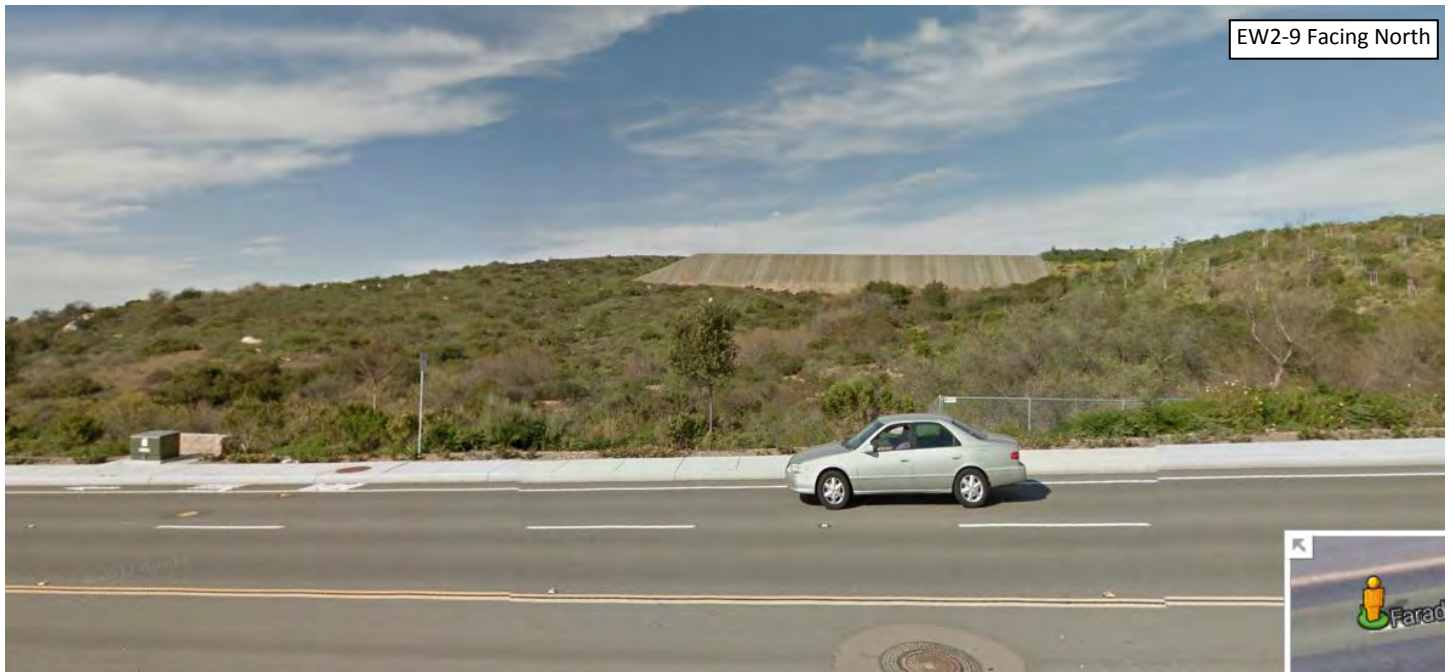
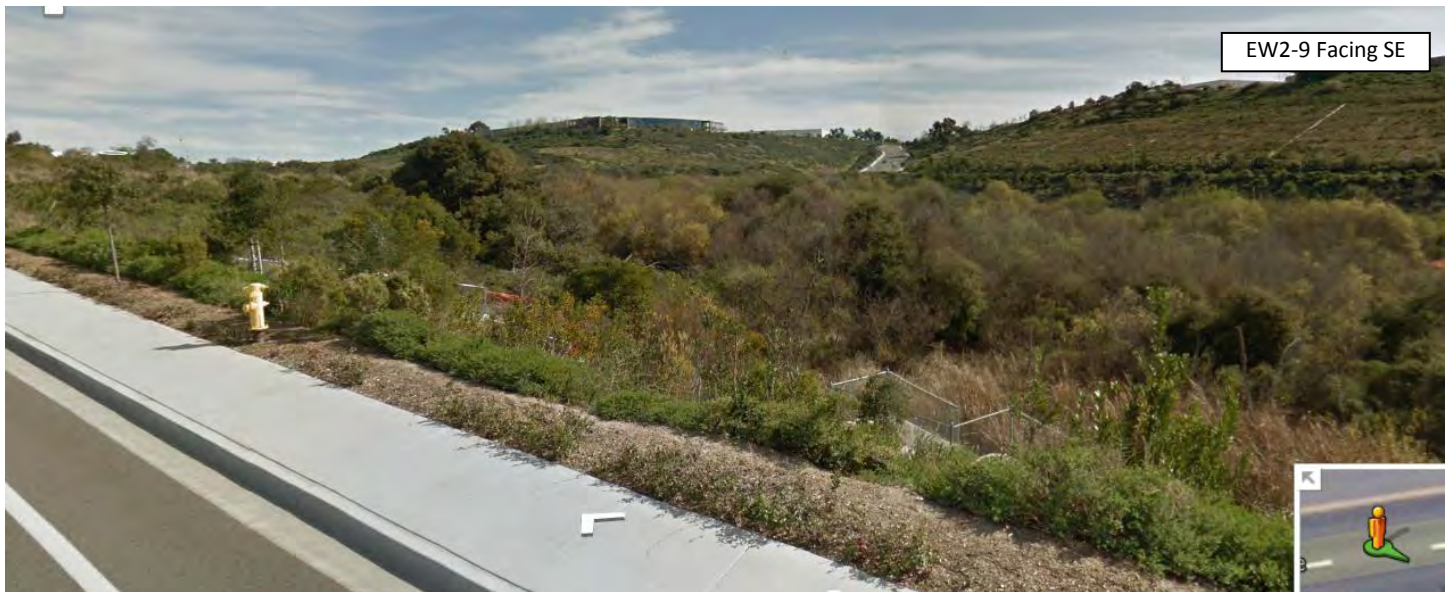
**EW2-9. High Priority.** Fencing around the tops of the box culverts, but otherwise the area is unfenced.

The installation of fencing can be useful if a viable alternative route, typically an undercrossing, is available. Fencing can also be used to restrict human access to an area with the possible benefit of protecting the pinchpoint and making the area more conducive to animal use. As discussed in Section 3.3, however, the installation of fencing does not always guide animals to the undercrossing; deer approaching EW3-6a go around the fencing along Rancho Santa Fe Road rather than using the tunnel, which is 3.7 meters high and 4.6 meters wide. Any recommendation for fencing to guide animals should be implemented only after a more detailed study of roadkill, tracking, and perhaps camera monitoring is completed. In the future, the area around EW3-1 and EW3-7 leading out from Batiquitos Lagoon may benefit from fencing to preclude human access, as well as both sides of the tunnel at EW2-9.

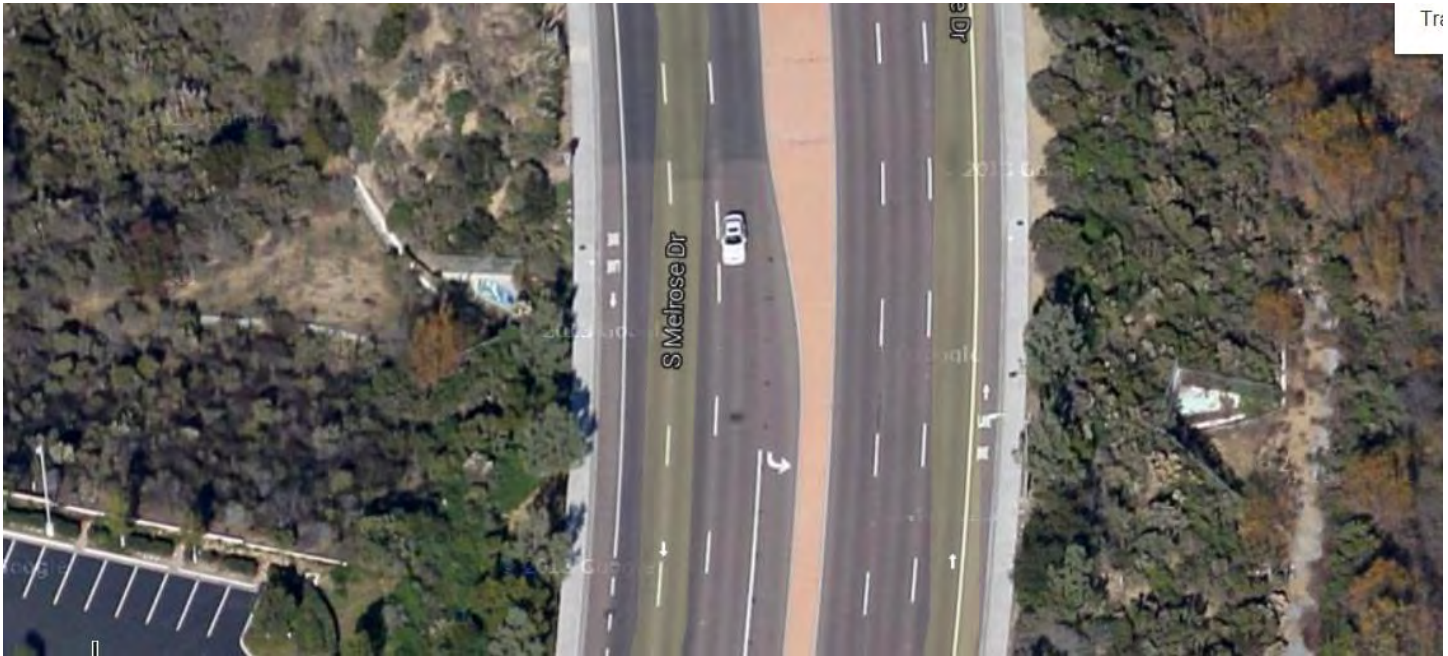
**EW2-10. High Priority.** Does not appear to be any fencing.

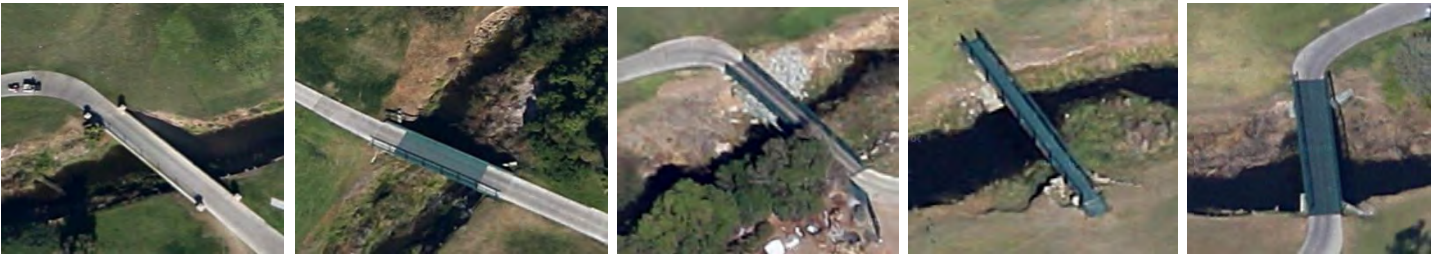
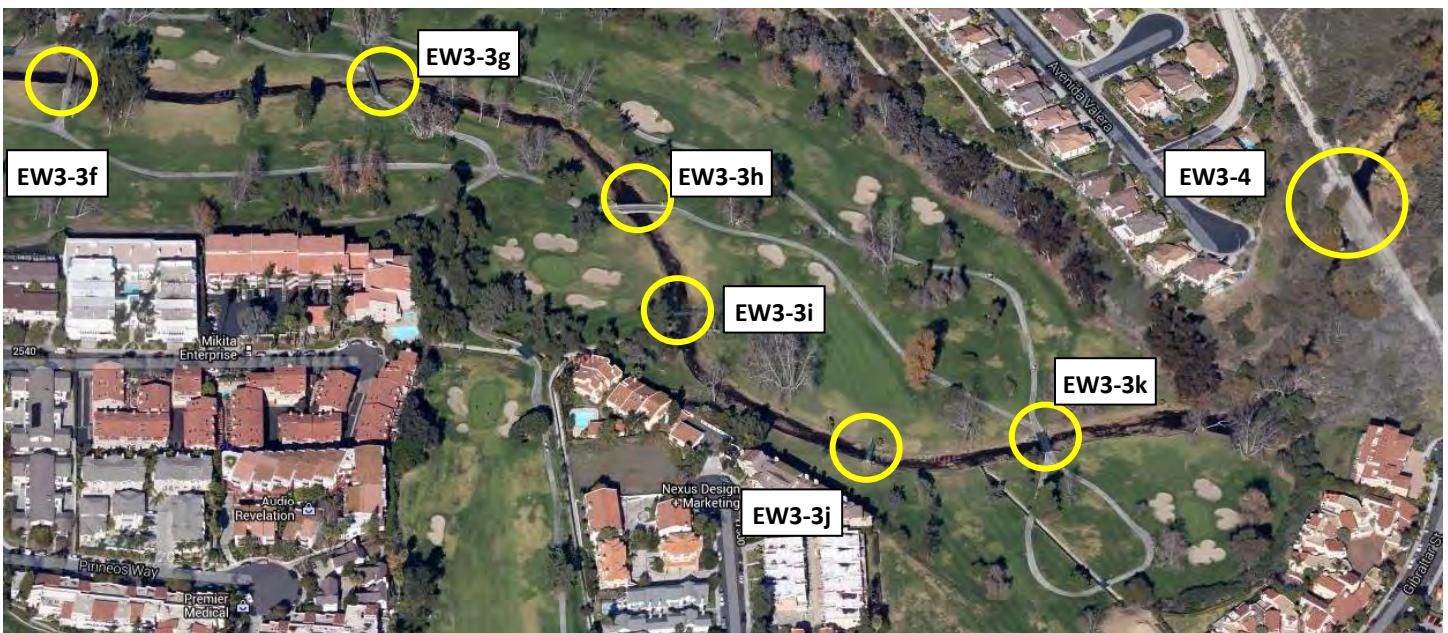
**EW3-3a-3a-e.** Narrow bridges along San Marcos Creek for golf cart access. These may not be great impediments to movement since animals can easily move along golf course surrounding the creek. Animals can move at night when the golf course is closed. There does not appear to be any fencing or other obstructions along the creek, but this should be confirmed. Private property; therefore, access might not be possible.

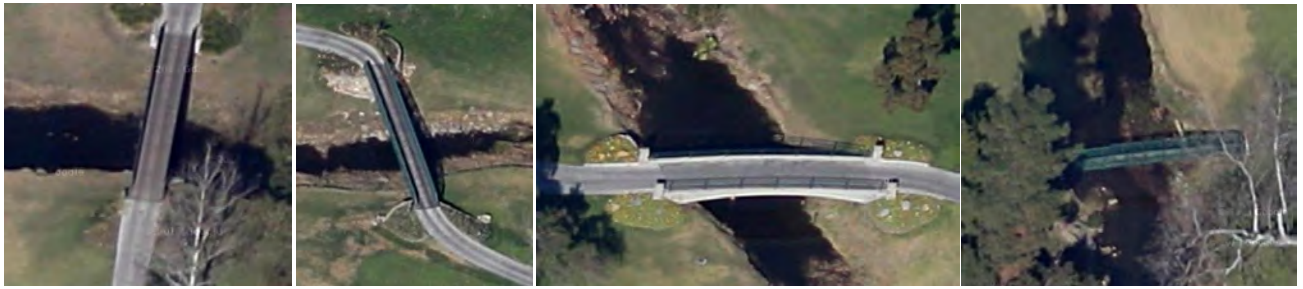
EW3-3f-i

**EW3-3a-3f-k.** Narrow bridges along San Marcos Creek for golf cart access.

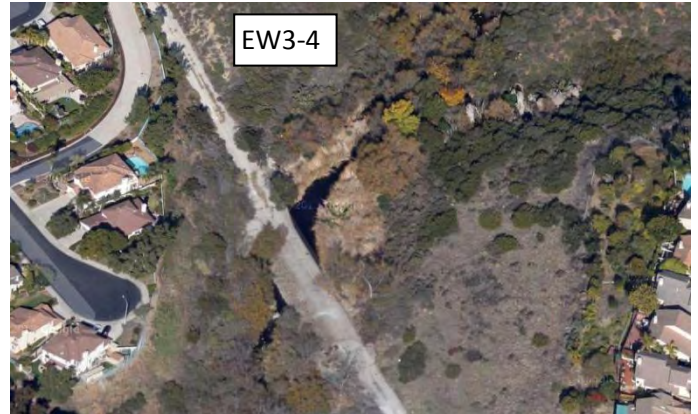
EW3-4

**EW3-4.** Unnamed road crossing San Marcos Creek; may be abandoned or used for maintenance. Does not appear to obstruct movement (at grade crossing), but this should be confirmed in the field if possible.

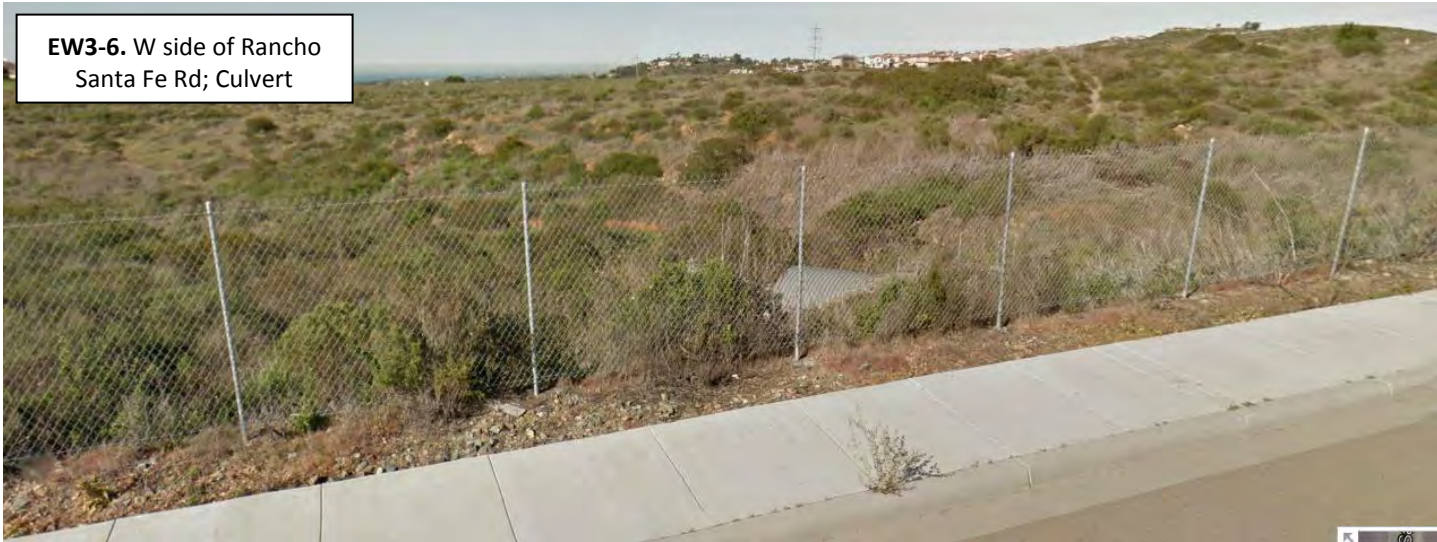
**EW3-6.**  
Culvert

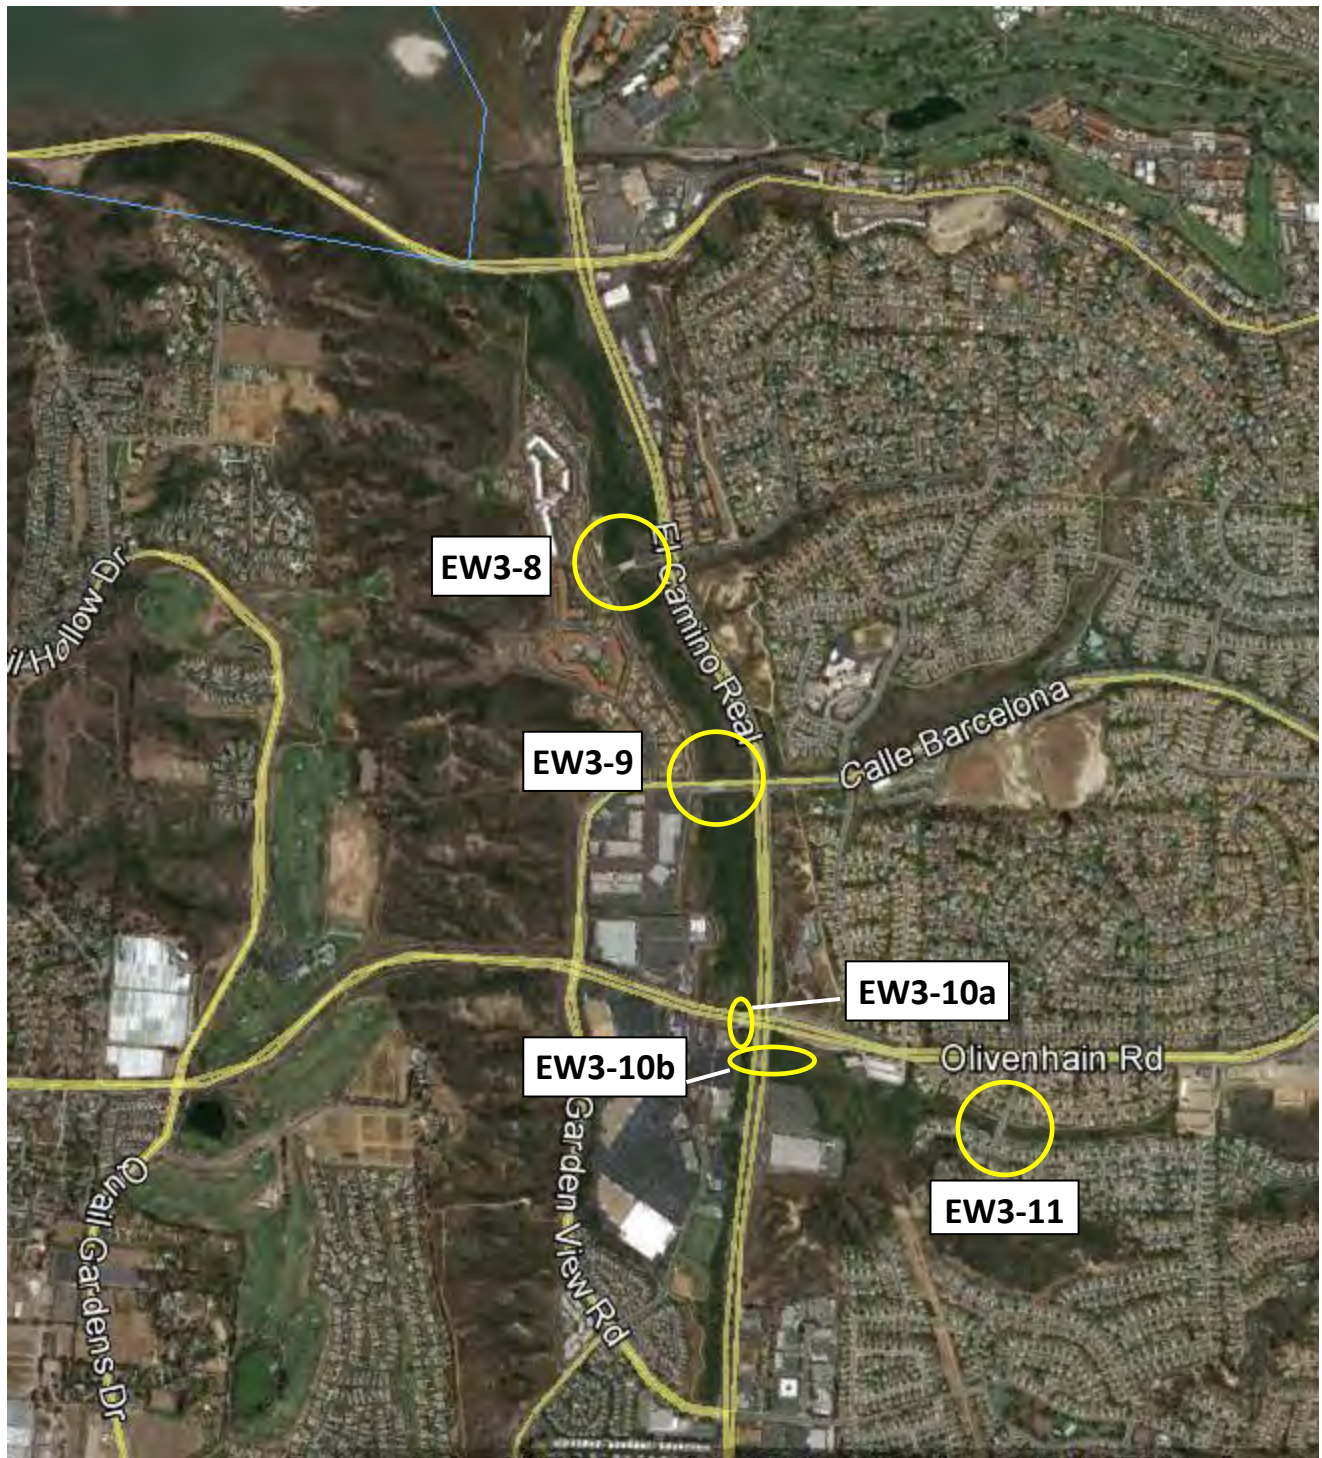
**EW3-7.** N side La  
Costa Ave. facing NW

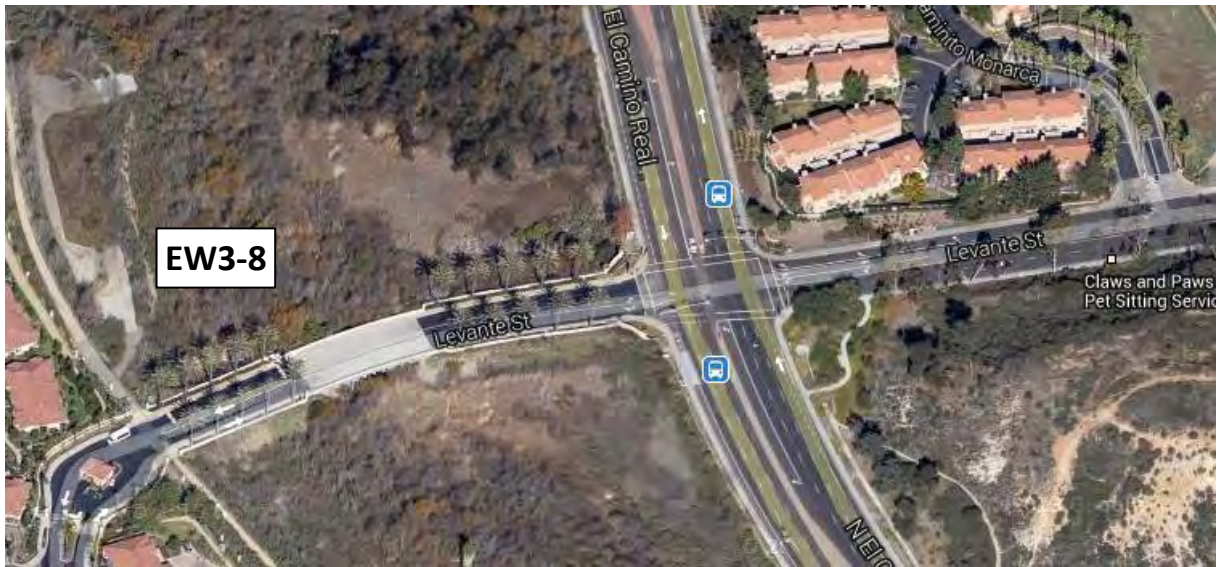
**EW3-8.** Encinitas Creek and Levante Street.

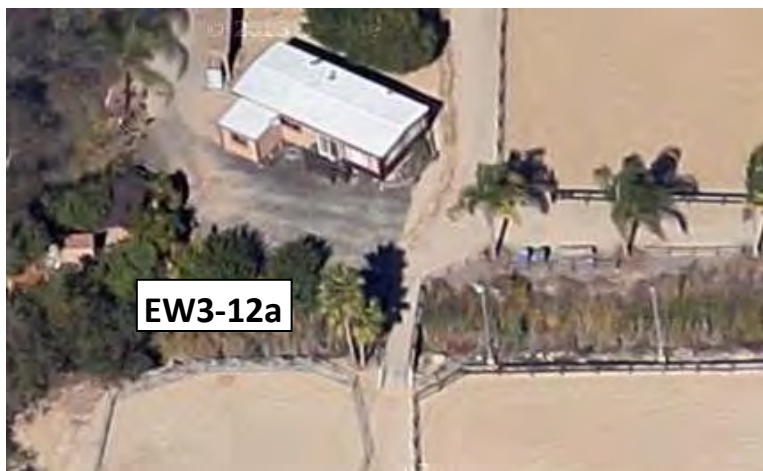
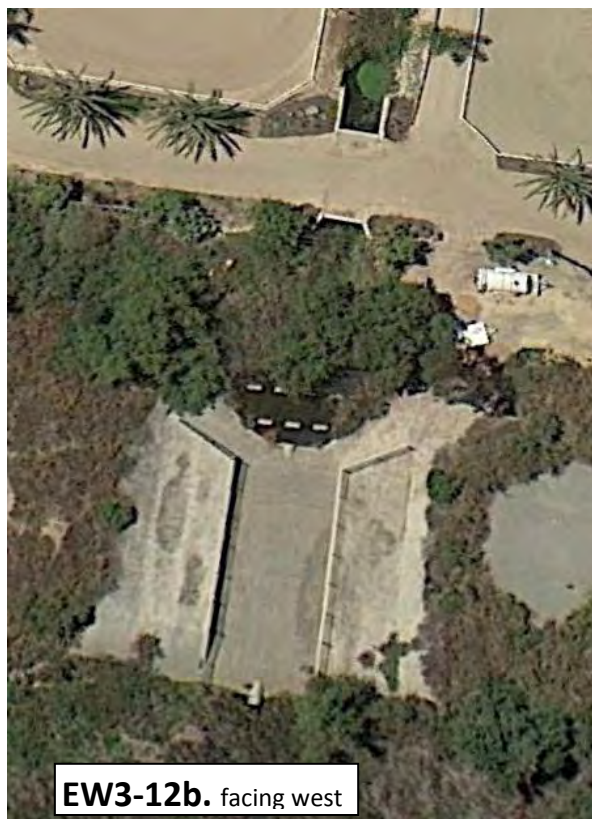
Overview of EW3-12a-c. Encinitas Creek and equestrian facilities (?), E of Amargosa, S of Olivenhain Rd. Not sure if wildlife movement through this area is possible. May not be access to this area.

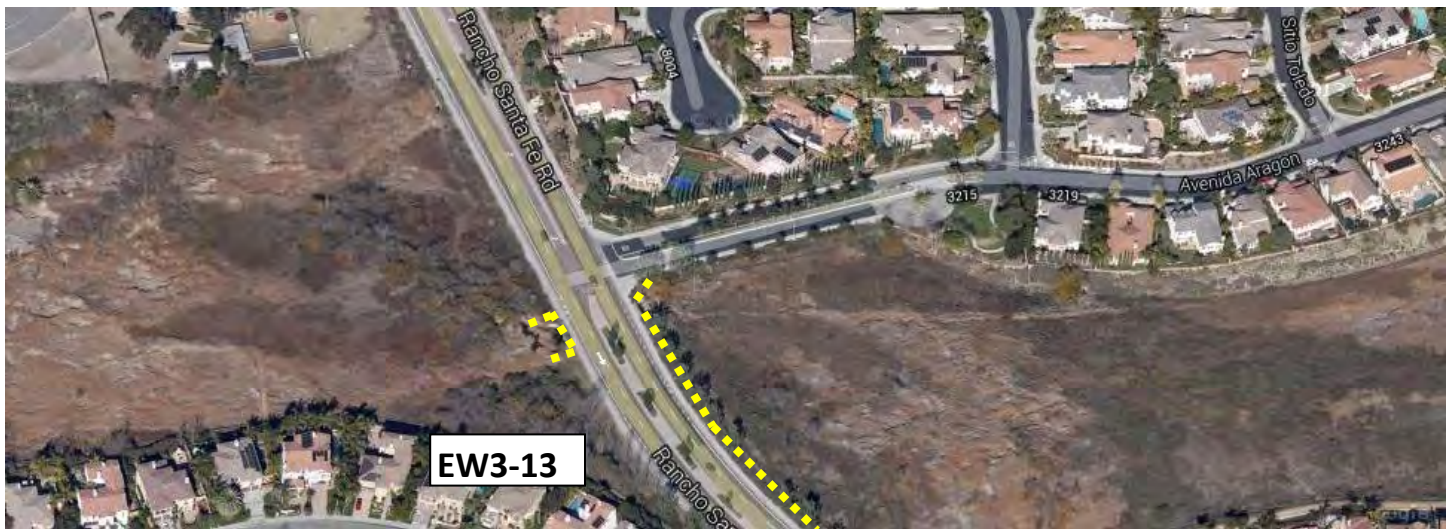
EW3-13. High Priority. MHCP-recommended monitoring location.

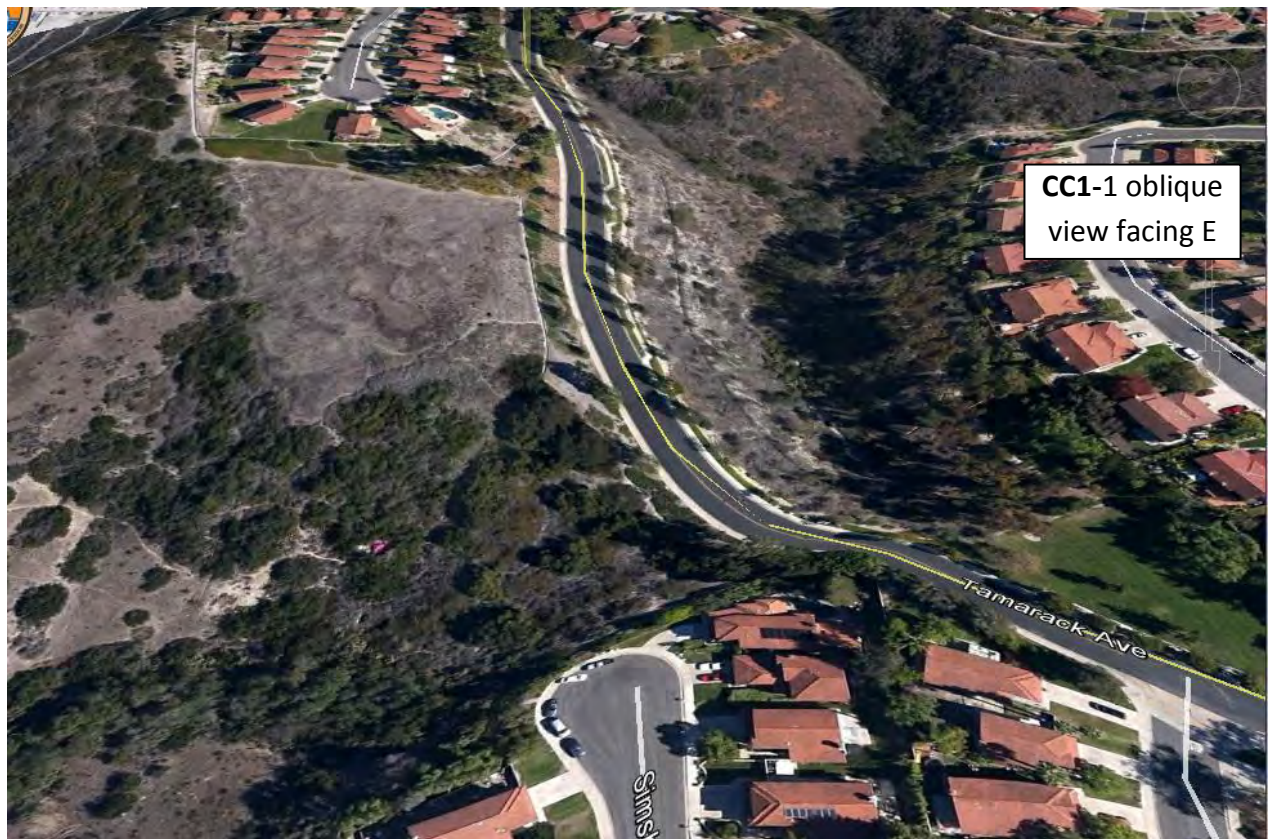
**CC1-1.**  
Tamarack Ave near Cheshire Ave. There does not appear to be a culvert here. At grade crossing.

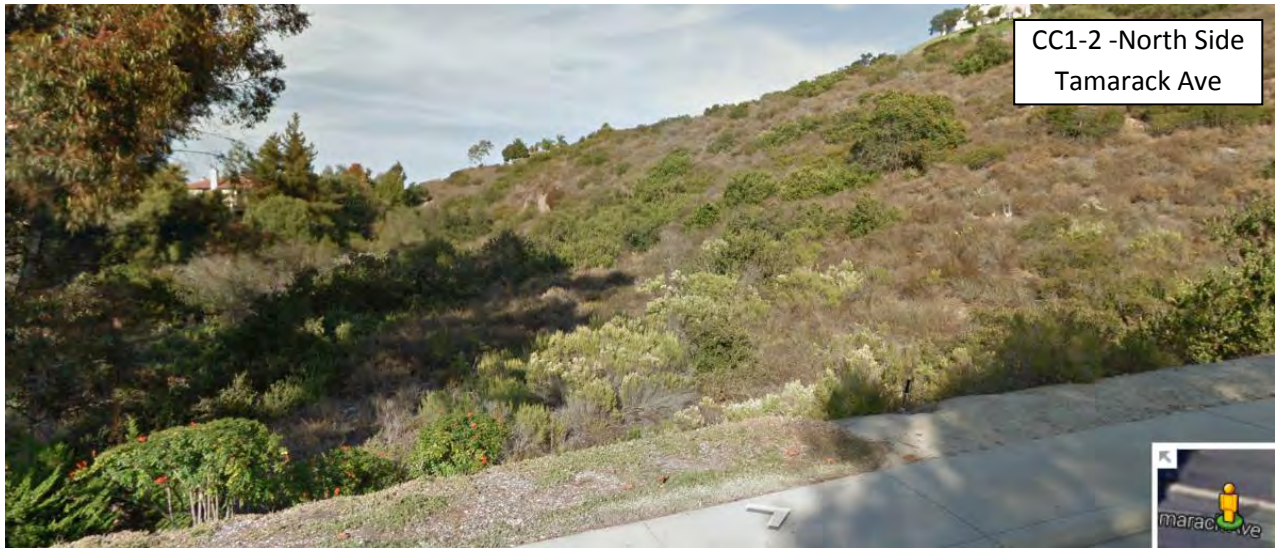
**CC1-2.** Tamarack Ave near Chatham Rd. Oblique view facing N. At grade crossing?

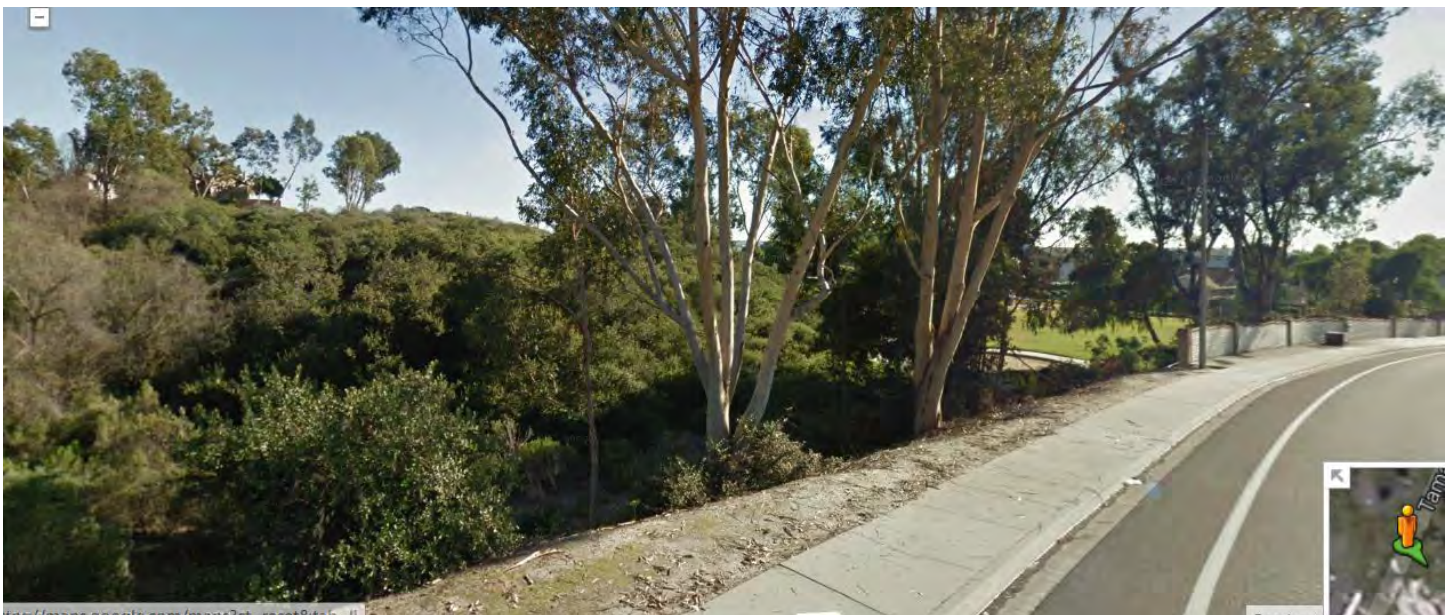
M1-2 and M1-2. Tamarak/Edinburgh Dr. and Glasgow Dr./Edinburgh Dr. At grade crossings?

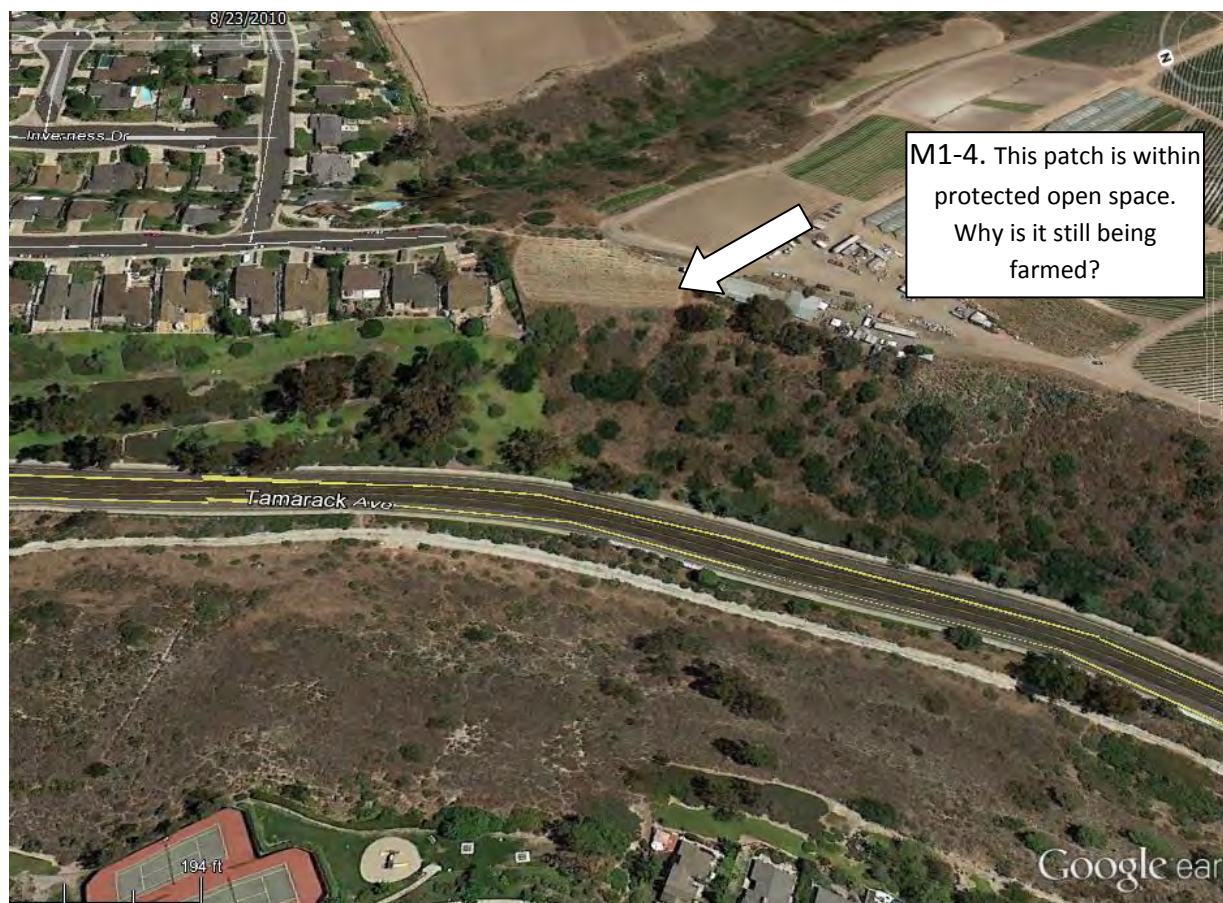
M1-4. Tamarack Ave near Gateshead R. Oblique view facing W. Appears to be no culverts or fencing along Tamarack Ave. Can animals travel across agricultural areas?

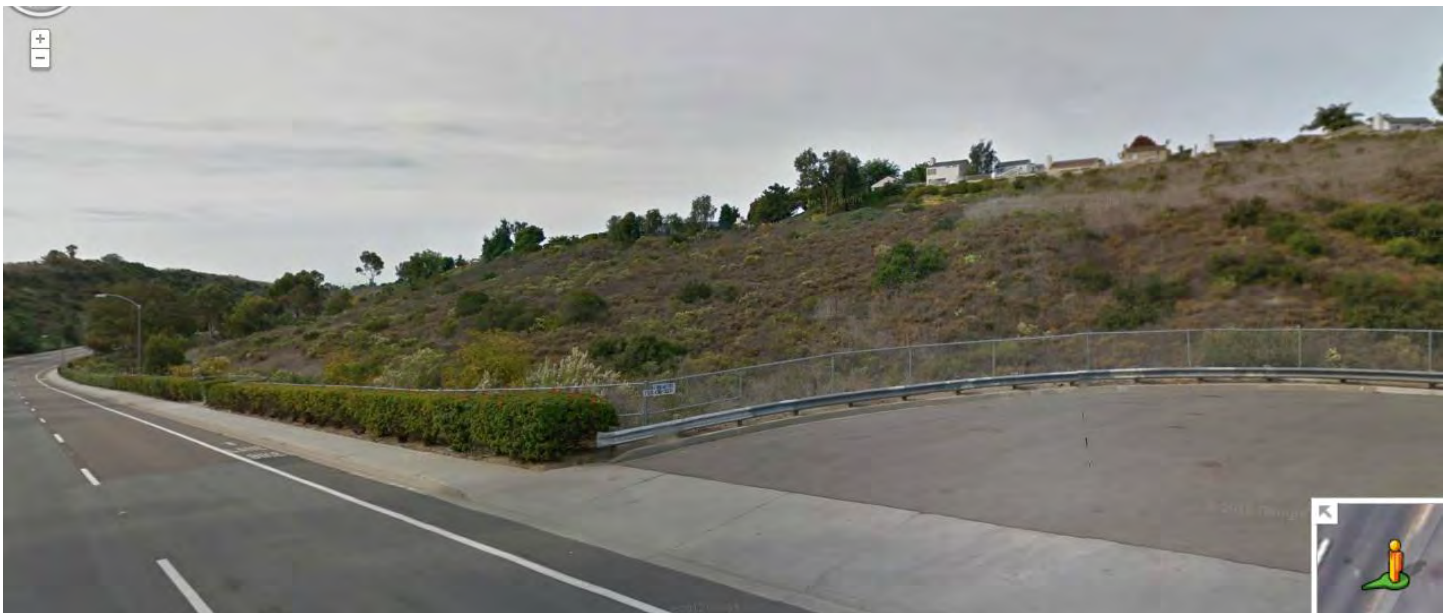
M1-4. Along W side of Tamarack Ave showing fencing (above). Photo below shows fencing around Calavera Hills Storage development. Fence seems fairly short – short enough for a coyote/bobcat to jump over?

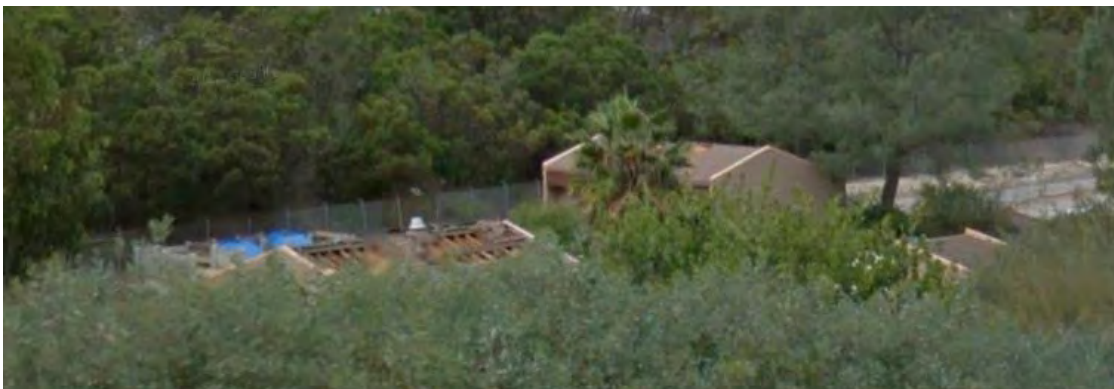
M1-4. Tamarack Ave showing chain-link fence in yellow, facing west. This fence may prevent movement along this linkage.

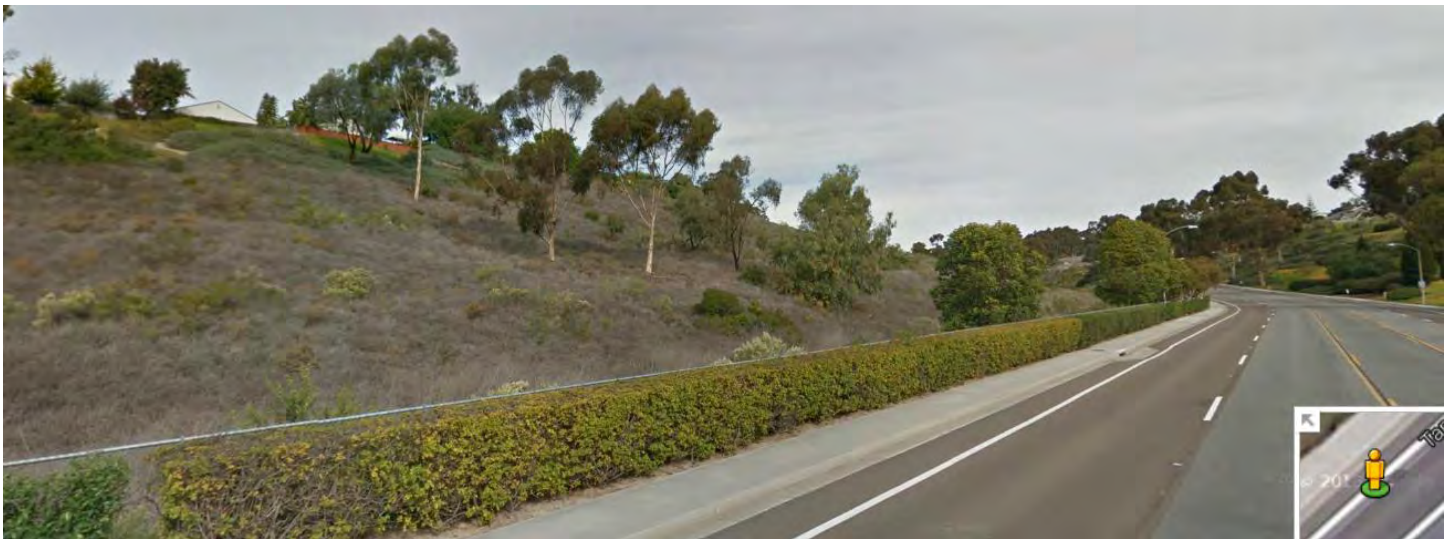
M1-4. Along Tamarack Ave showing low chain-link fence.
