# City of Carlsbad Wildlife Movement Analysis Final Report

Local Assistance Grant Agreement No.  
P1282107

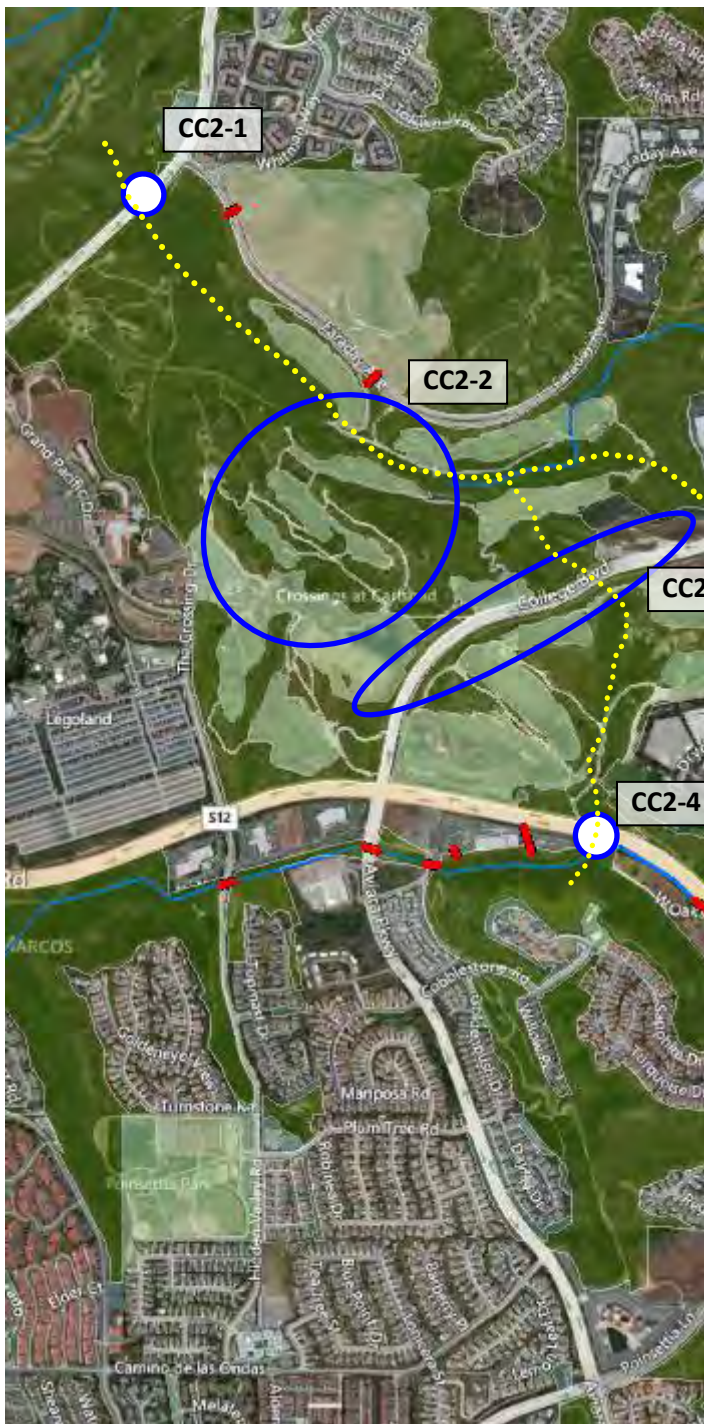
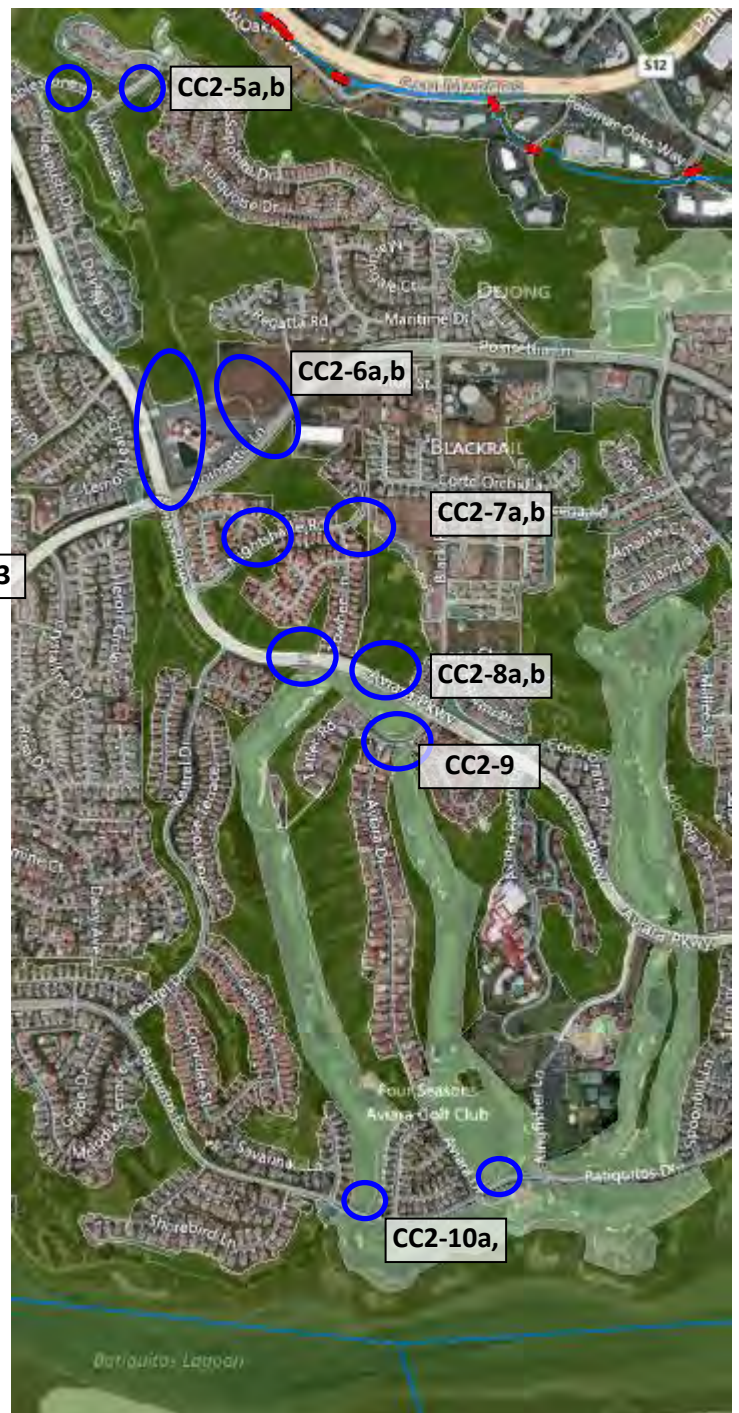
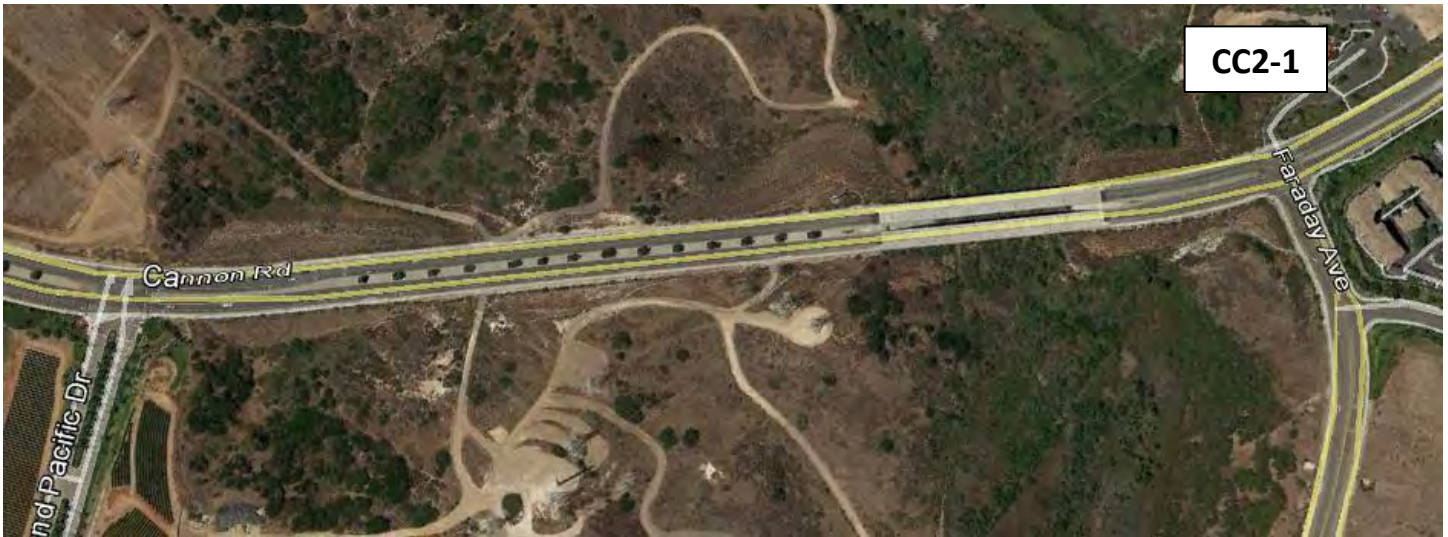
CC2-1. Cannon Road, near Faraday Ave. Most likely, movement is through bridge. 2012 and 2010 maps

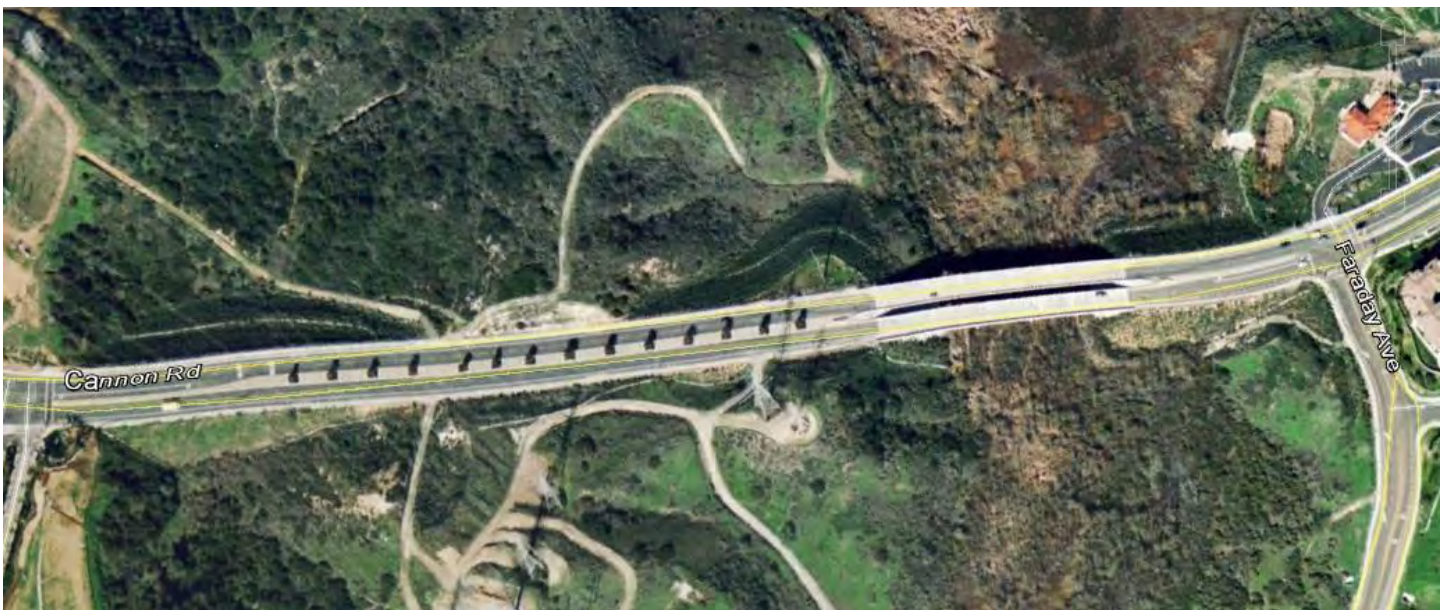
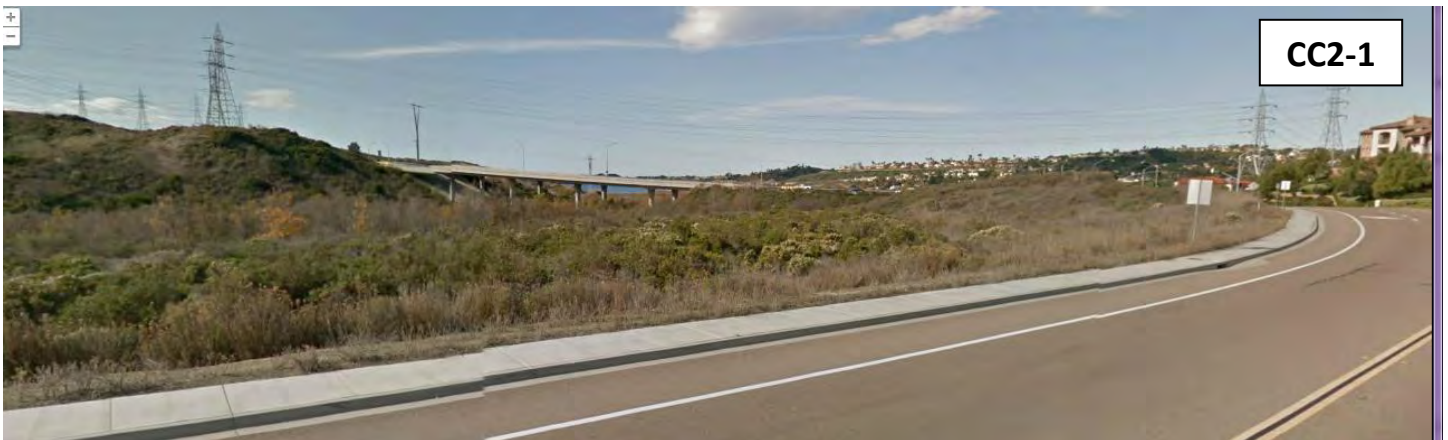
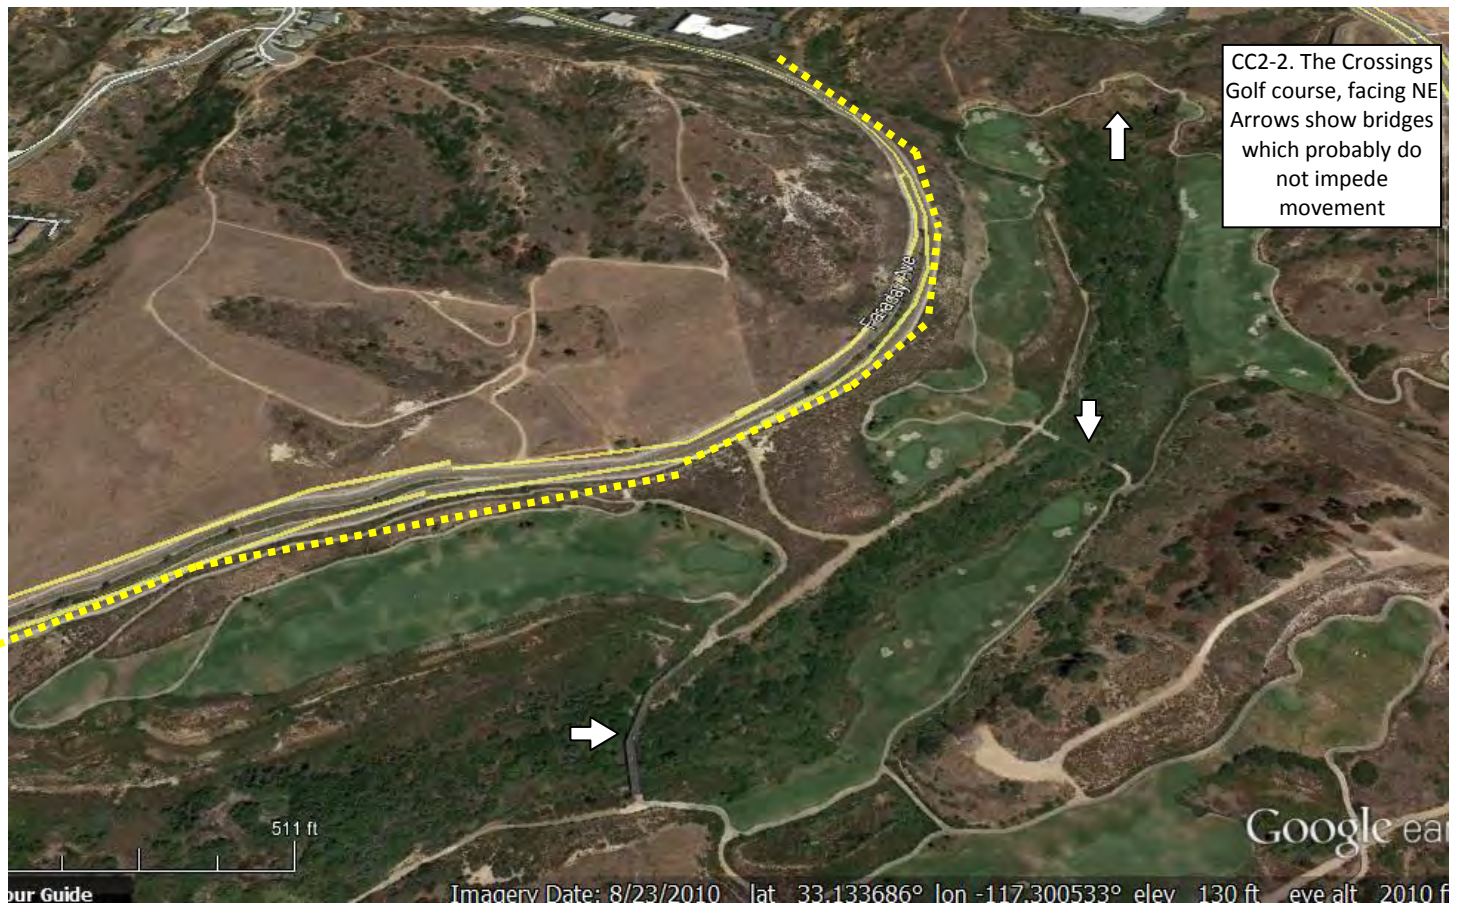
CC2-2. The Crossings Golf Course. Riparian corridor and upland habitat interspersed with golf greens. There are a couple of bridges the cross the riparian corridor (photos below). Faraday Ave is fenced with chainlink. MS: CC2 Faraday movement along Macario. Likely movement is within Marcario Creek, but it's dense, so I would think animals move along the SDGE roads/golf course fairways within the GC.

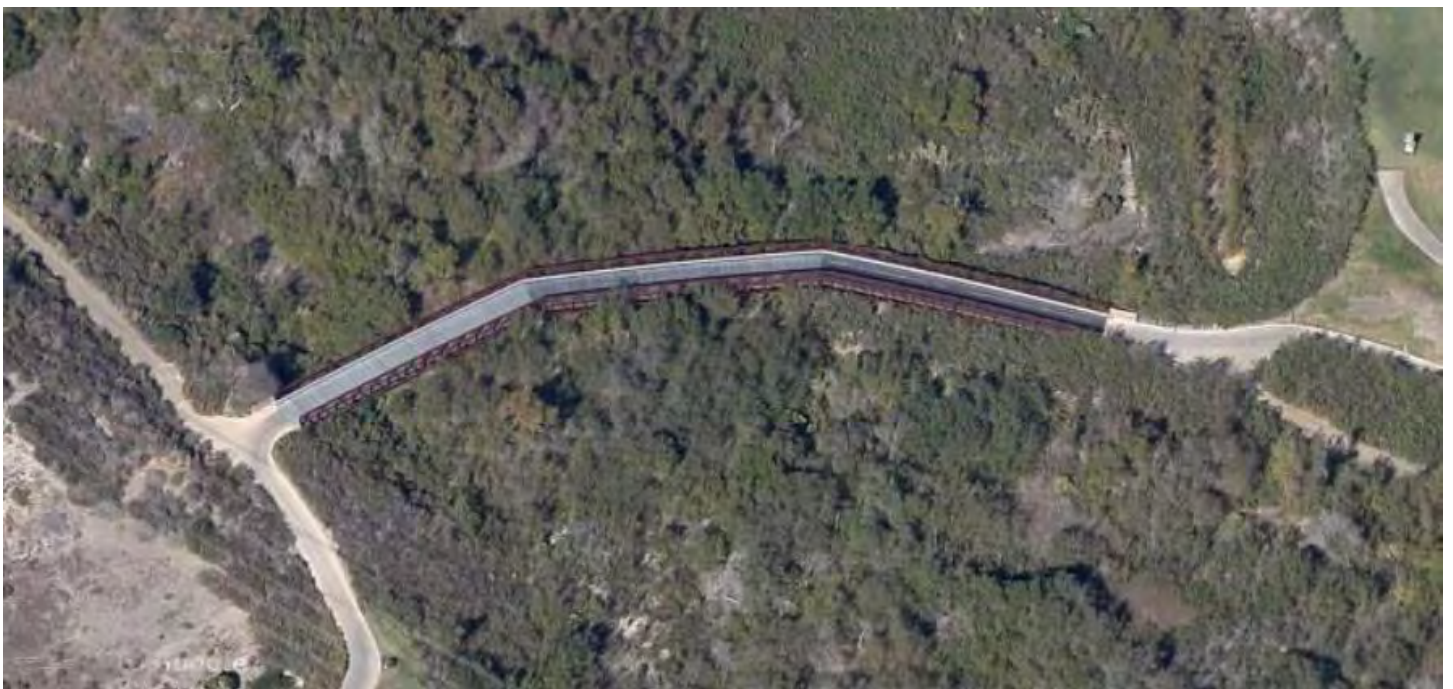
CC2-2- bridge for golf cart traffic. Not likely to be impediment to movement.

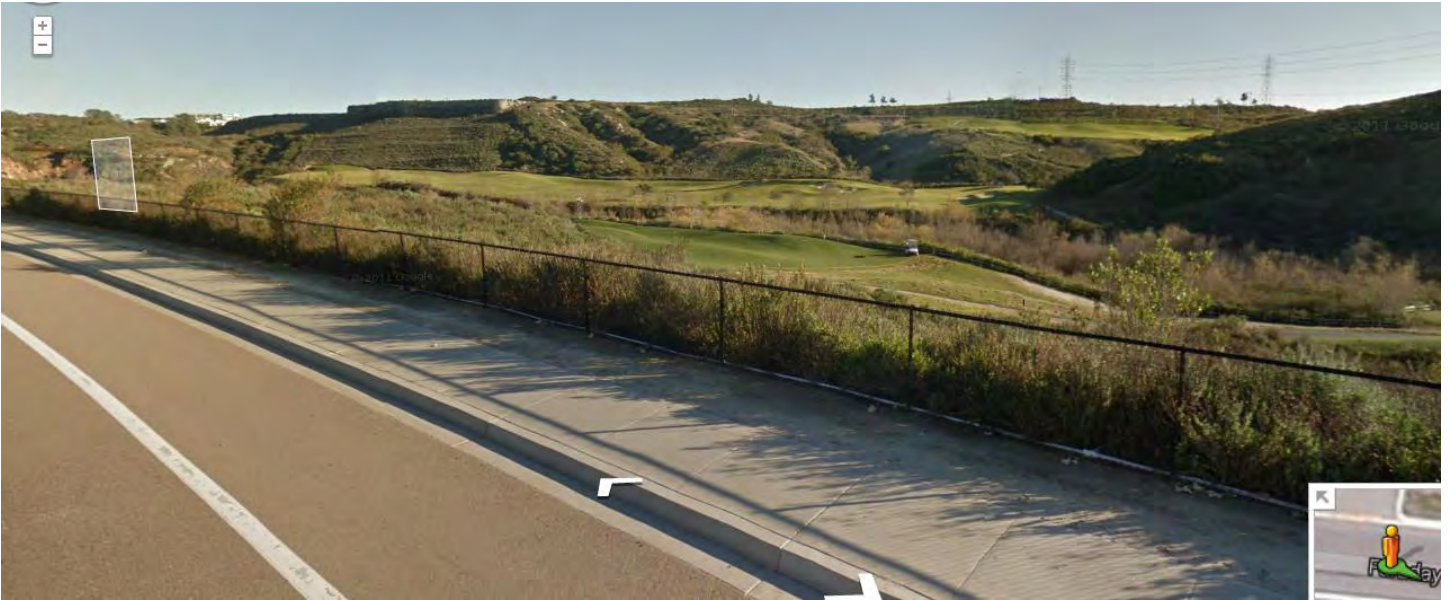
CC2-2 along Faraday (The Crossings Golf Course), showing riparian corridor and surrounding upland habitat.

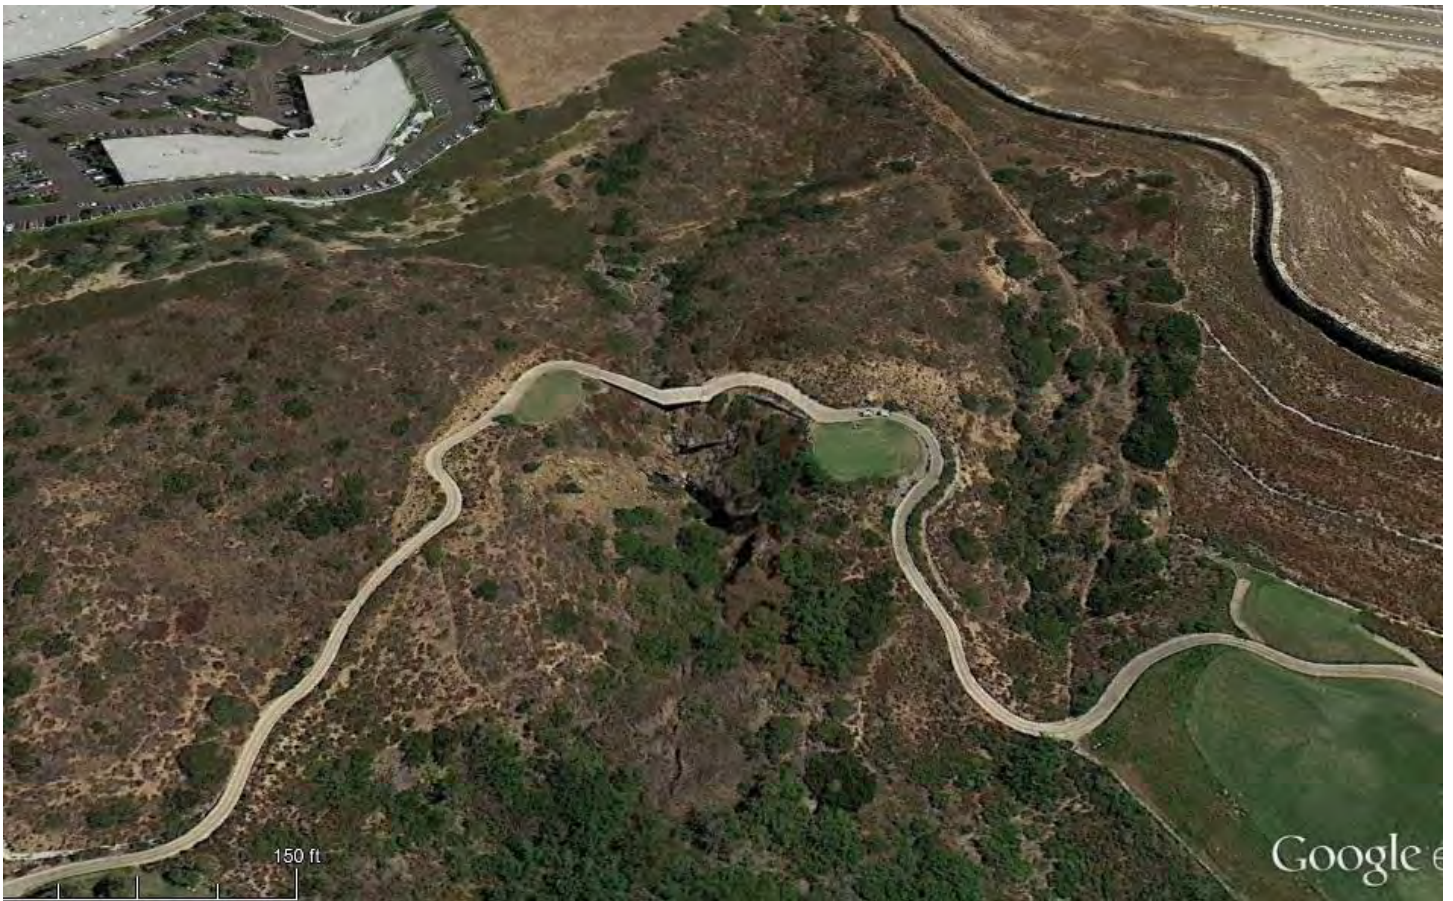
CC2-2. Far eastern end (facing E) of The Crossings Golf Course. Does not appear to be any obstructions to movement.

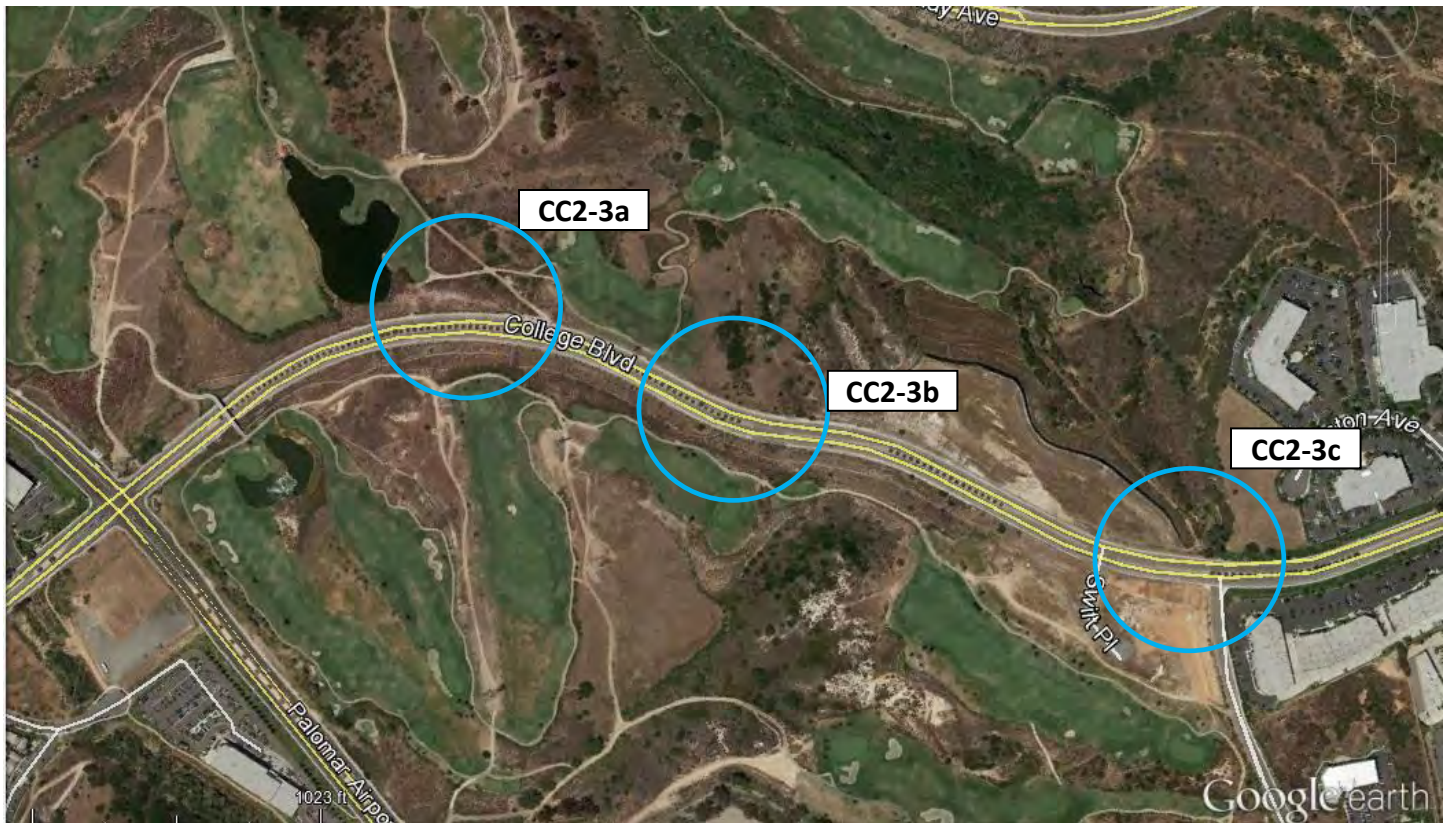
CC2-3a-c. College Blvd near Palomar Point Way. Snapshot is facing NW. Wildlife may be funneled to CC2-3c due to topography. Or animals may move across the greens or within upland habitat through CC2-3a or CC2-3b. There may be no culverts along College here. No fencing.

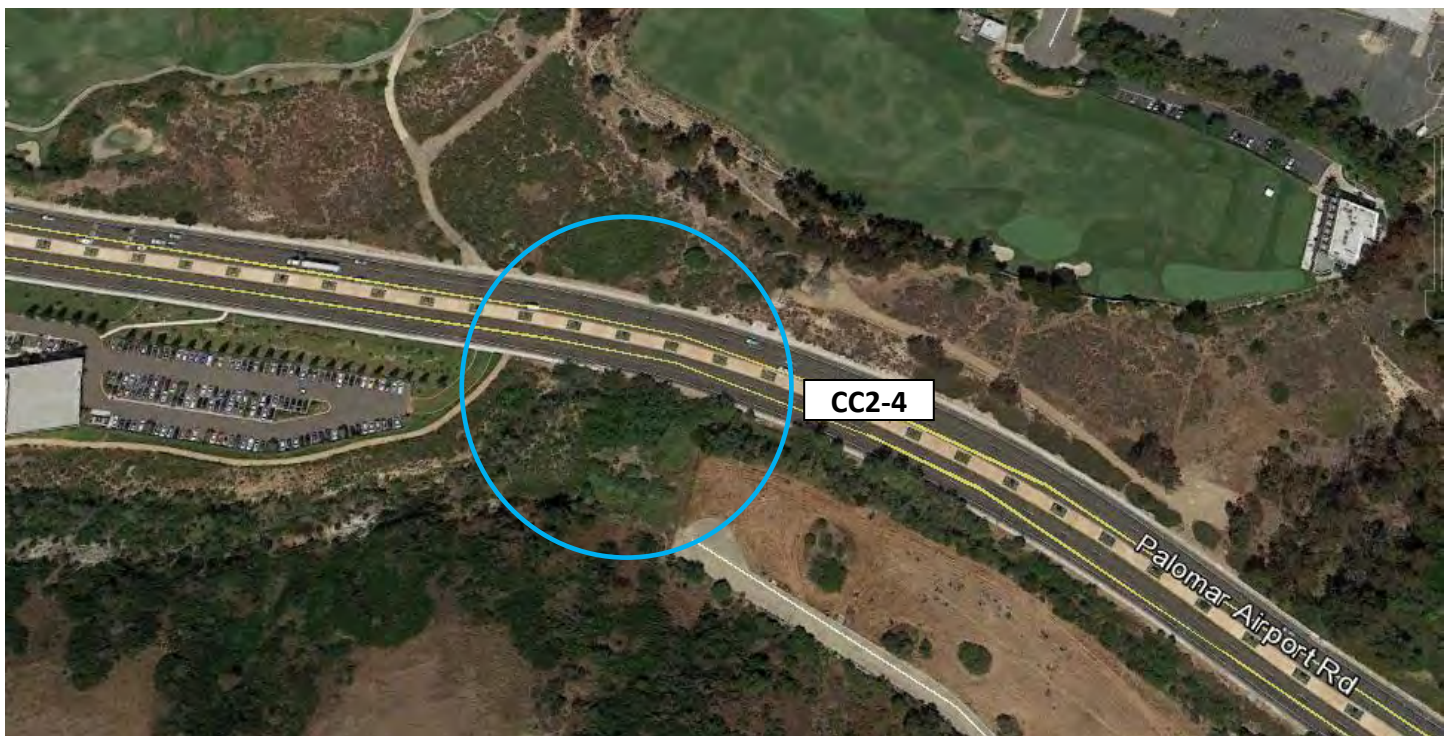
CC2-4. Palomar Airport Rd near West Oaks Way. Is there a culvert here?

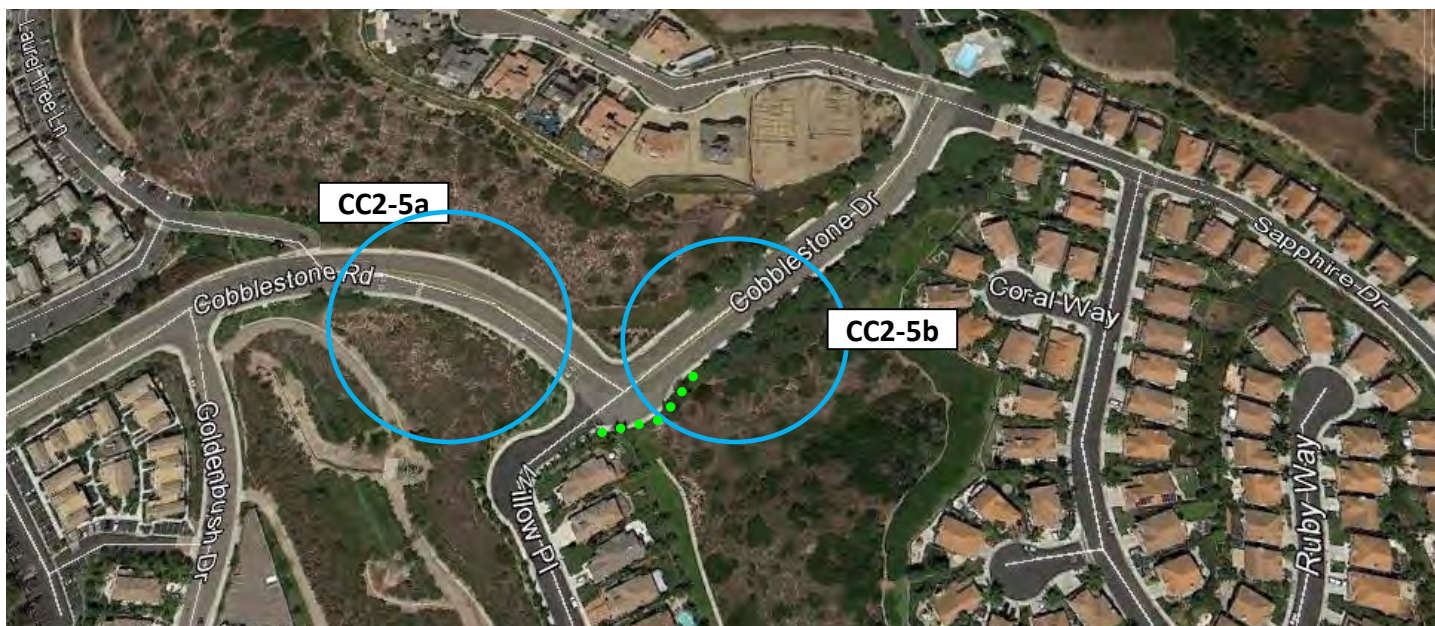
CC2-5. Cobblestone Drive. Green dotted line = wrought iron fencing. Unclear how far it goes.

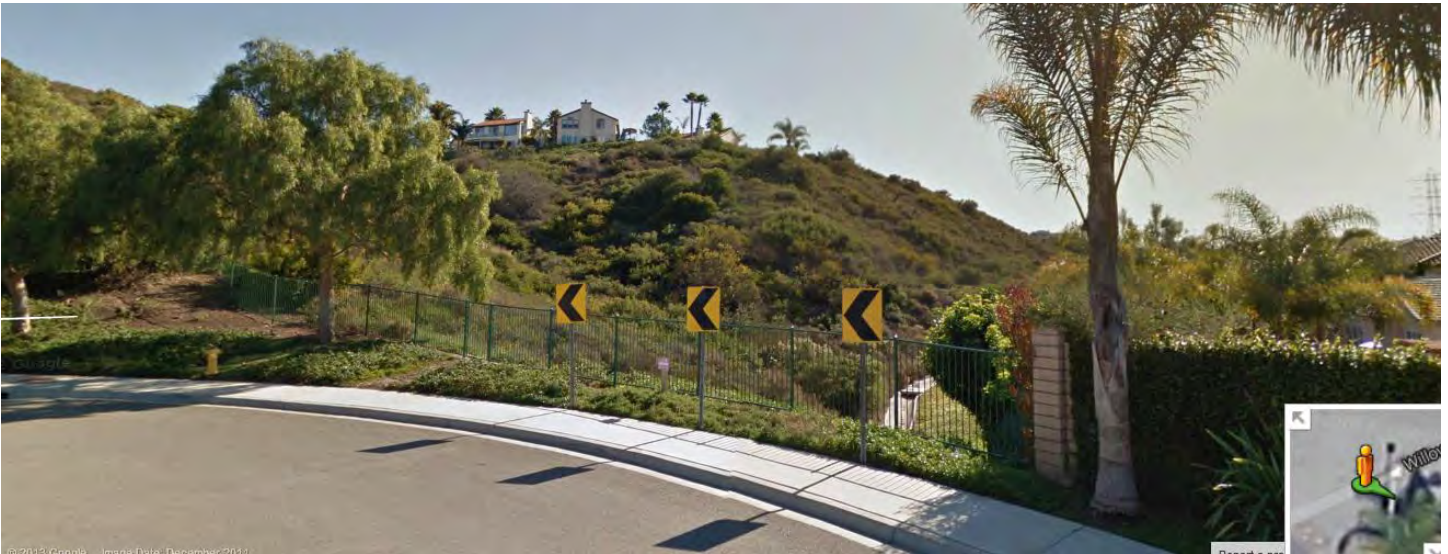
CC2-6a and b. Avira Parkway and Poinsettia Lane. Movement is from north to south of Poinsettia Lane. Too many constraints to movement through CC2-6a? CC2-6b appears to be an at-grade crossing; lots of traffic along this road. Who owns the mowed property NE of the Church? Might this ever be developed?

Twenty potential pinchpoints were identified for analysis within Core to Core 2; eight in the primary Core to Core 2 corridor, two in Core to Core 2a, six in Core to Core 2b, and four in Core to Core 2c. Results of the field reconnaissance found that the Core to Core 2 corridor offers little opportunity for unrestricted wildlife movement, as all branches of the corridor contain multiple at-grade crossings of roadways with moderate to heavy traffic. Although wildlife movement through individual pinchpoints is feasible, large-scale movement within the Core to Core 2 corridor is unlikely. Habitat within Core to Core 2 tends to be a mosaic of relatively open and relatively constricted areas. The Crossings at Carlsbad Municipal Golf Course and Aviara Golf Club offer relatively open habitat for potential movement, but human presence may deter daytime travel by wildlife. Fencing and heavy traffic associated with Poinsettia Lane and Aviara Parkway likely prevent wildlife movement.

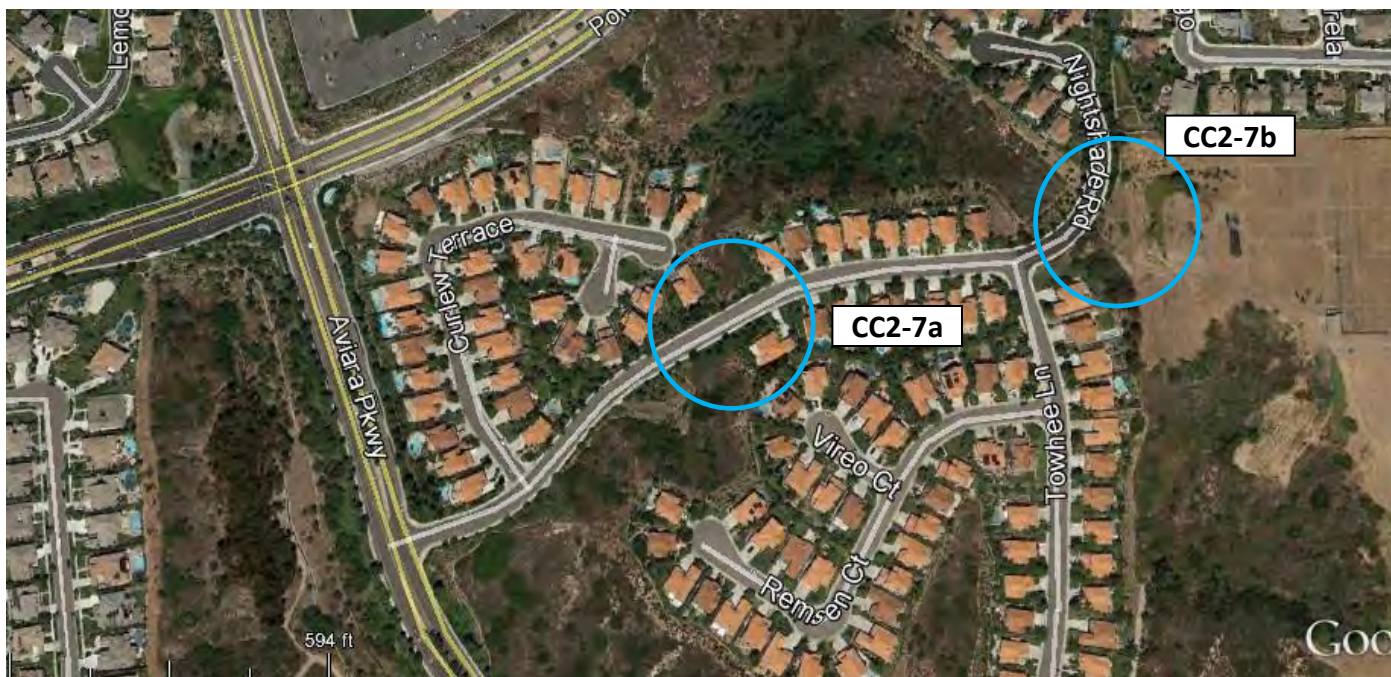
CC2-7a, b. Nightshade Rd. At-grade Crossings. No fencing.

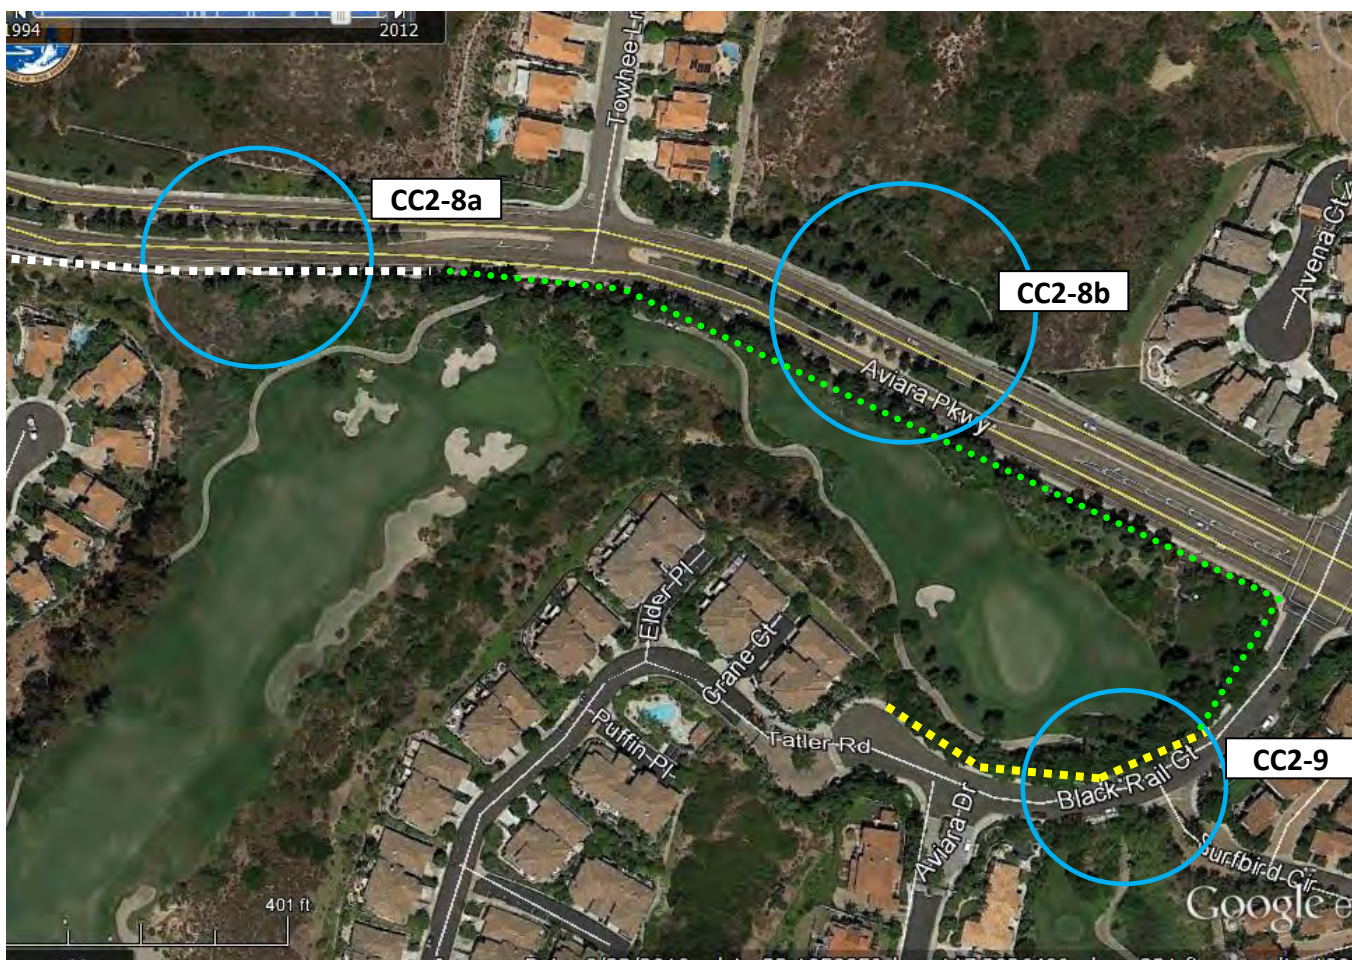
CC2-8a, b. Aviara Parkway at Aviara Golf Course. At-grade Crossings. No fencing on northern side of Aviara Parkway. Concrete wall (white dotted line) and wrought Iron fencing (green dotted line) on south side. No movement across Aviara possible?

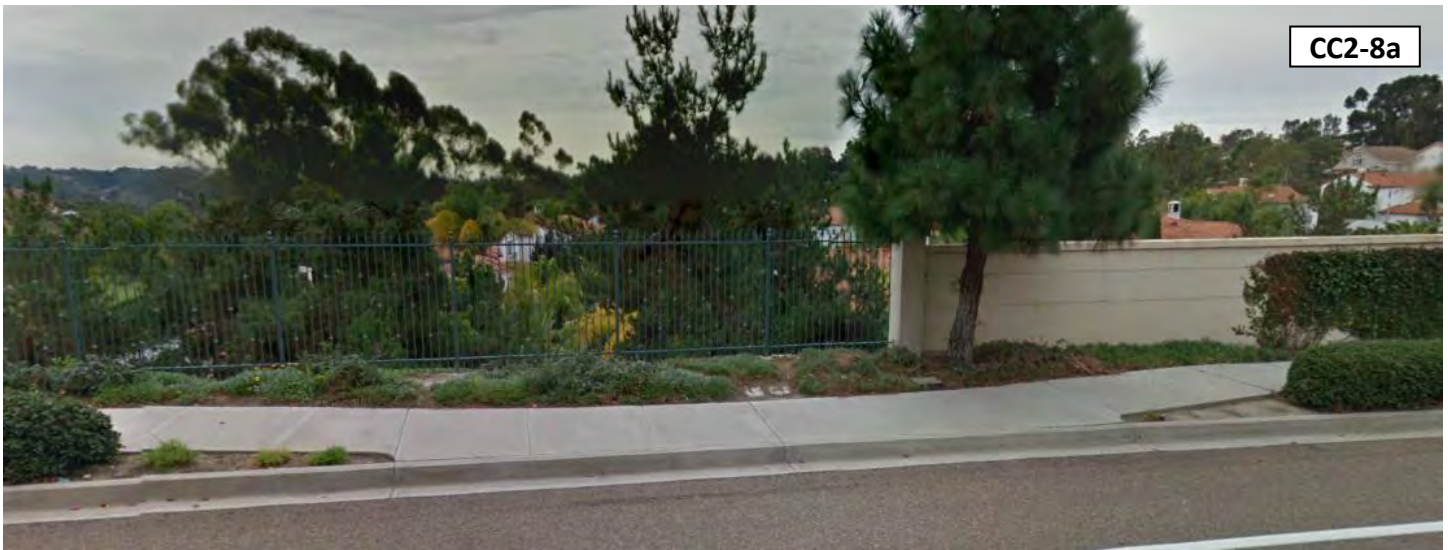
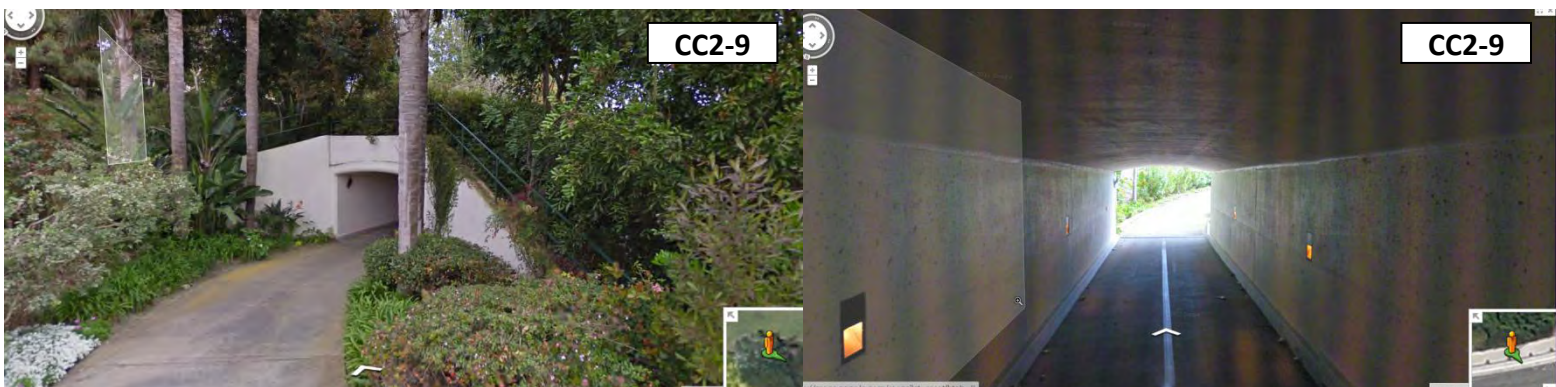
CC2-9-golf cart undercrossing under Black Rail Ct. Chainlink (yellow dotted line in previous aerial snapshot) along Black Rail Rd.

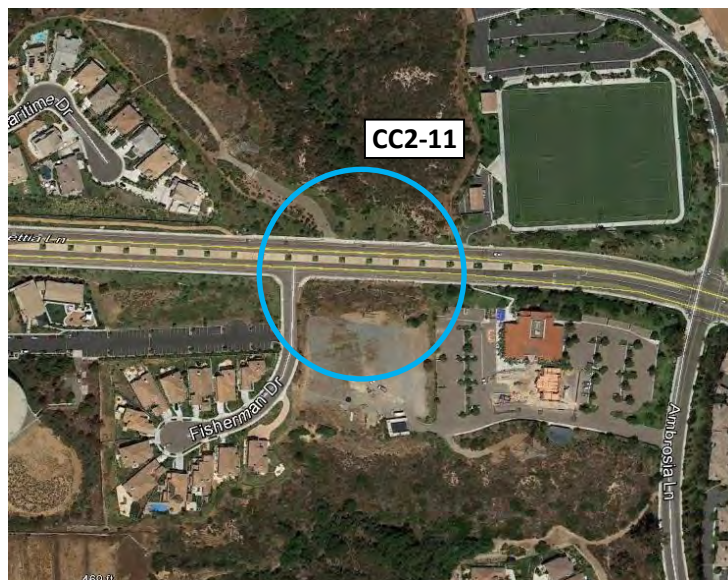
CC2-11. Poinsettia Lane at Fisherman Dr. No culvert? Open field to the south is privately owned and may block access if it is developed in the future.

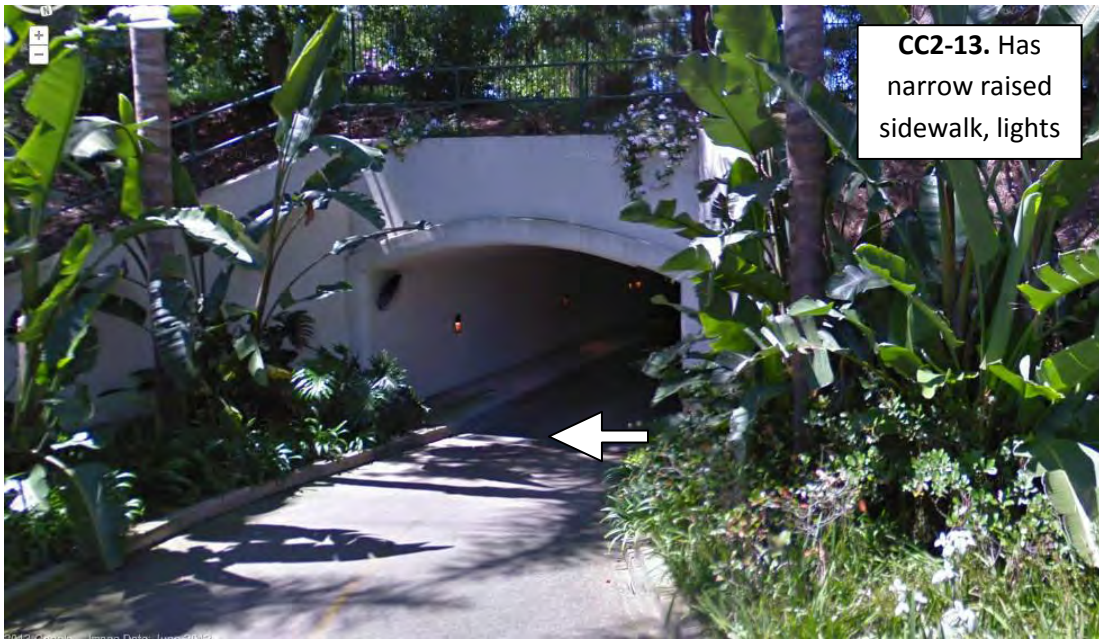
**CC2-13.** Has narrow raised sidewalk, lights

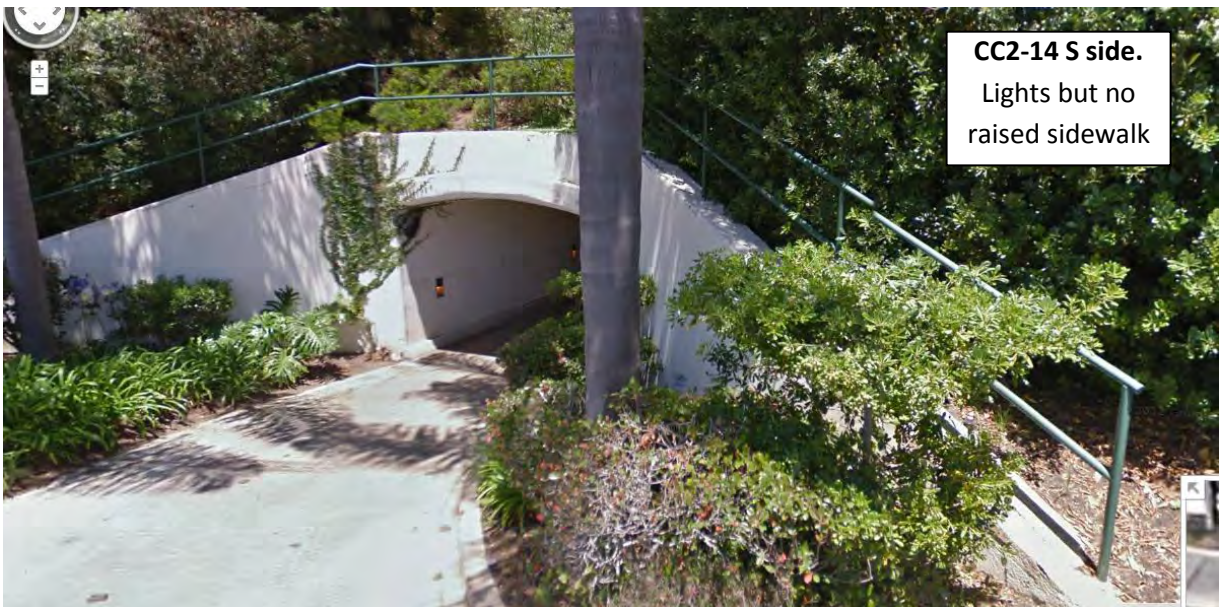
**CC2-14 S side.**  
Lights but no raised sidewalk

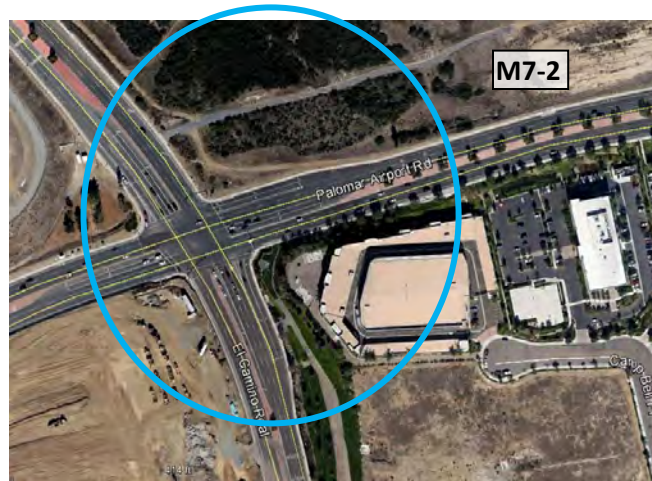
M7-1. Faraday near Orion Rd.  
Box culverts

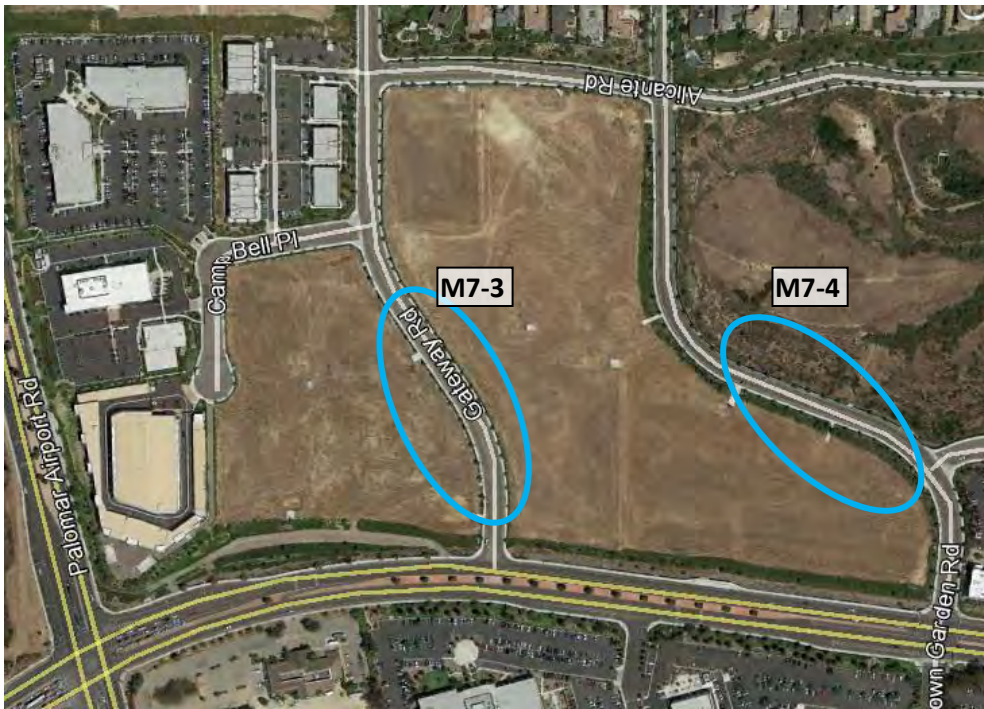
M7-3. Gateway Rd. Not sure what this area is, but future development could restrict animal movement.

M7-4. Town Garden Rd. Steep hill south of road. At-grade crossing.

Overview of M7-3 and M7-4.

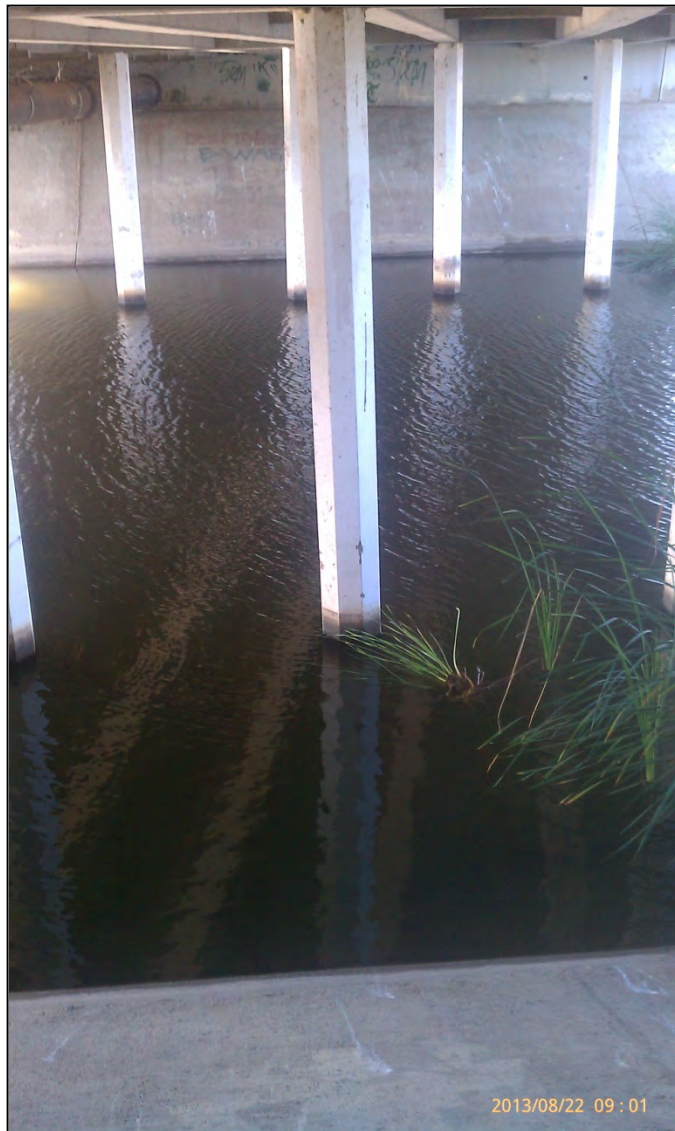
EW1-3, interior looking south from N side, August 2013.

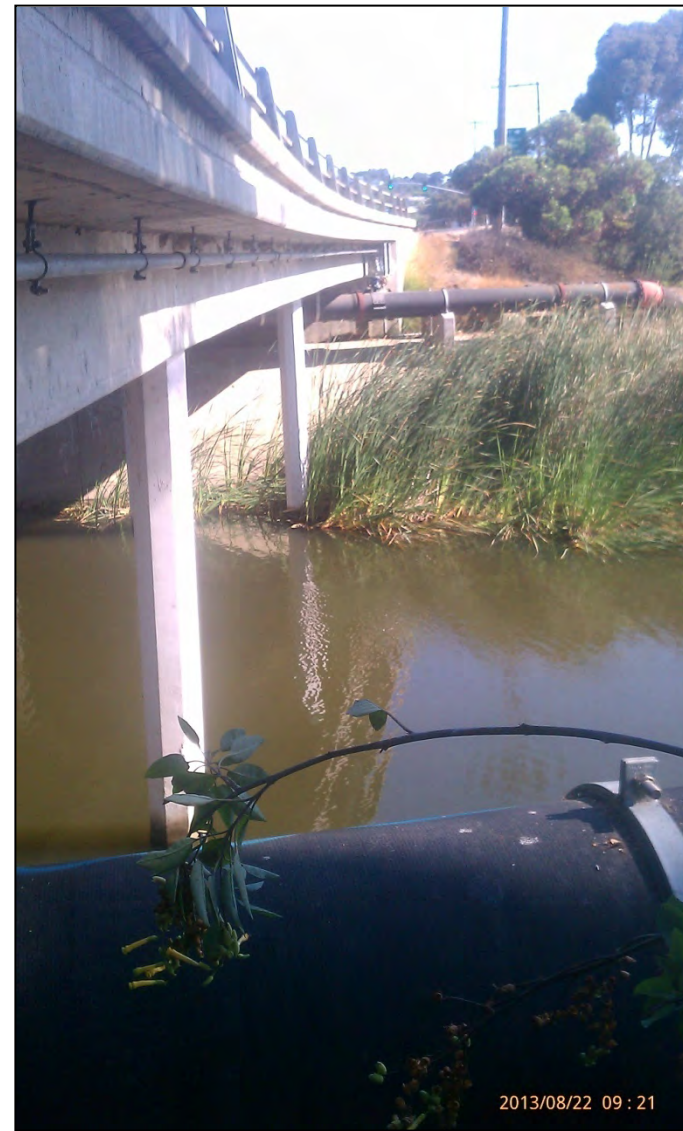
EW1-3, looking south along east entrance, August 2013

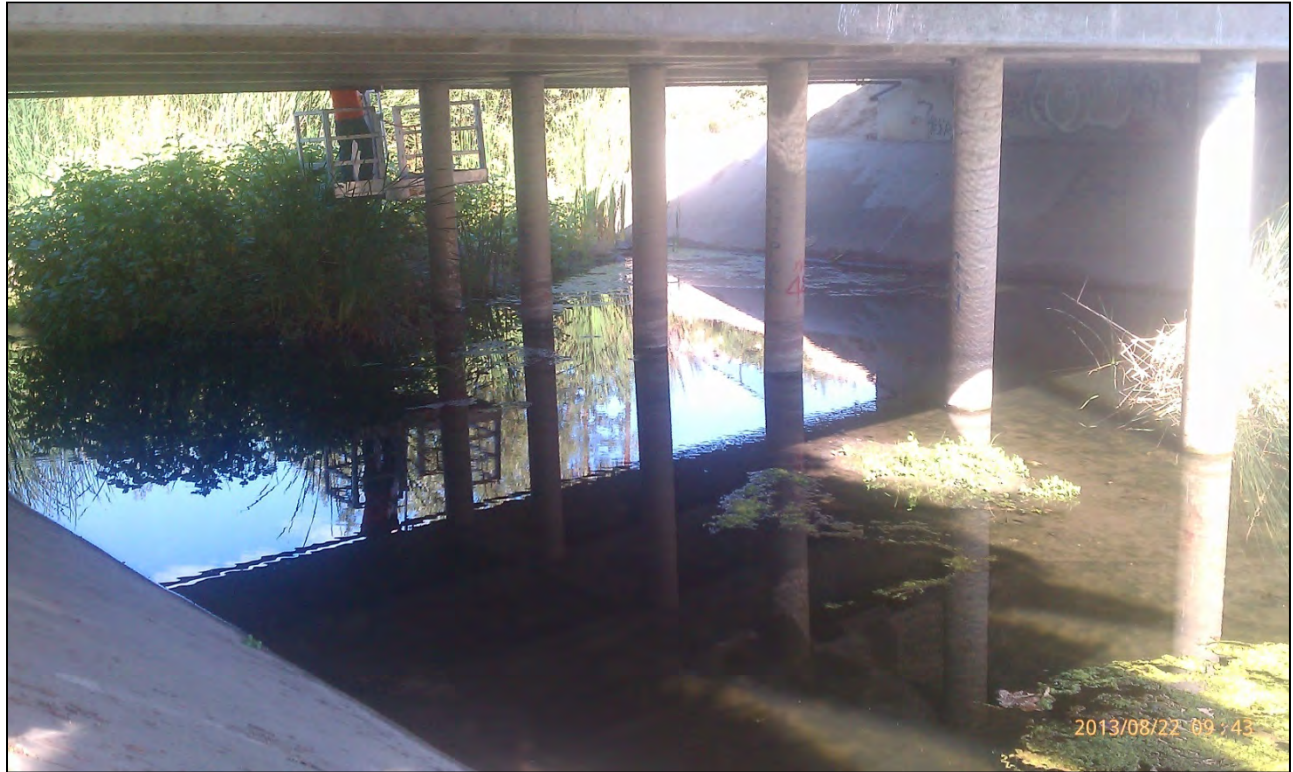
EW1-4, looking underneath from SE entrance, August 2013
