# City of Carlsbad Wildlife Movement Analysis Final Report

Local Assistance Grant Agreement No.  
P1282107

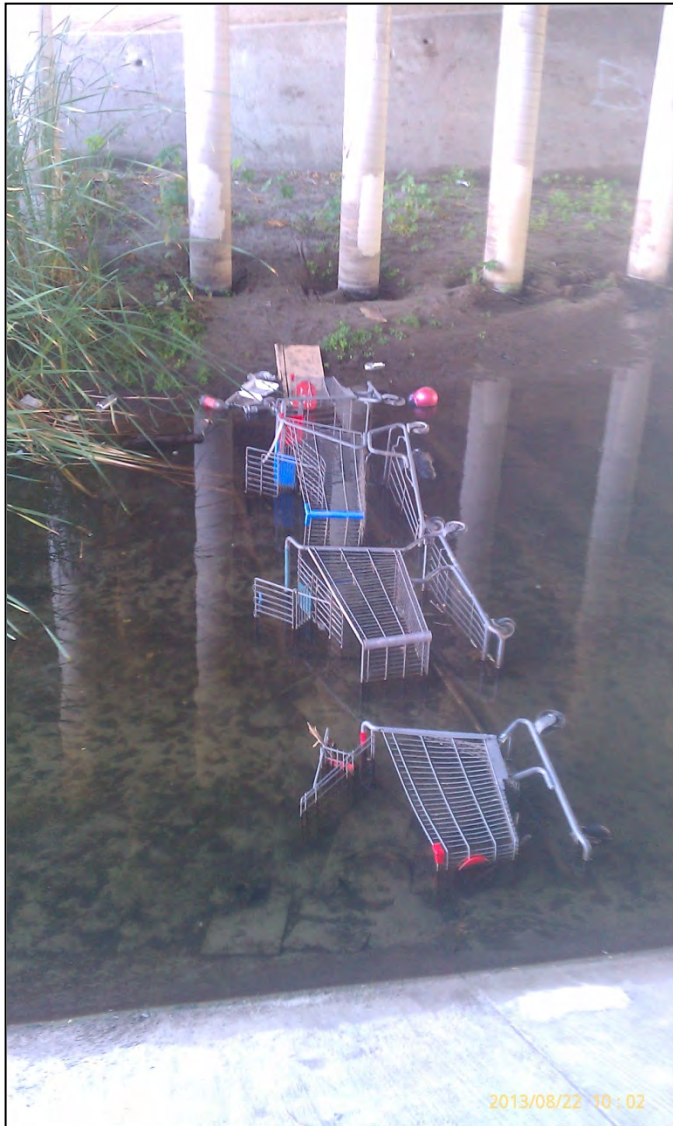
EW1-5, interior showing human impacts, August 2013.

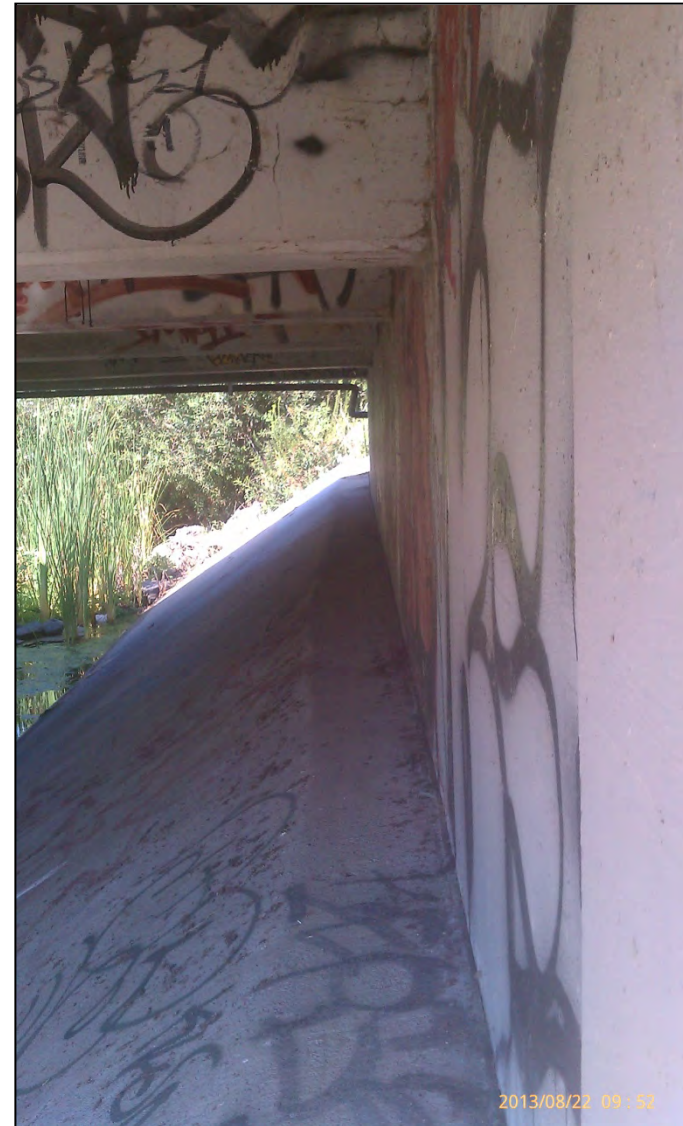
EW1-5, looking east on south side, August 2013

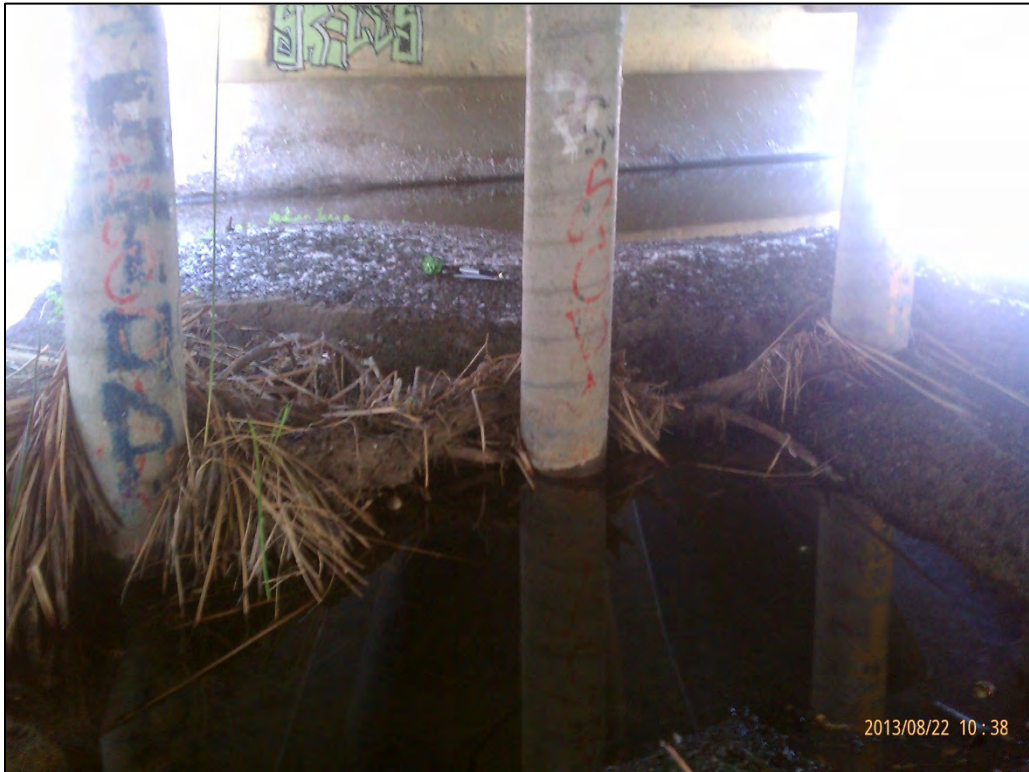
Results of the field reconnaissance found that wildlife connectivity within the corridor is severely constrained at several points due to standing water and bridge abutments. Heavy human presence and existing infrastructure (e.g., sewer pipes, fencing) may further deter use of the corridor, especially by large mammals. All surveyed points were considered constrained to some degree and large scale movement within East/West 1 by large mammals would likely require significant at-grade crossing of potential pinchpoints. Possible Task 2 monitoring could include cameras at EW1-3, EW 1-4, and/or EW 1-5 to confirm suspected barriers to movement and tracking at EW1-6 to identify species using the corridor in this area.

EW1-6, interior looking east, August 2013.

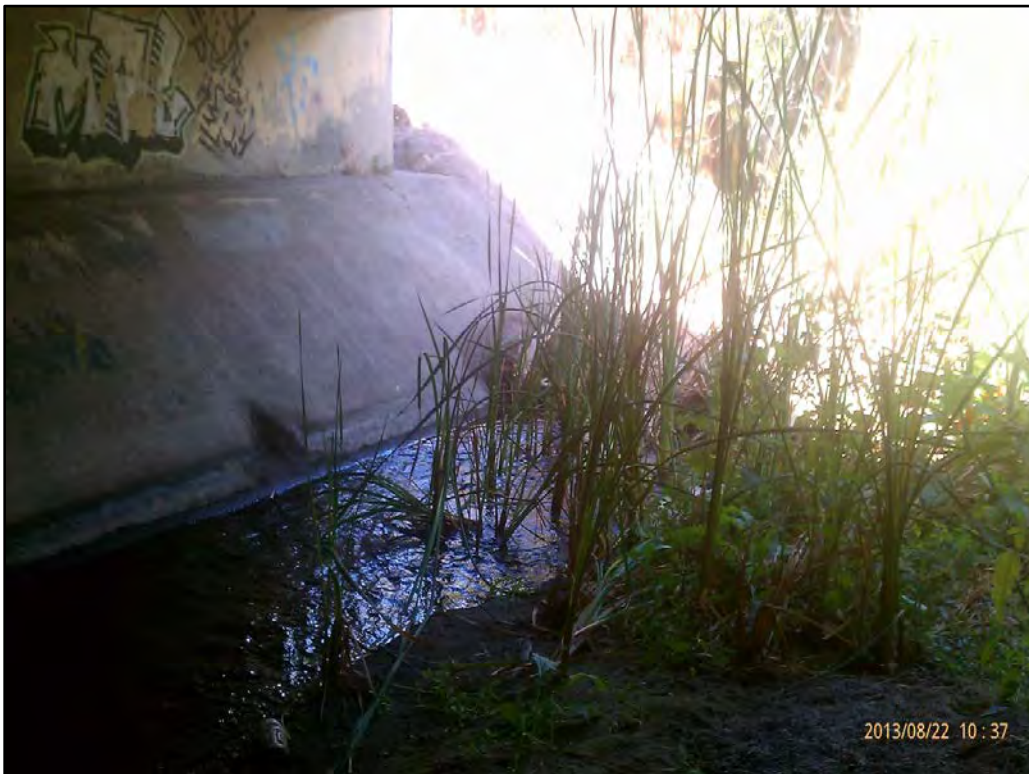
EW1-6, looking north from west entrance, August 2013.

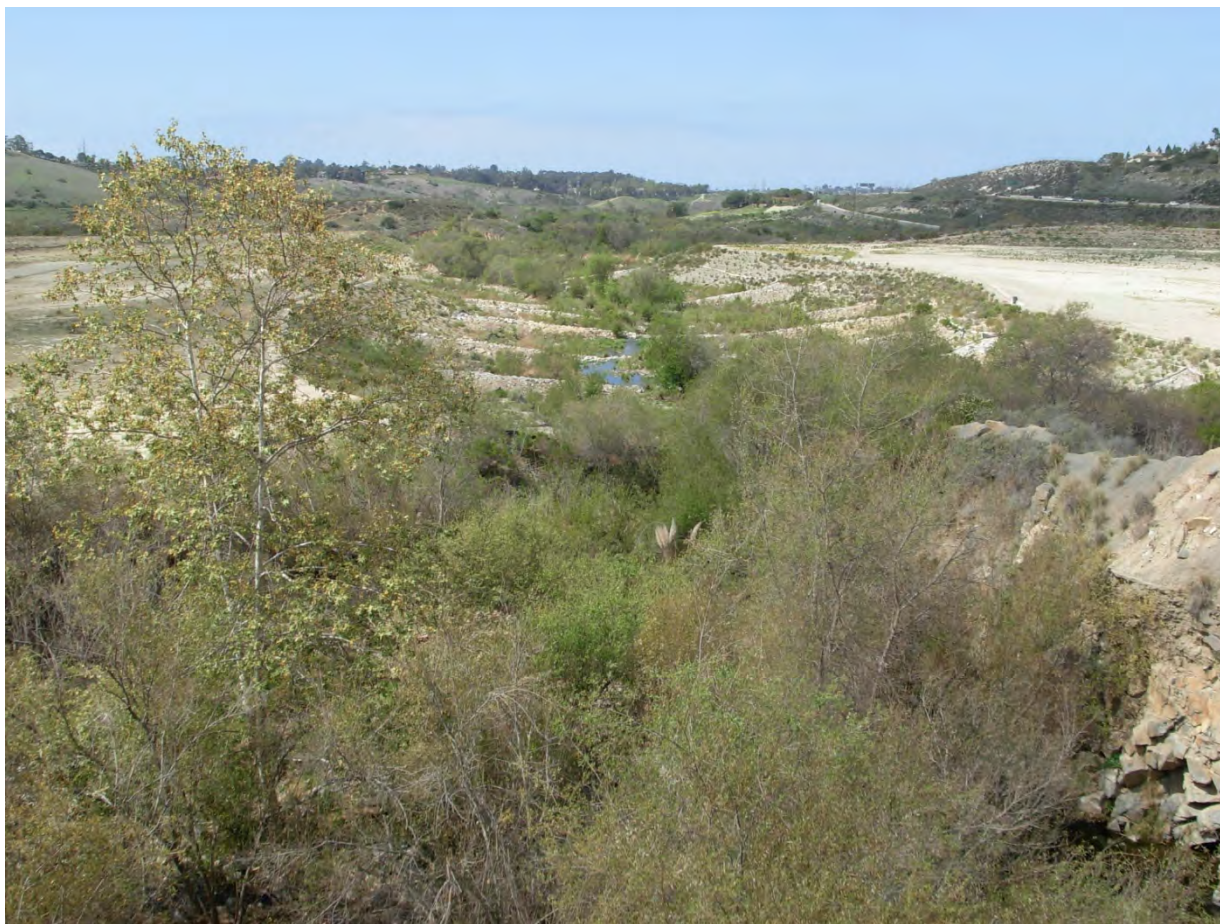
EW1-7, looking west from adjacent developed property in Oceanside.

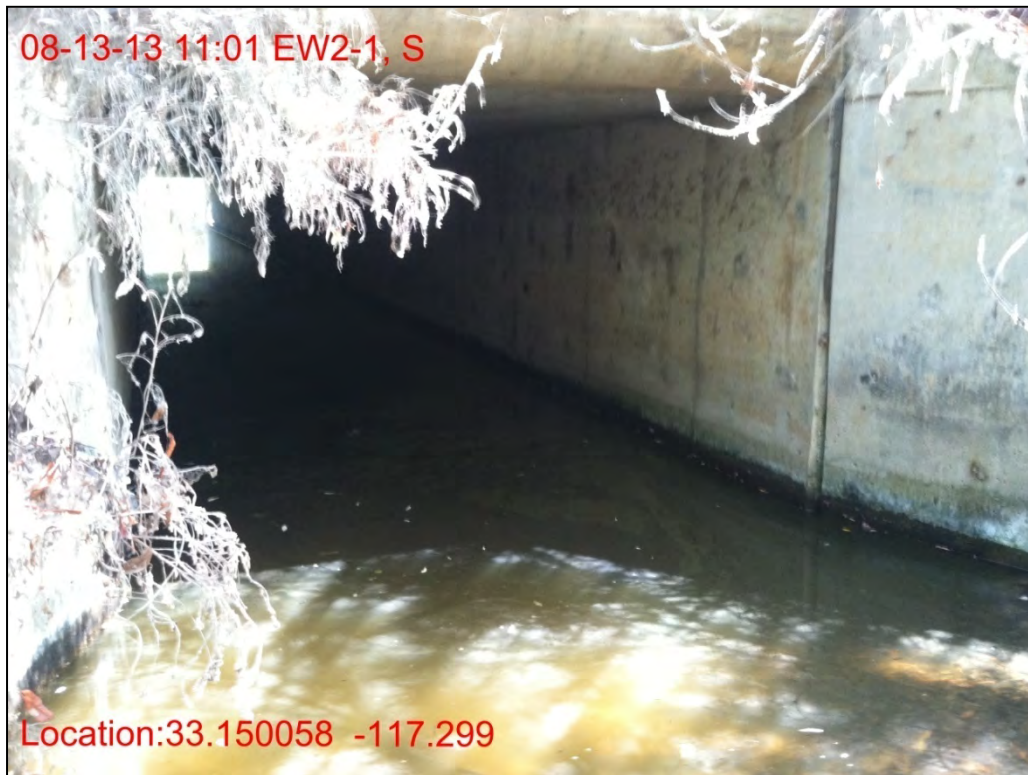
Regarding possible Task 2 monitoring, no further camera work is likely needed at EW 2-3 and EW 2-9 because the previous CNLM camera surveys proved that many different species successfully use these undercrossings. EW2-1 is a permanently wet undercrossing and not recommended for future monitoring. Due to the lack of restrictions, EW2-2 in the Calavera Hills/Robertson Ranch preserve, and EW2-6, EW2-7, EW2-8a, and EW2-8b in and around the Rancho Carlsbad Golf Club, may be suitable for camera and/or tracking to document the species using this portion of the corridors, provided resources are available. Pinchpoints EW2-4, EW2-5a, and EW2-10 could provide opportunities for camera and/or tracking monitoring due to their importance and dispersed locations along the corridor.

EW2-1, southern entrance showing permanent water August 2013.

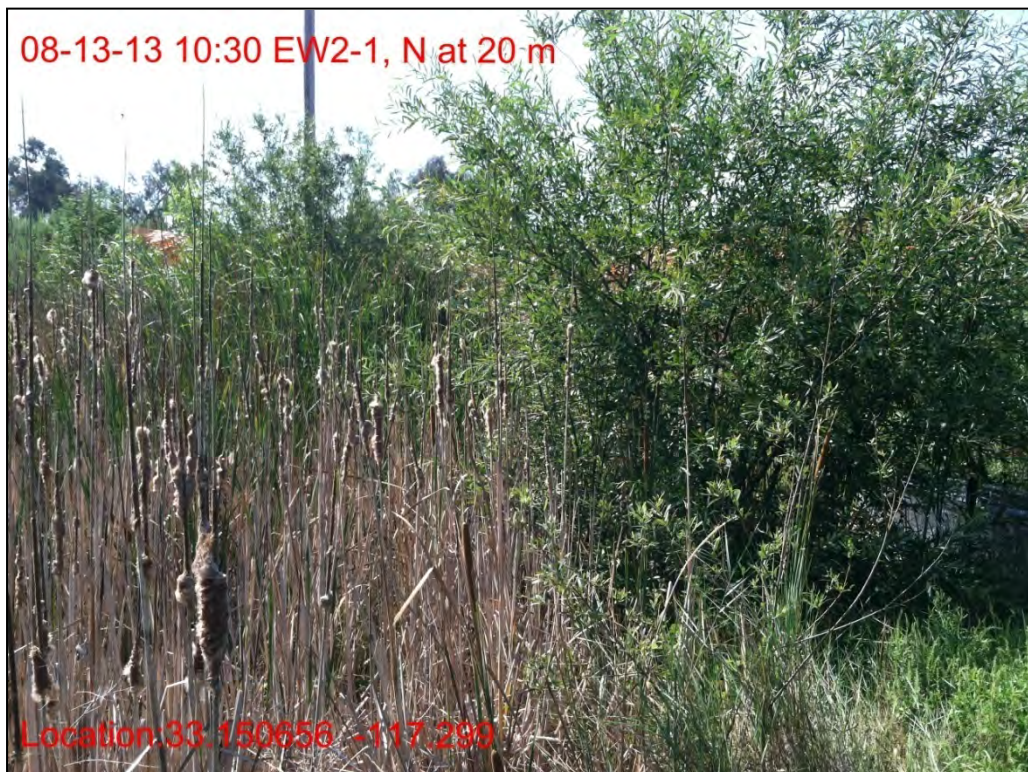
EW2-1, N end at 20 meters showing thick vegetation, August 2013.

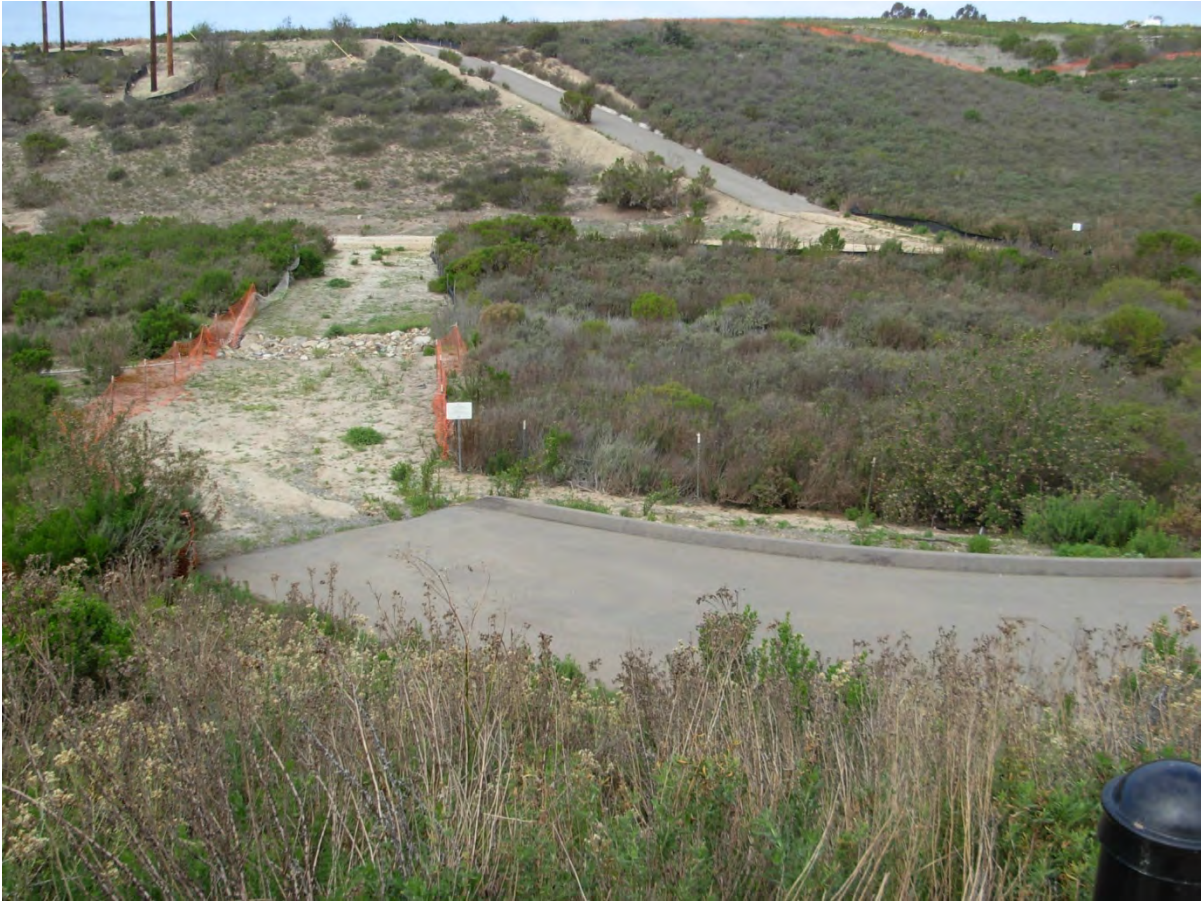
EW2-2, looking west from adjacent developed residential property.

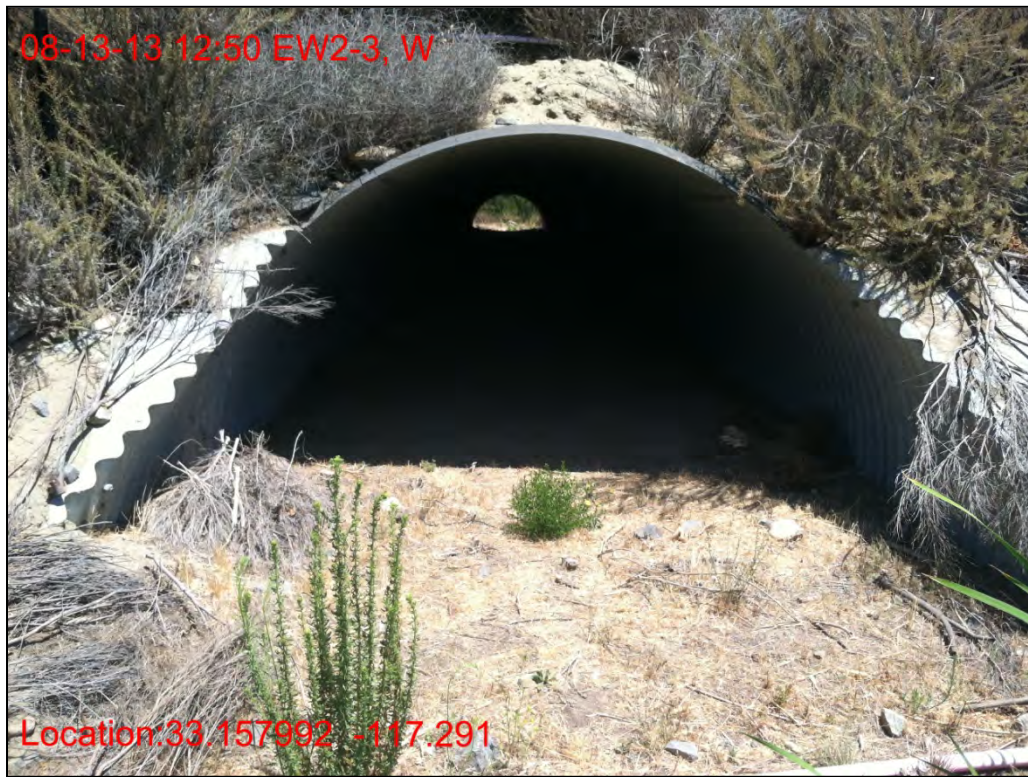
EW2-3, west side, August 2013.

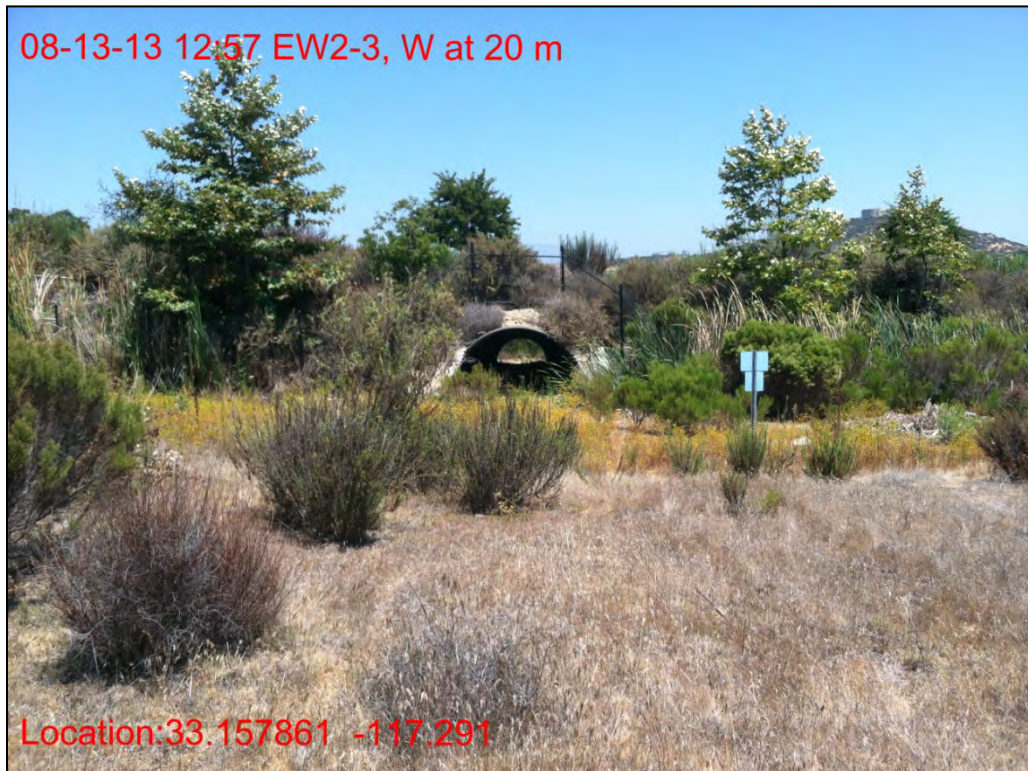
EW2-3, west side at 20 meters, August 2013.

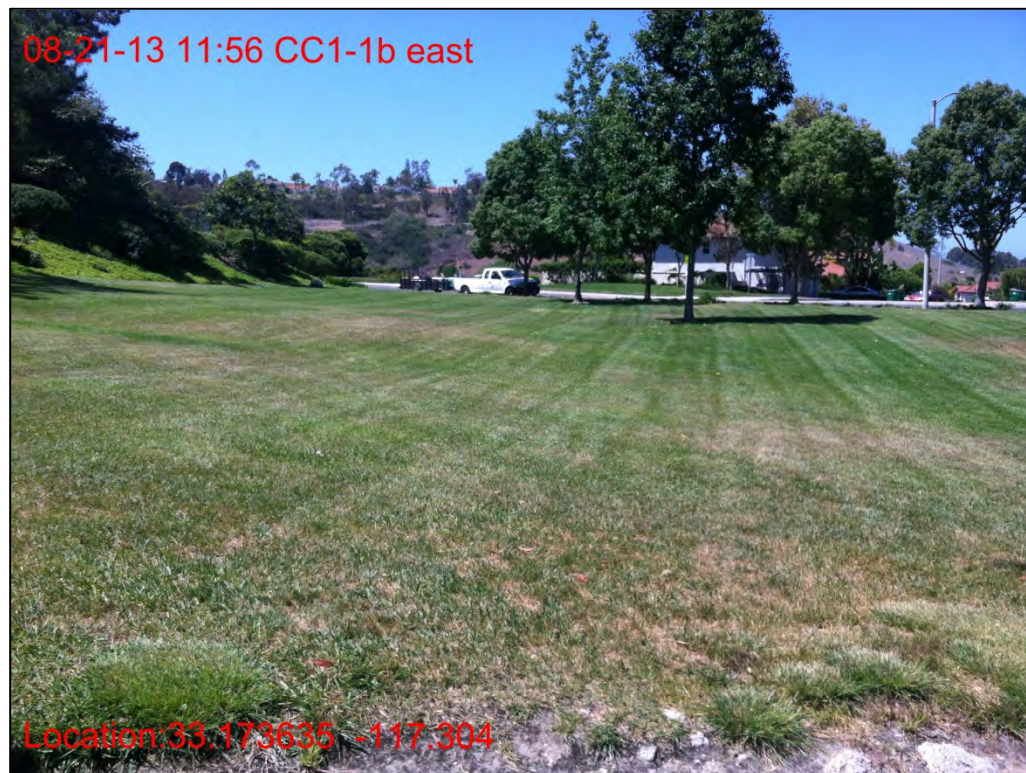
CC1-1b, looking southwest from east side, August 2013.

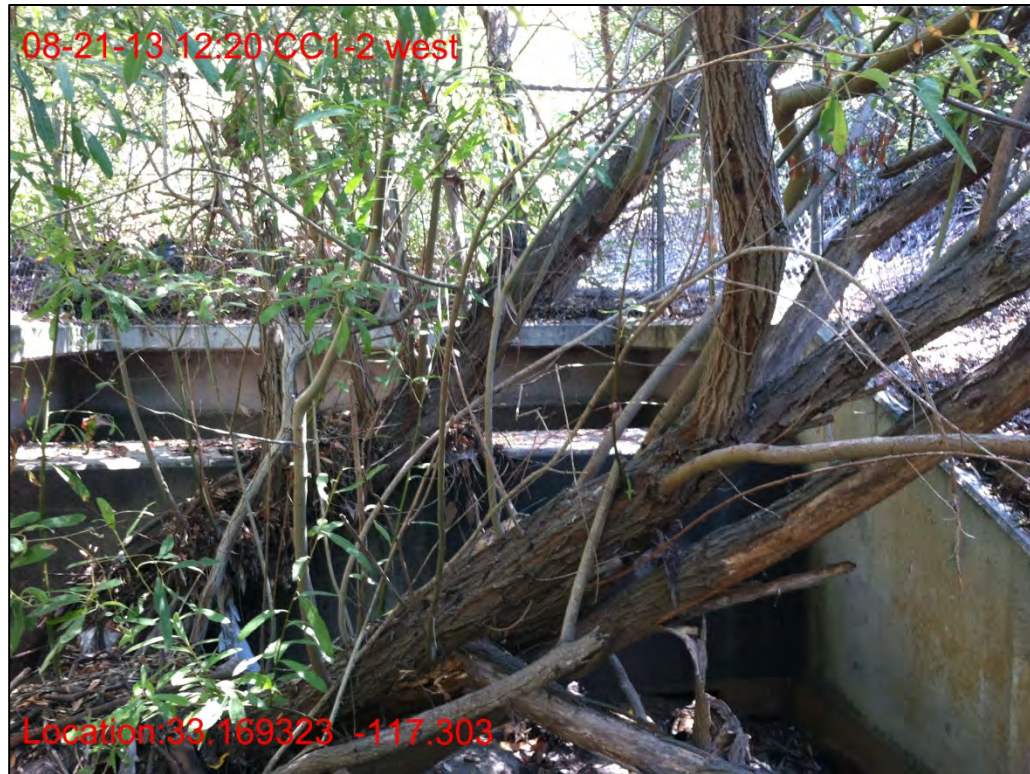
CC1-2, looking east from west side, August 2013.

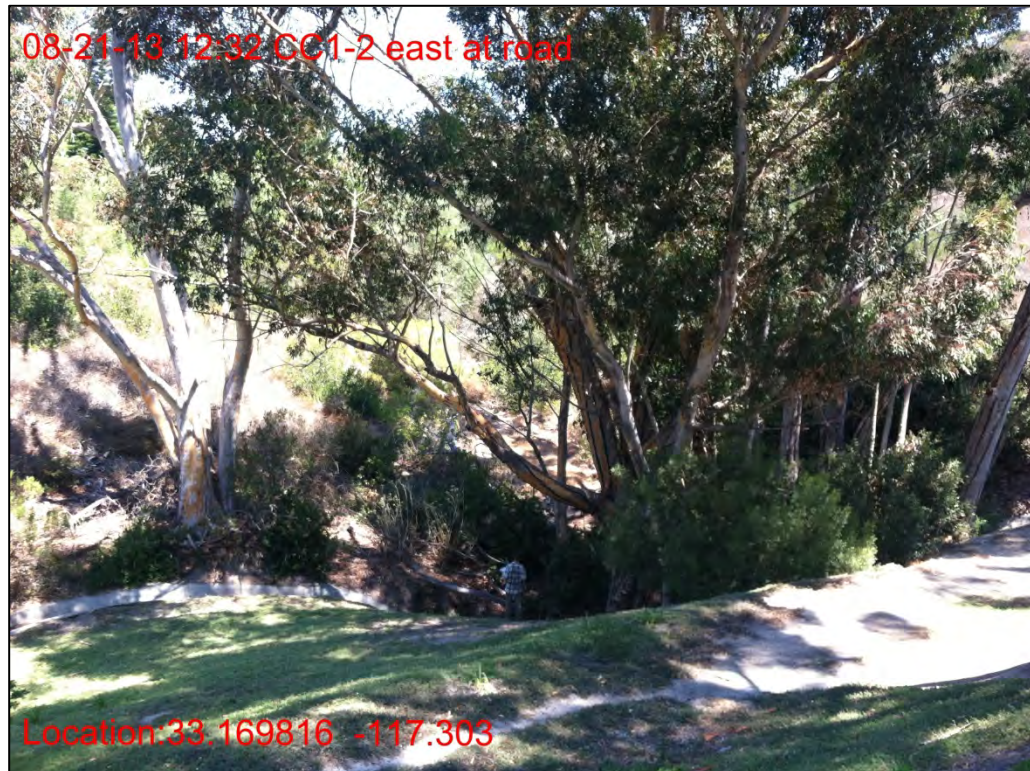
CC1-2, looking east from east side, August 2013.

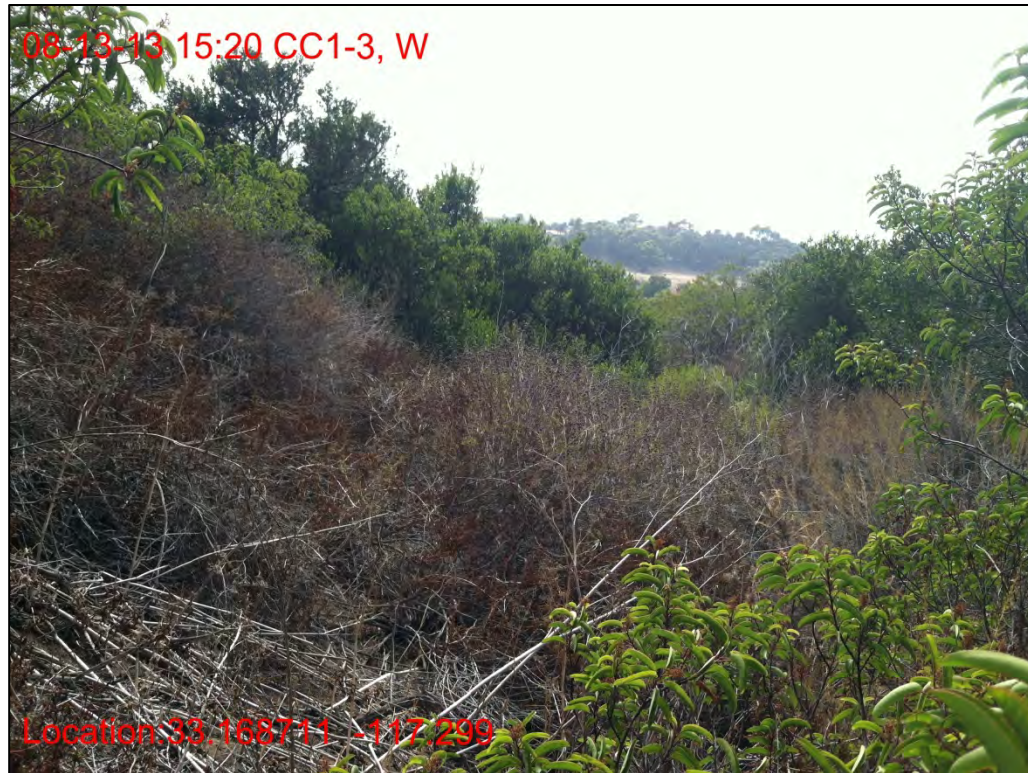
CC1-3, looking west from west side, August 2013.

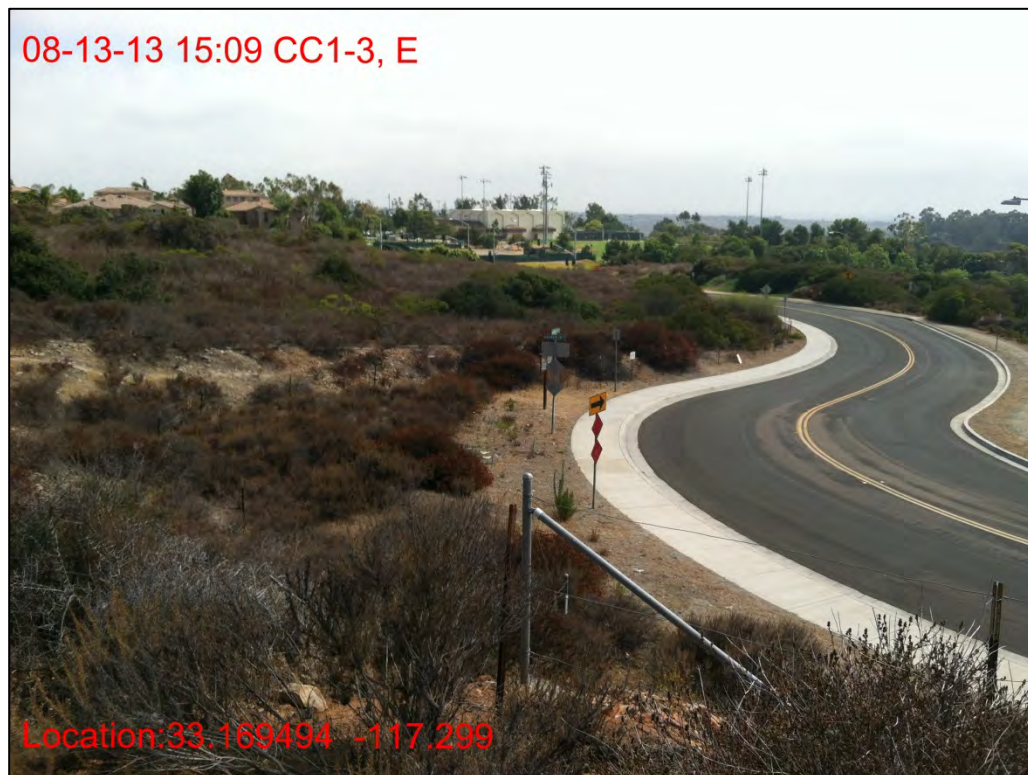
CC1-3, looking south from east side, August 2013.

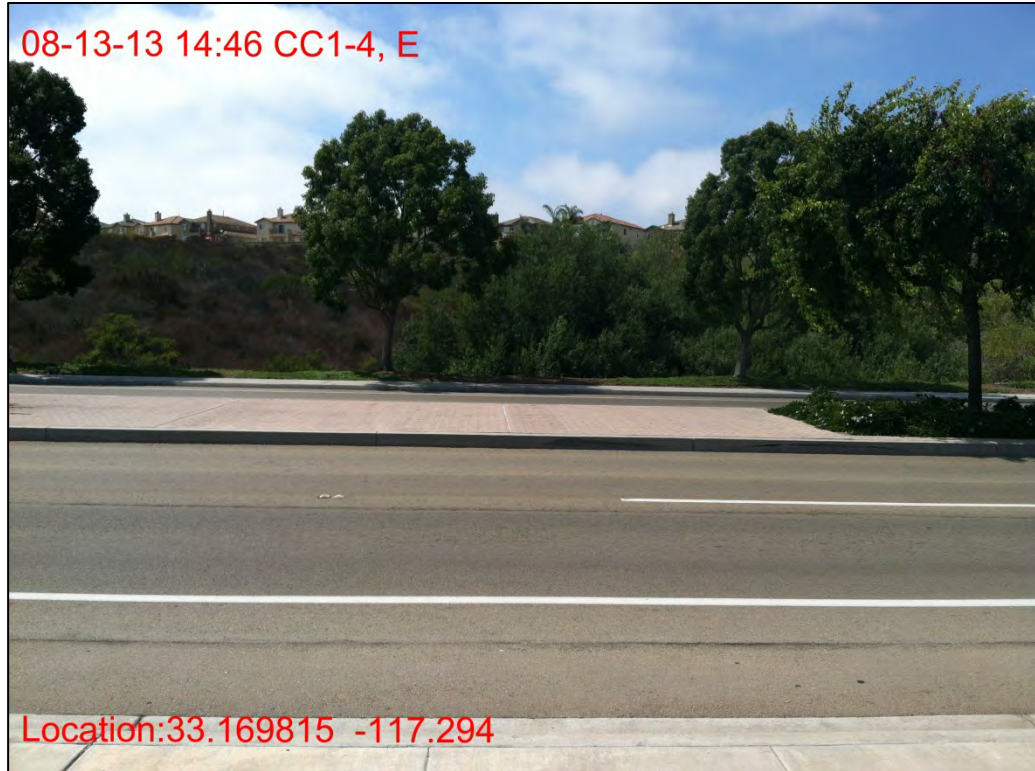
CC1-4, looking west from east side, August 2013.

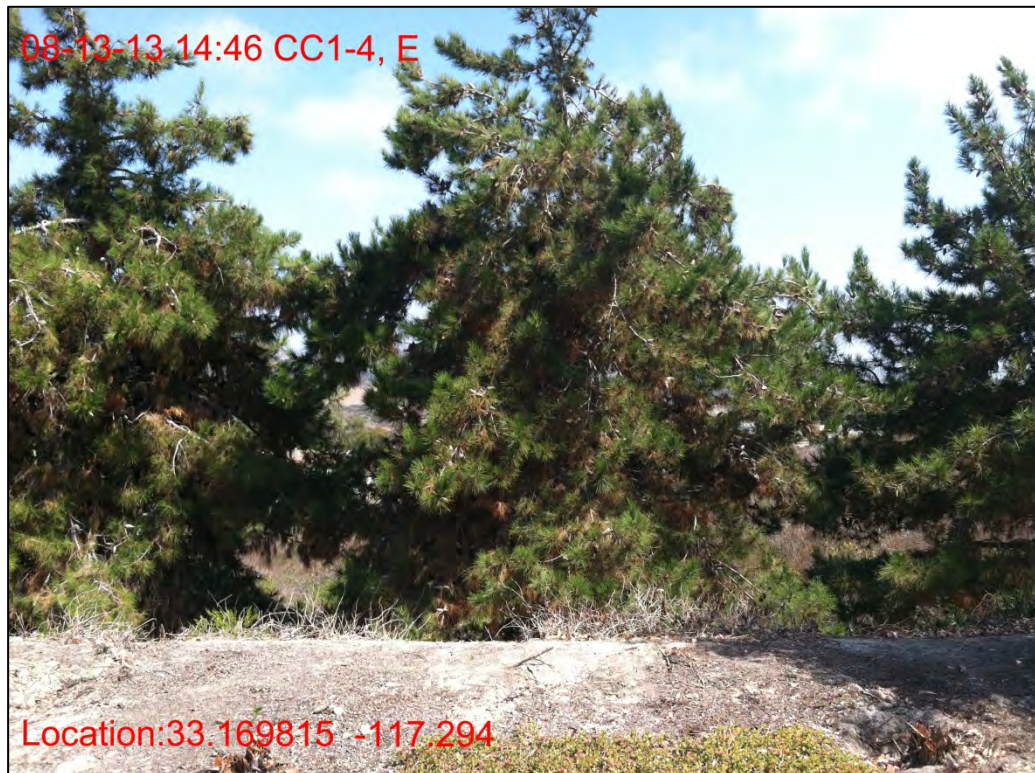
CC1-4, looking east from east side, August 2013.

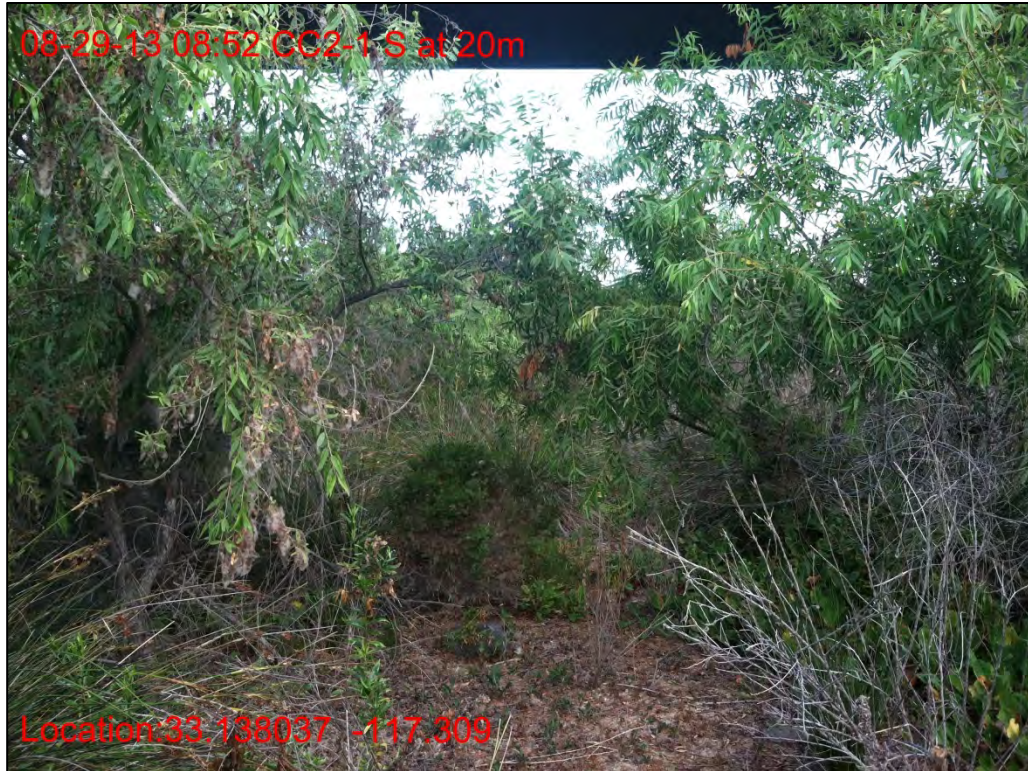
CC2-1, looking north at 20 meters from south side, August 2013.

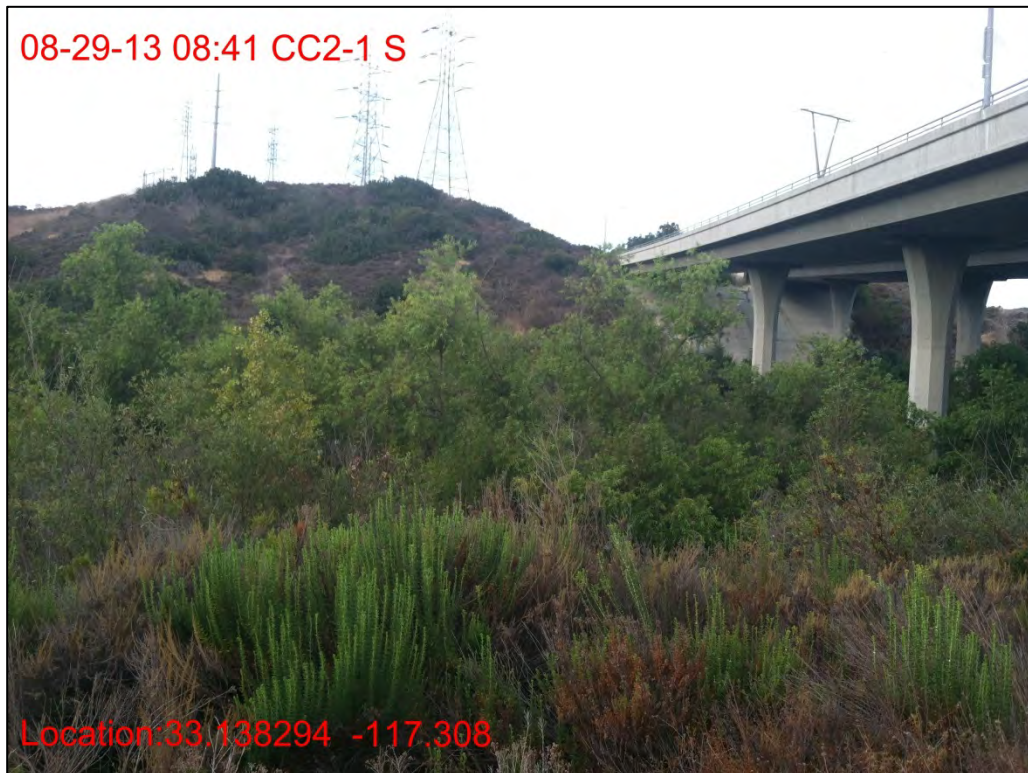
CC2-1, looking west at crossing from south side, August 2013.

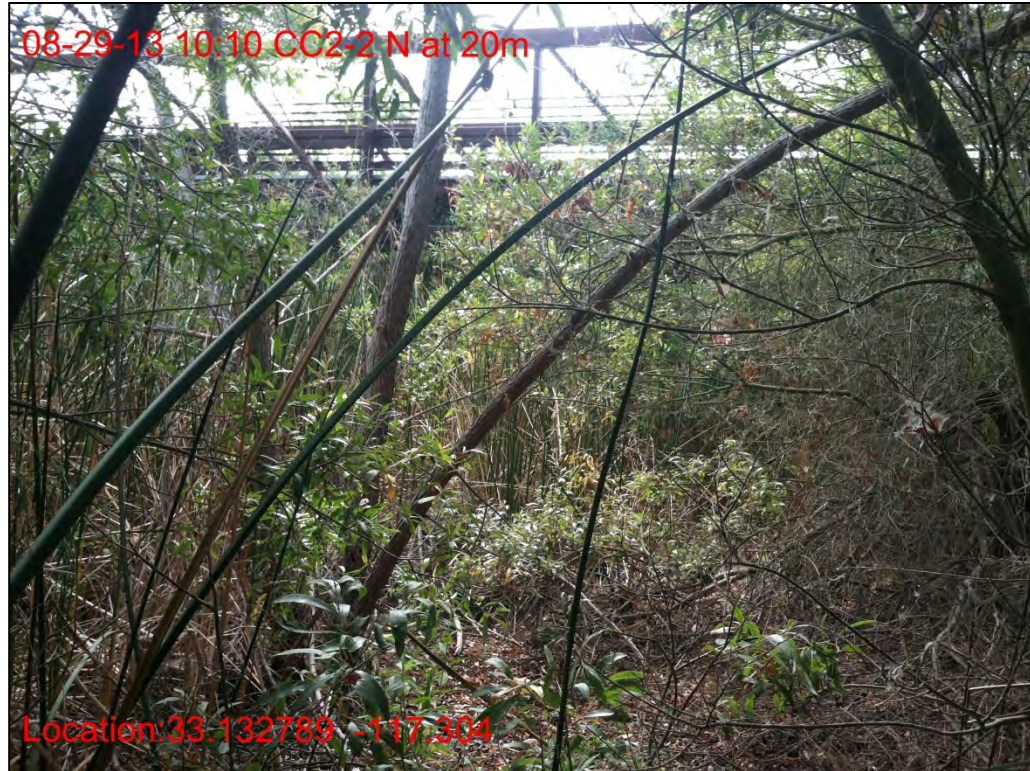
CC2-2, looking south from north side, August 2013.

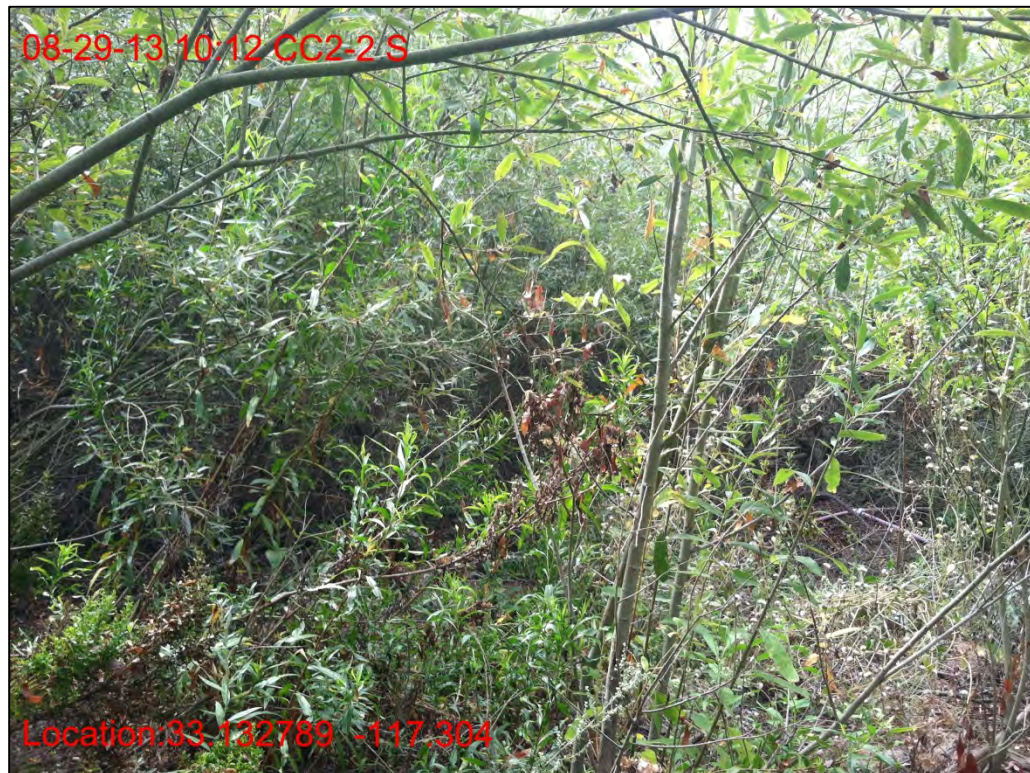
CC2-2, looking south from north side, August 2013.

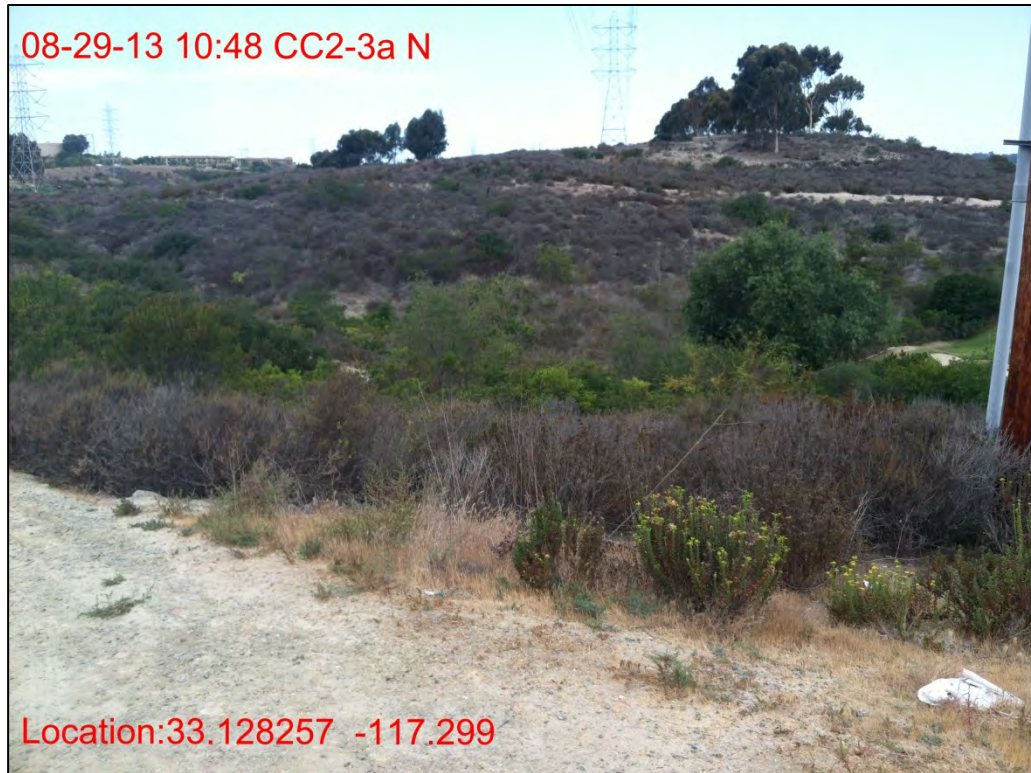
CC2-3a, looking north from north side, August 201

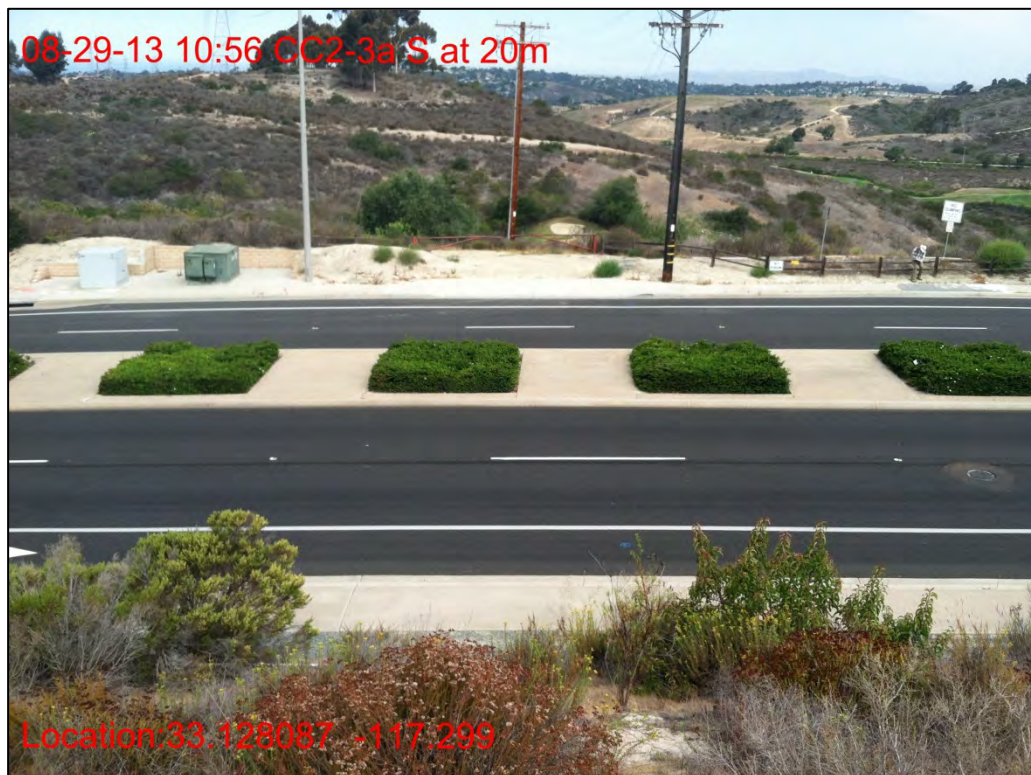
CC2-3a, looking north at 20 meters from south side, August 2013.

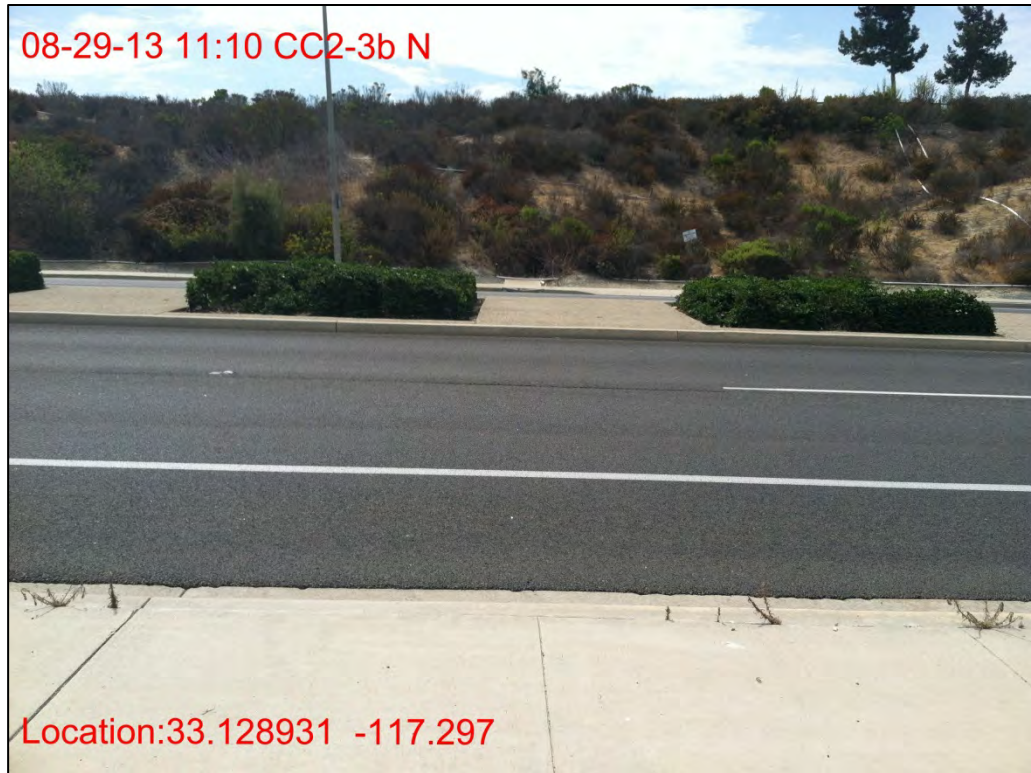
CC2-3b, looking south from north side, August 2013

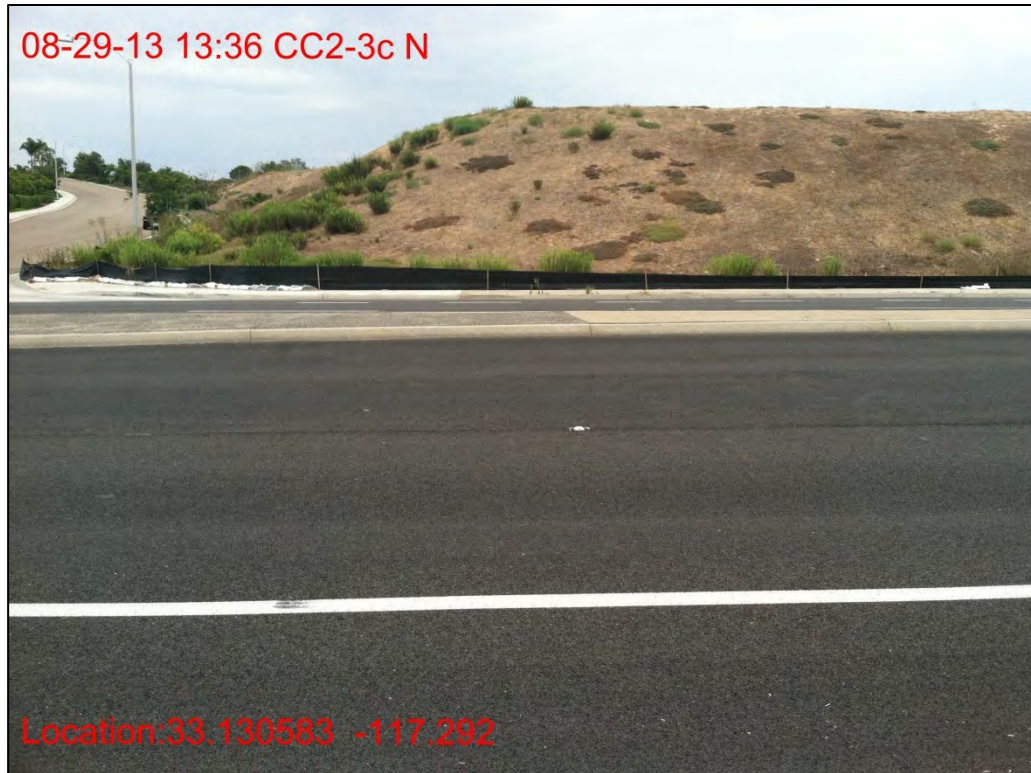
CC2-3c, looking north from south side, August 2013.

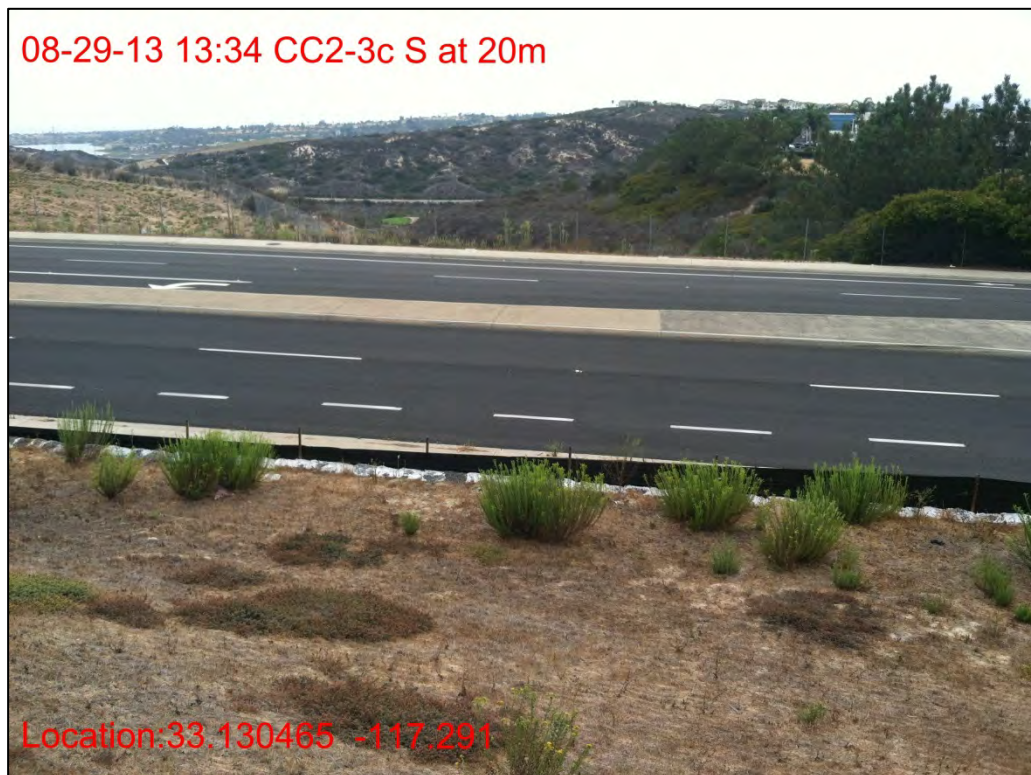
CC2-3c, looking south at 20 meters from north side, August 2013.

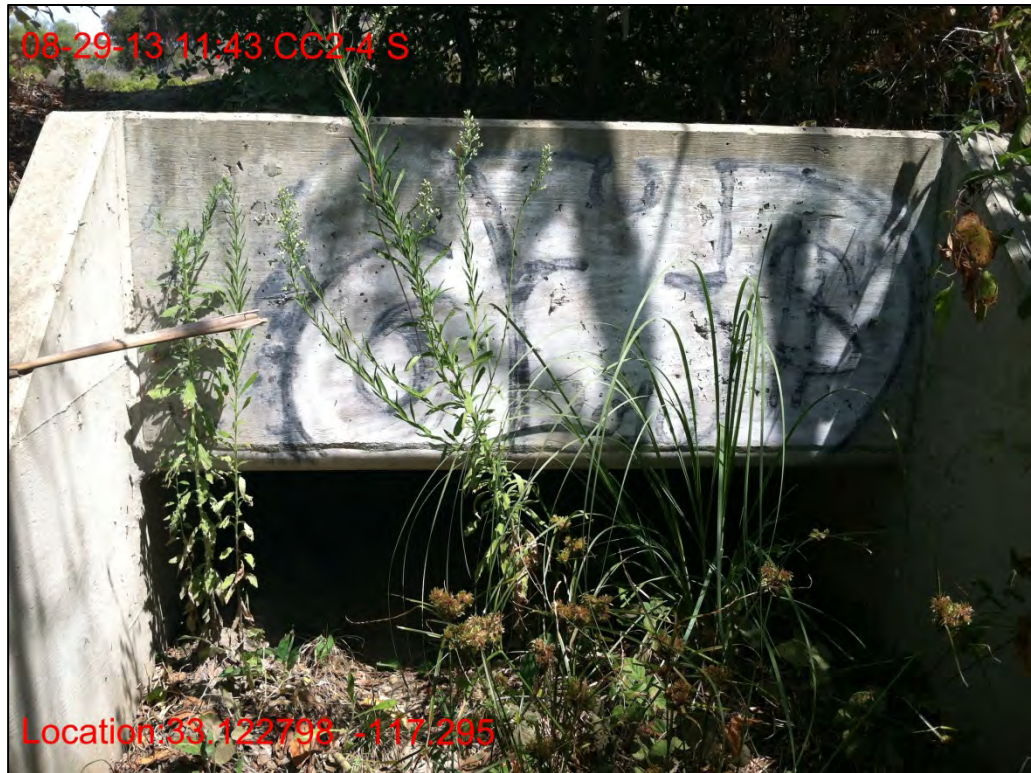
CC2-4, looking north from south entrance of culvert, August 2013.
