# City of Carlsbad Wildlife Movement Analysis Final Report

Local Assistance Grant Agreement No.  
P1282107

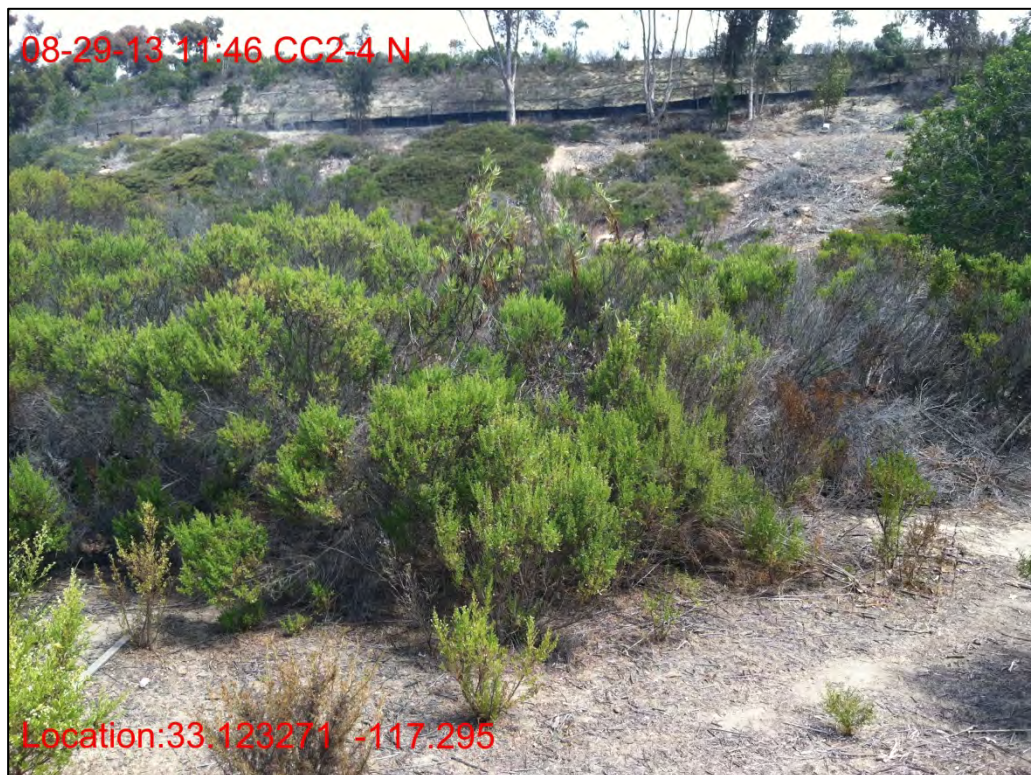
CC2-4, looking north from north end, August 2013.

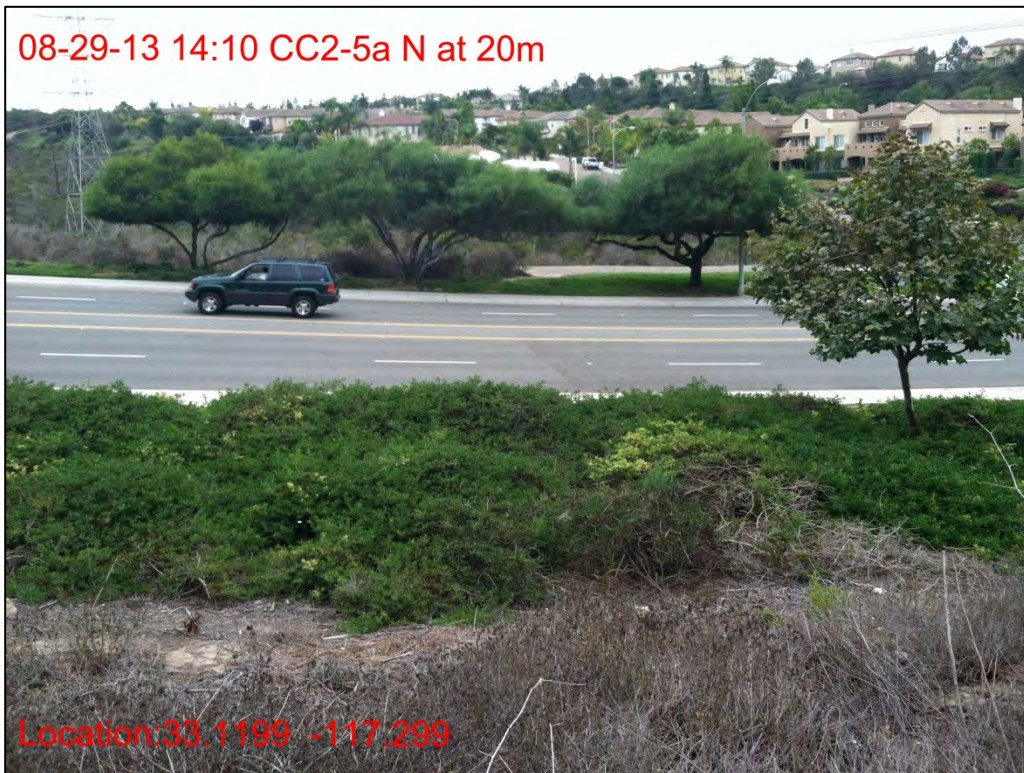
CC2-5a, looking south at 20 meters from north side, August 2013.

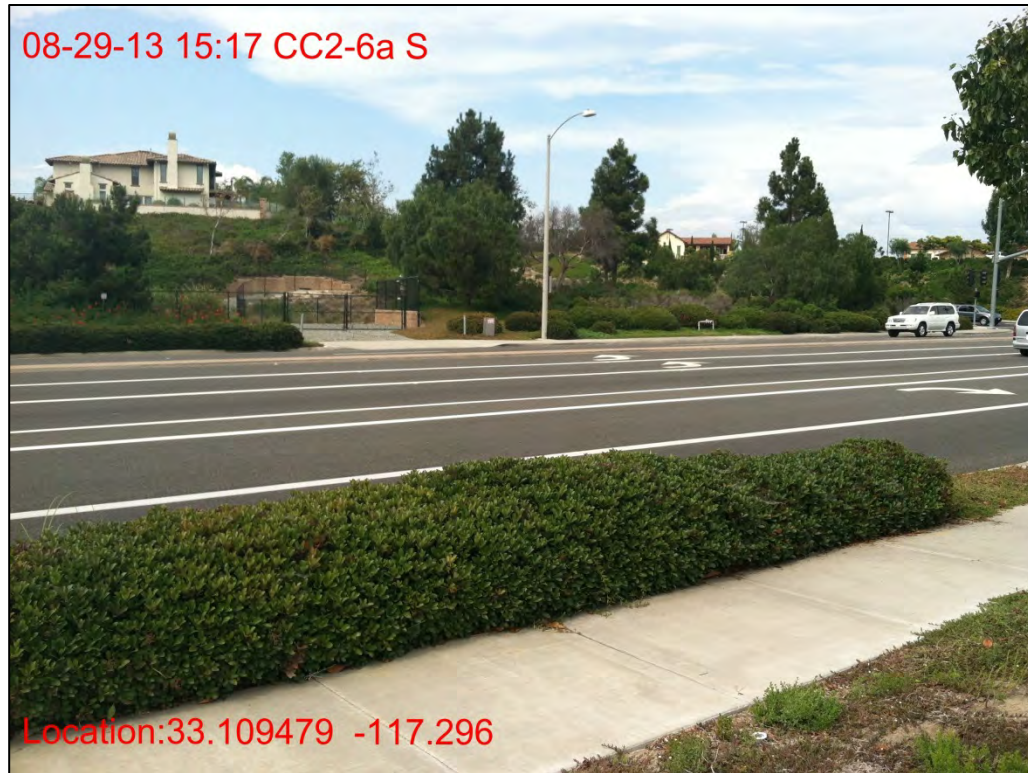
CC2-6a, looking north from south side, August 2013.

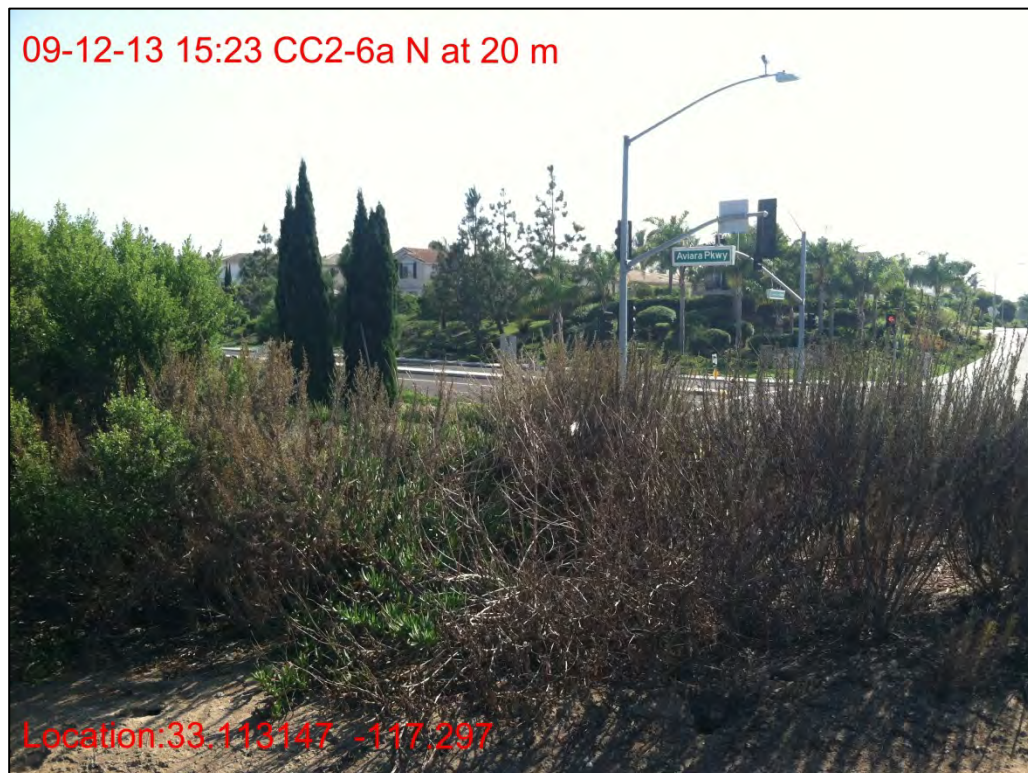
CC2-6a, looking south at 20 meters from north side, September 2013.

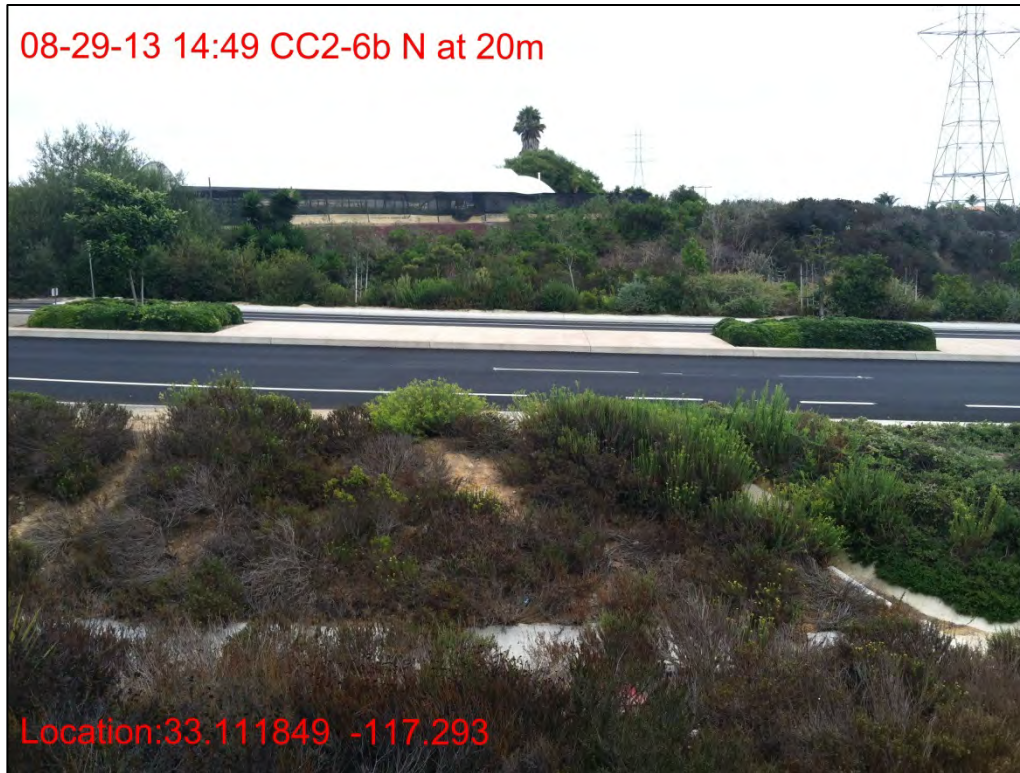
CC2-6b, looking south from north side, August 2013.

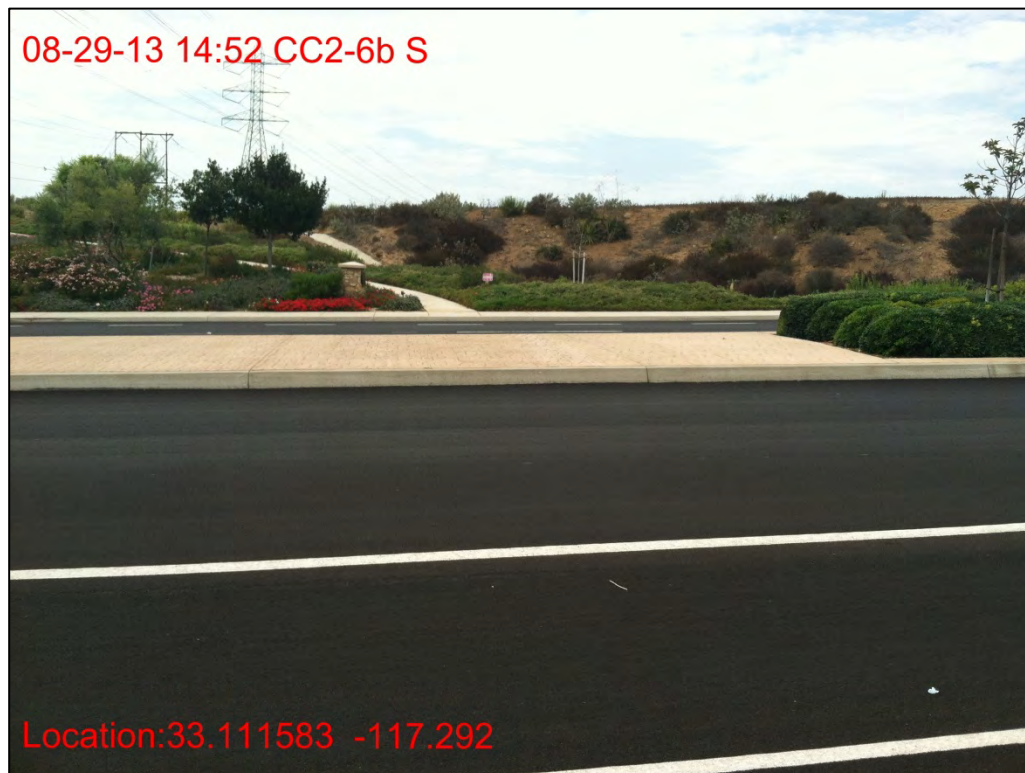
CC2-6b, looking north from south side, August 2013.

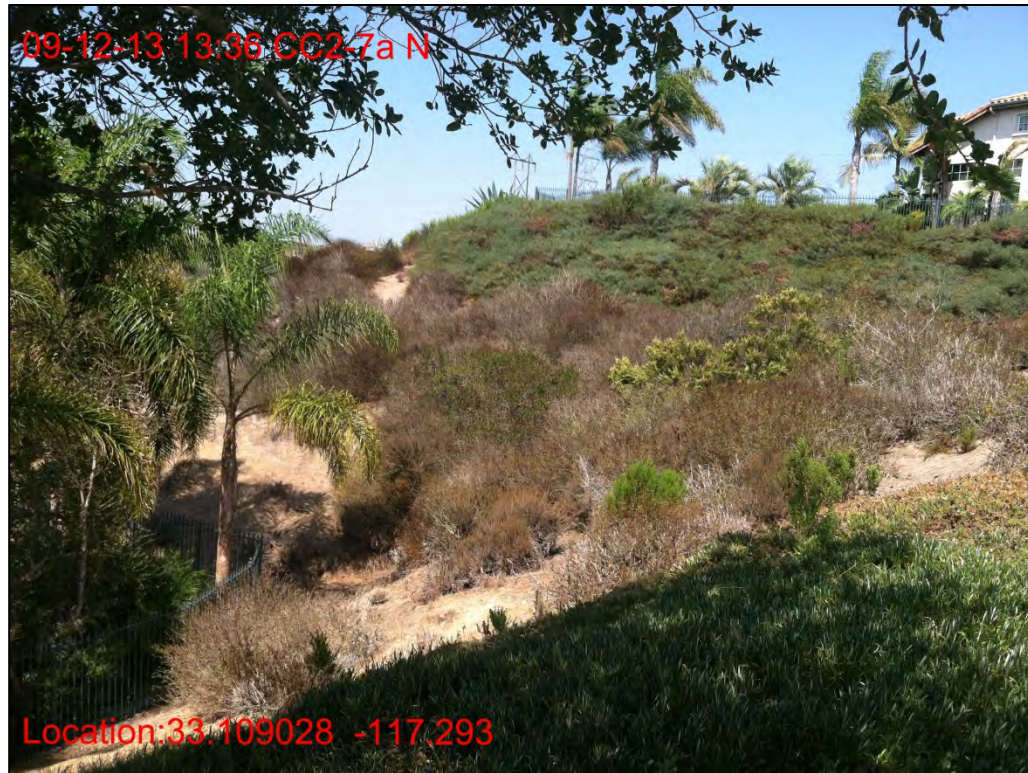
CC2-7a, looking north from north side, September 2013.

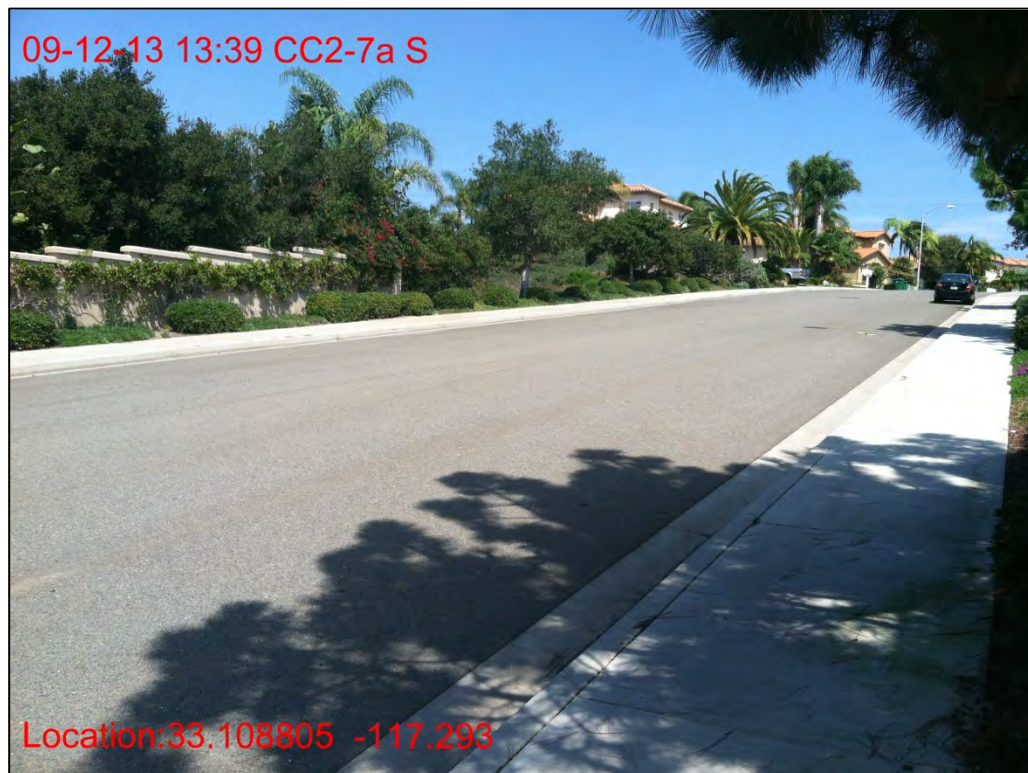
CC2-7a, looking northeast from south side, September 2013.

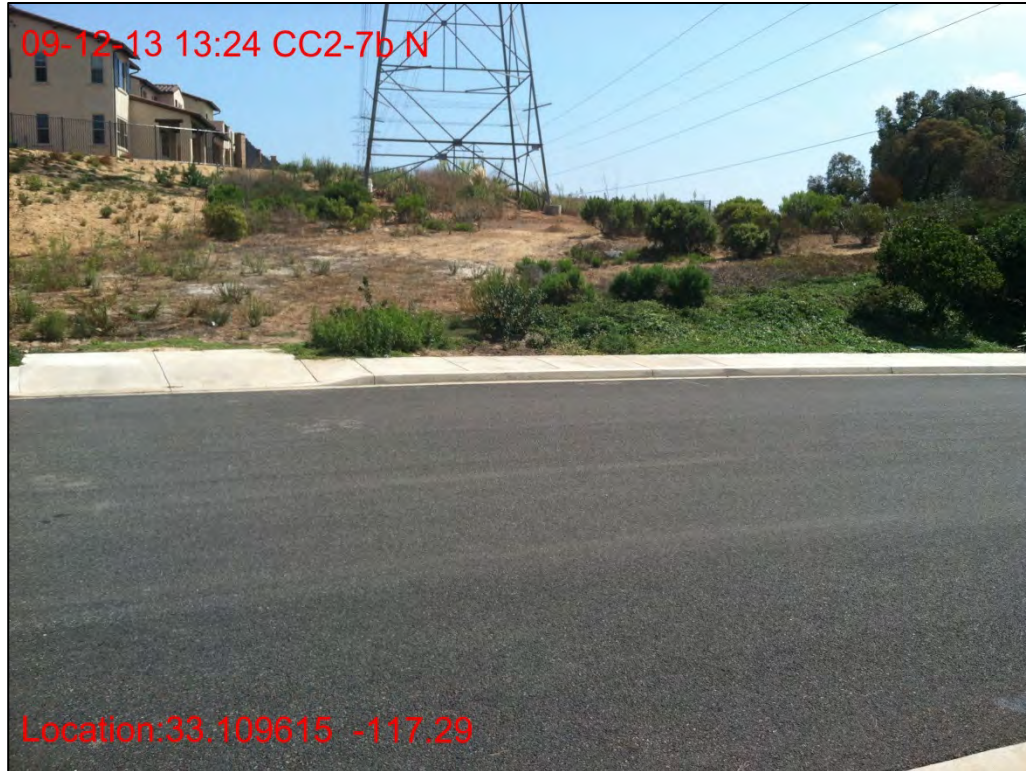
CC2-7b, at-grade crossing looking south from north side, September 2013.

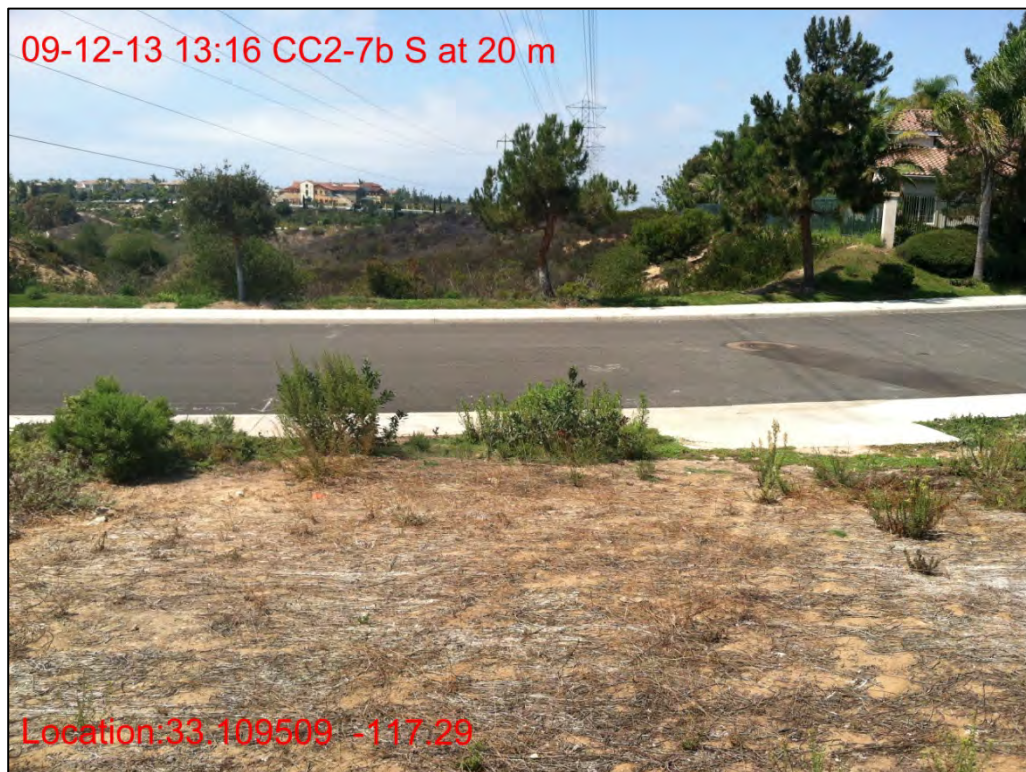
CC2-7b, south side at 20 meters out

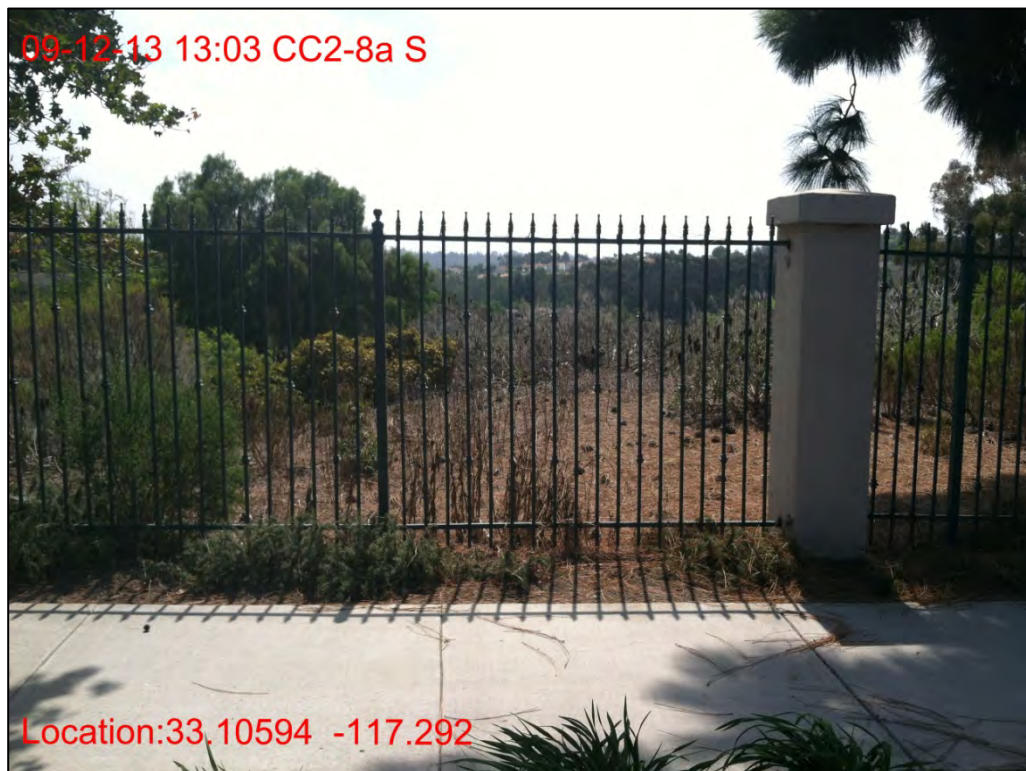
CC2-8a, fencing on south side, September 2013.

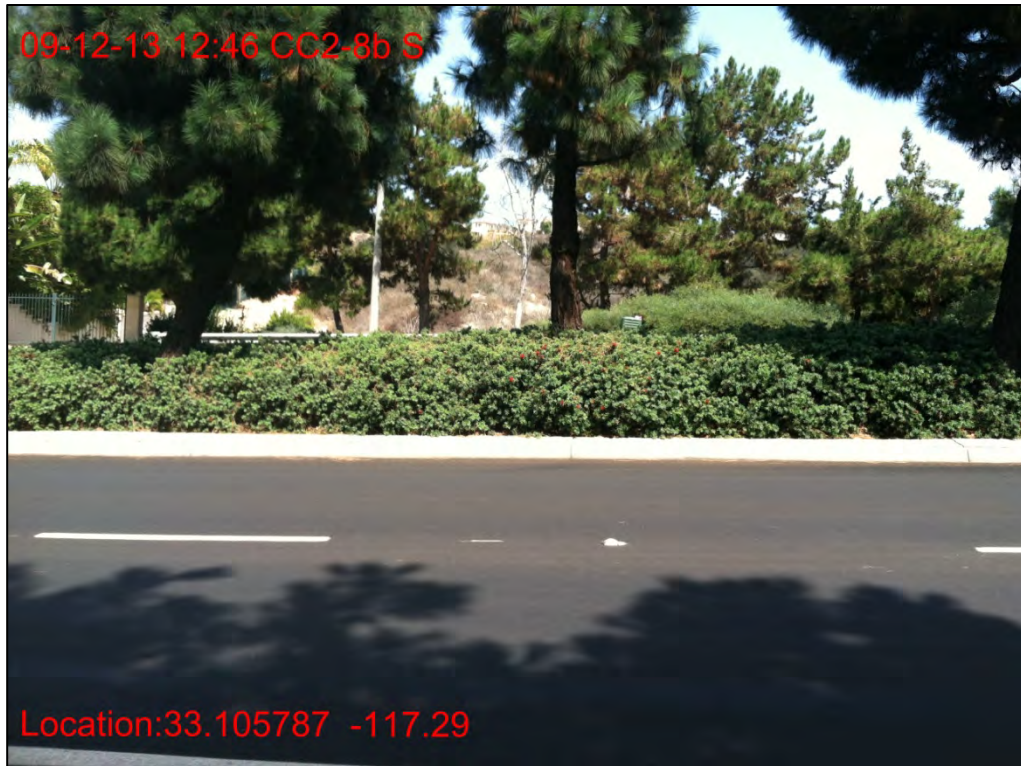
CC2-8b at-grade crossing, south side, September 2013.

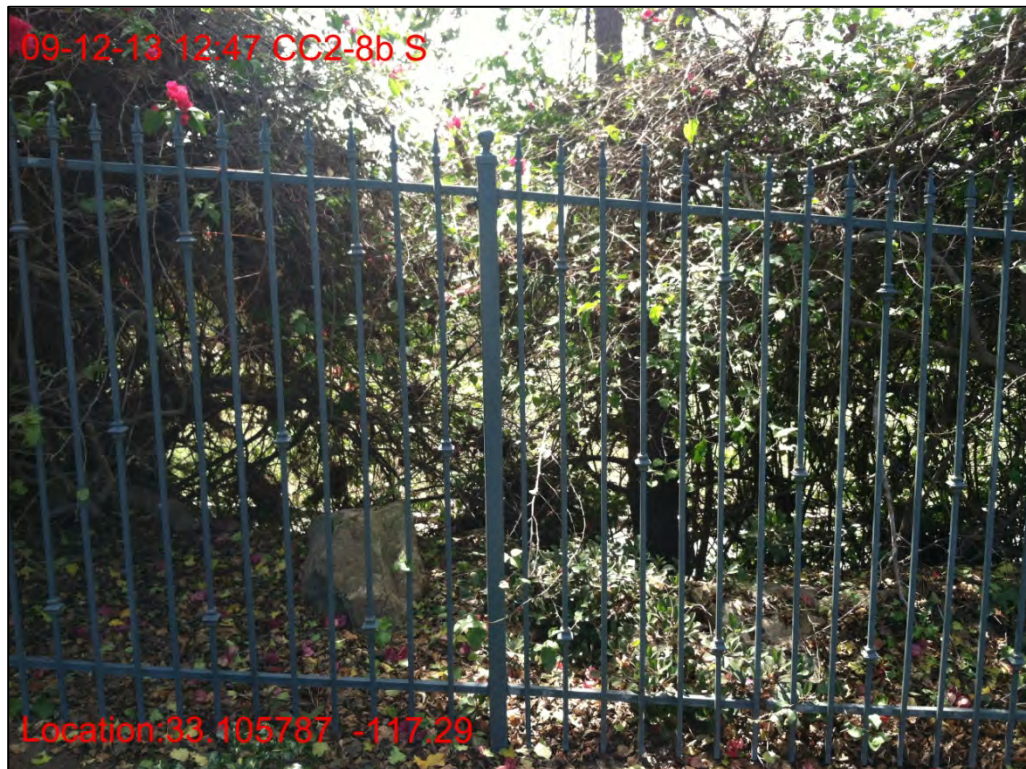
CC2-8b, fencing on south side, September 2013.

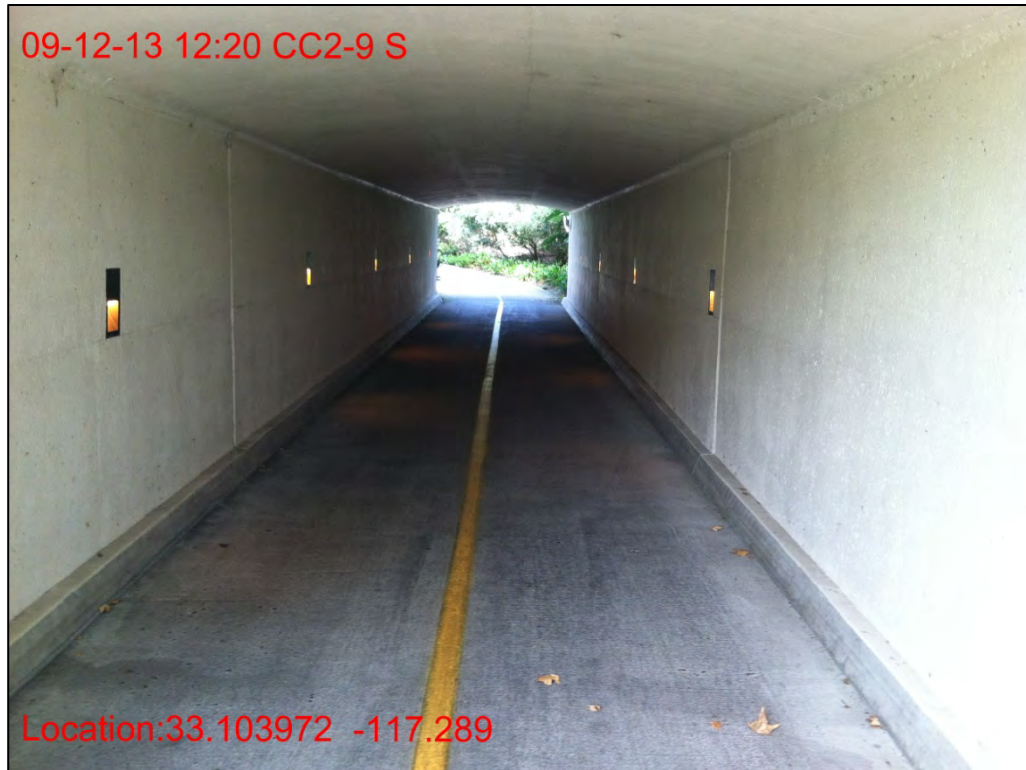
CC2-9, south side facing into undercrossing, September 2013.

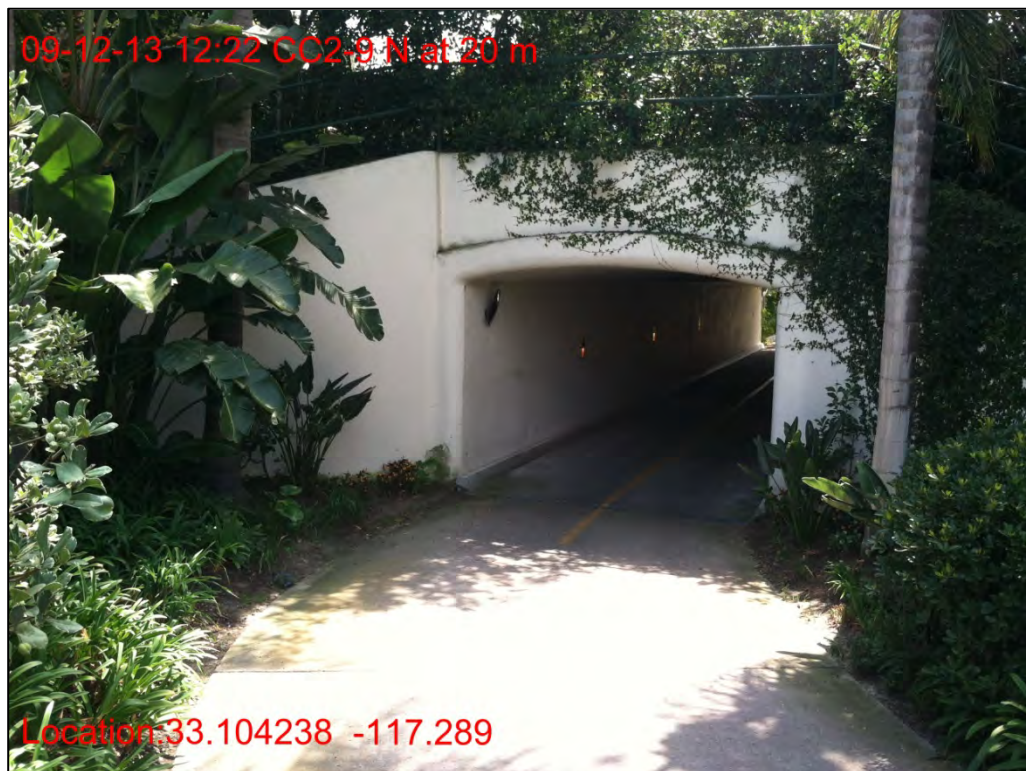
CC2-9, north side at 20 m out, September 2013.

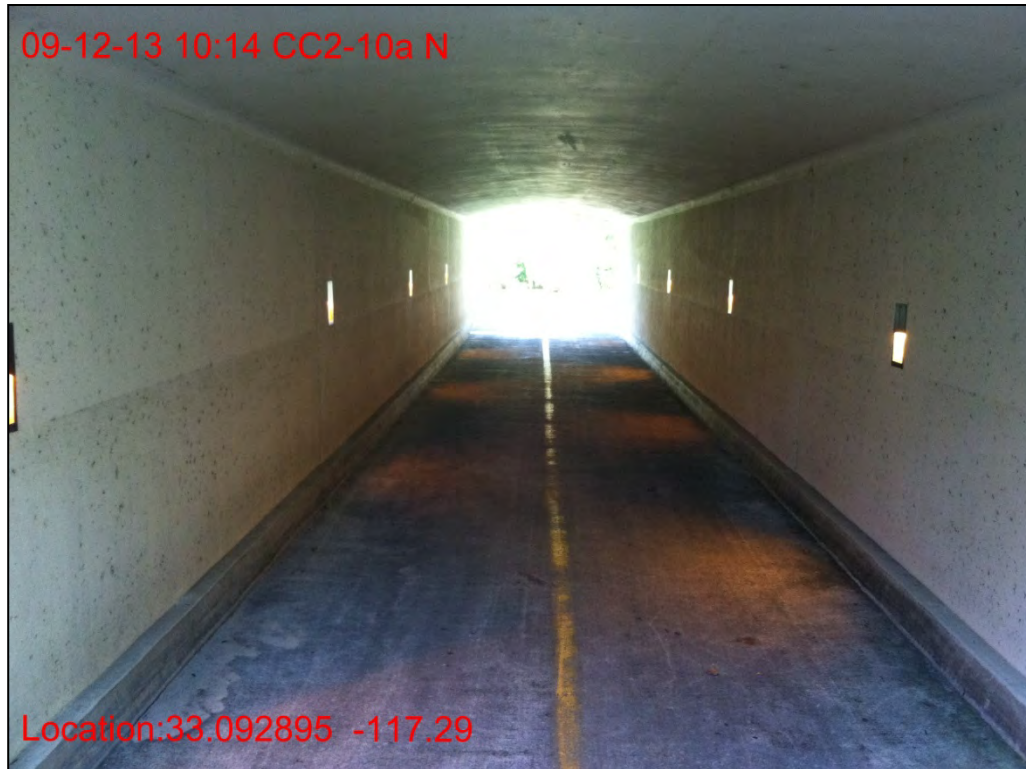
CC2-10a, north side facing into undercrossing, September 2013

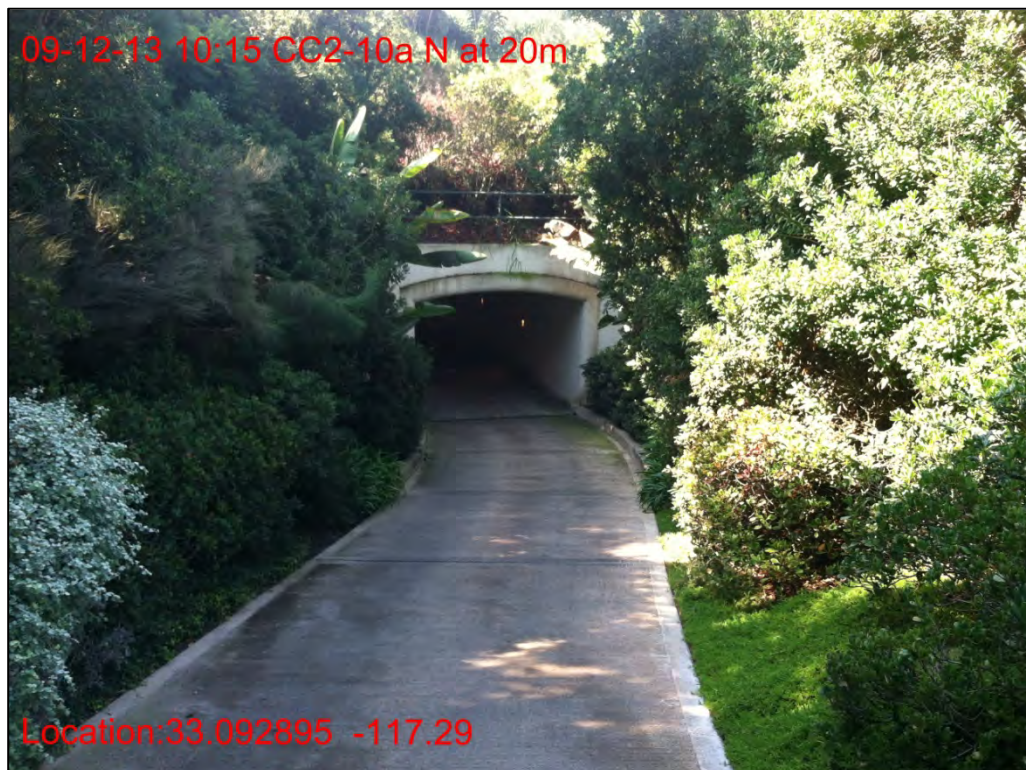
CC2-10a, north side at 20 meters out, September 2013

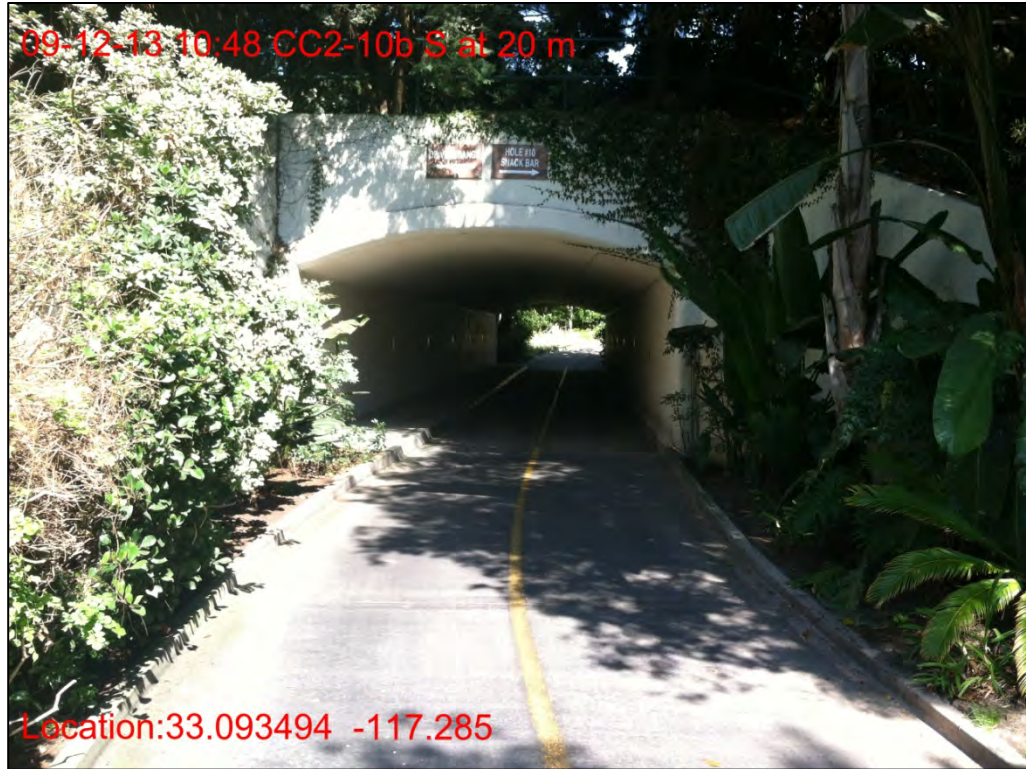
CC2-10b, south side at 20 m out, September 2013.

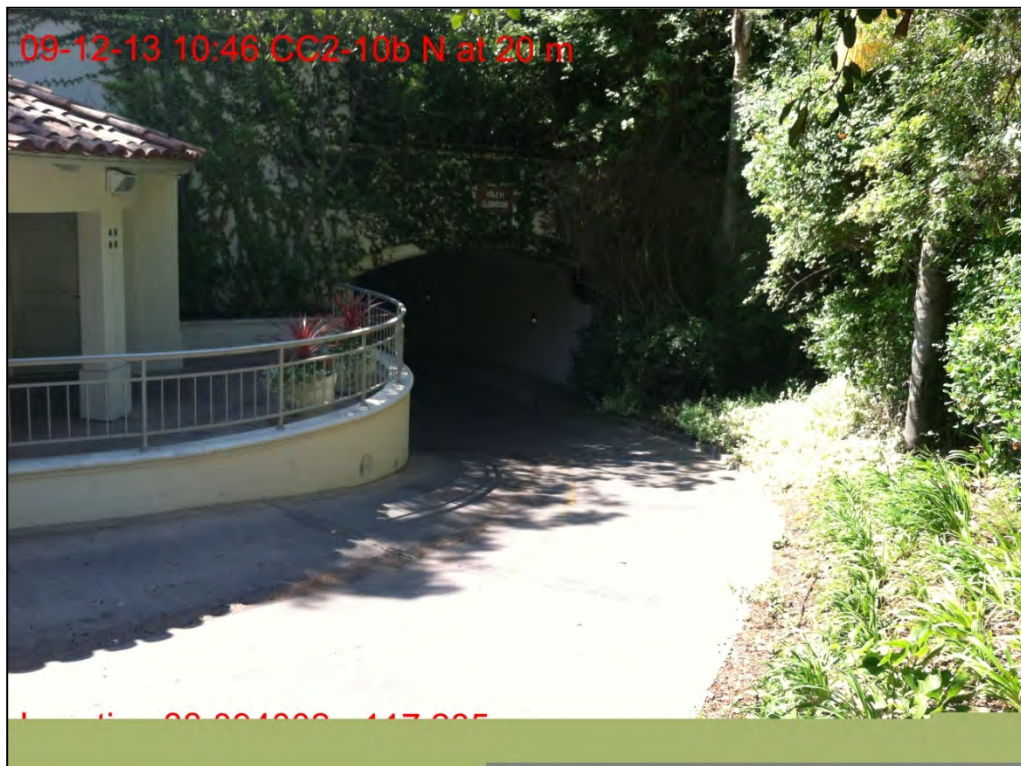
CC2-10b, north side at 20 m out, September 2013.

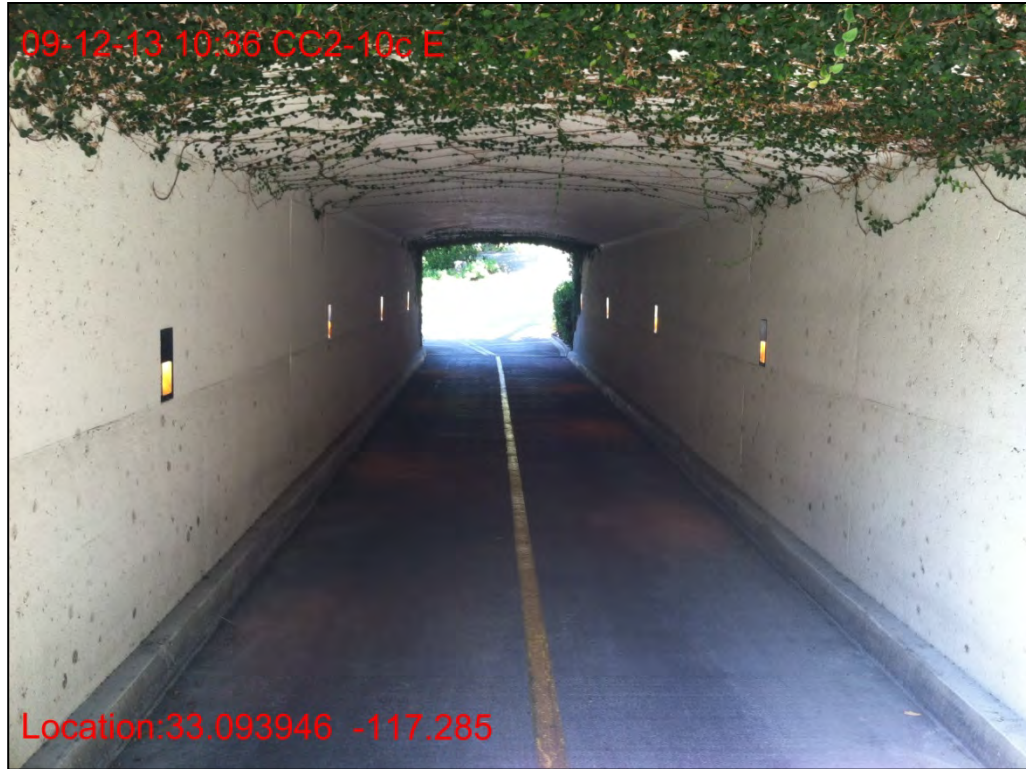
CC2-10c, east side facing undercrossing, September 2013.

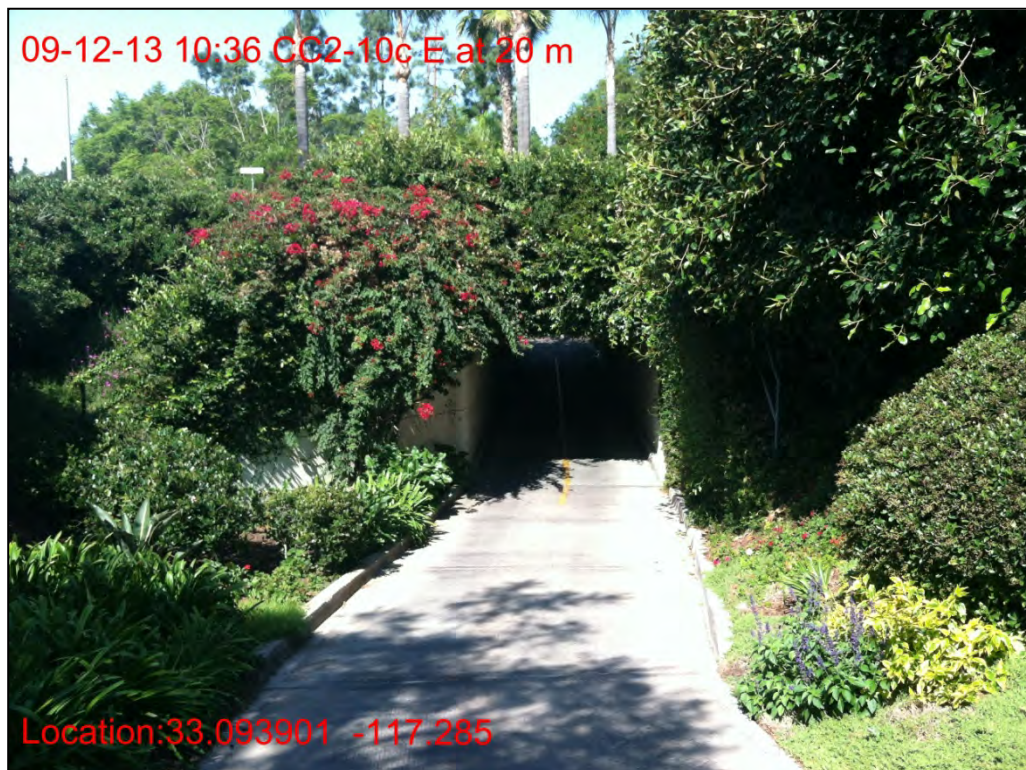
CC2-10c, east side facing undercrossing, September 2013

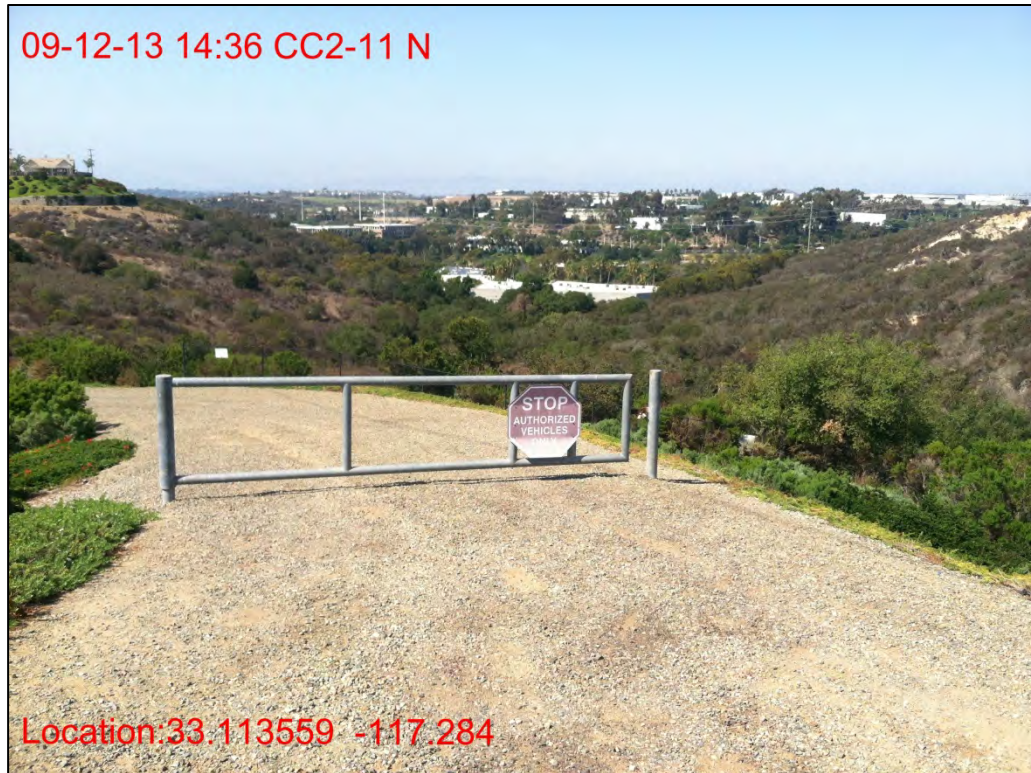
CC2-11, looking north from north side, September 2013.

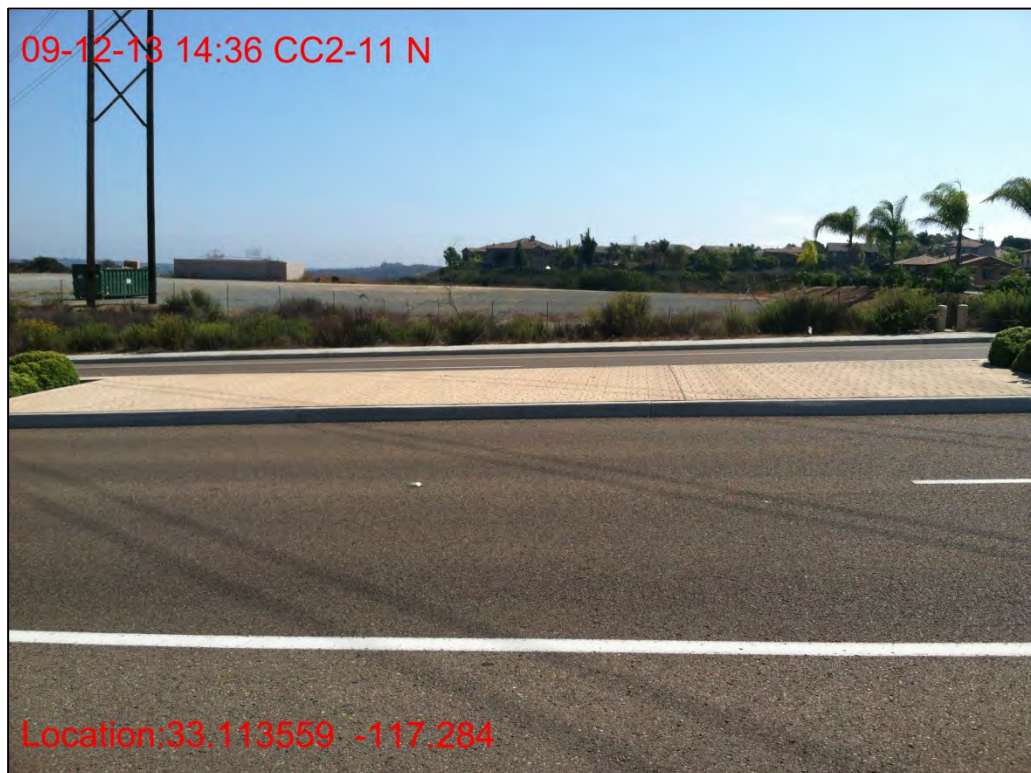
CC2-11, looking south from north side, September 2013.

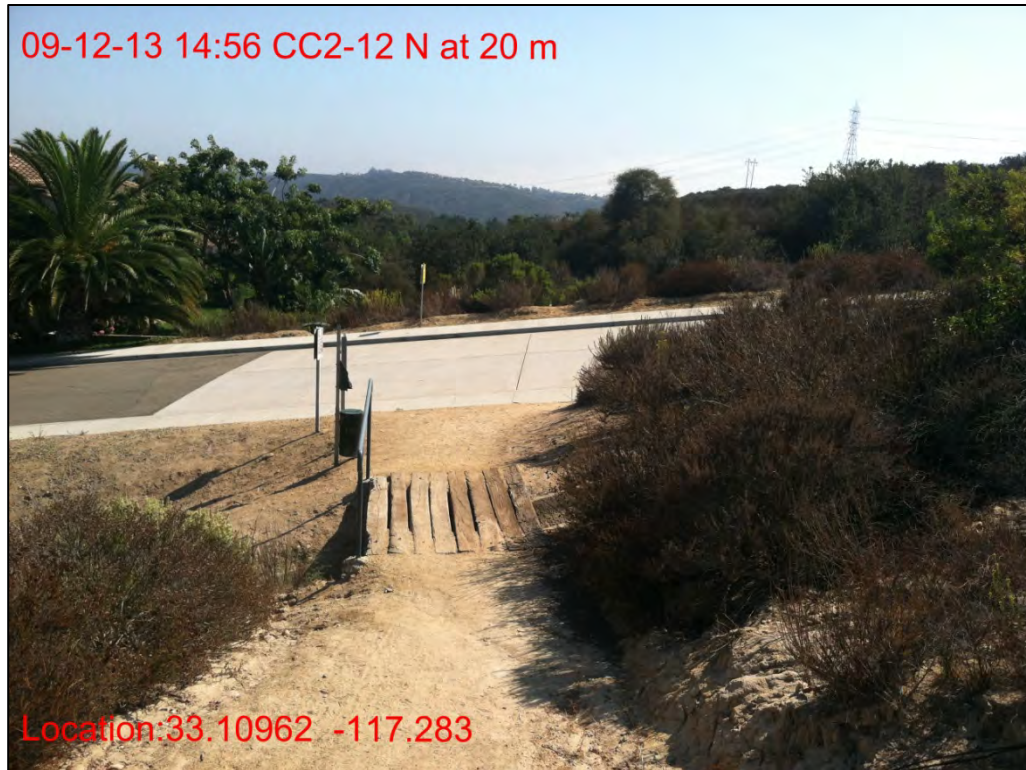
CC2-12, north side, at-grade crossing at 20 m out, September 2013.

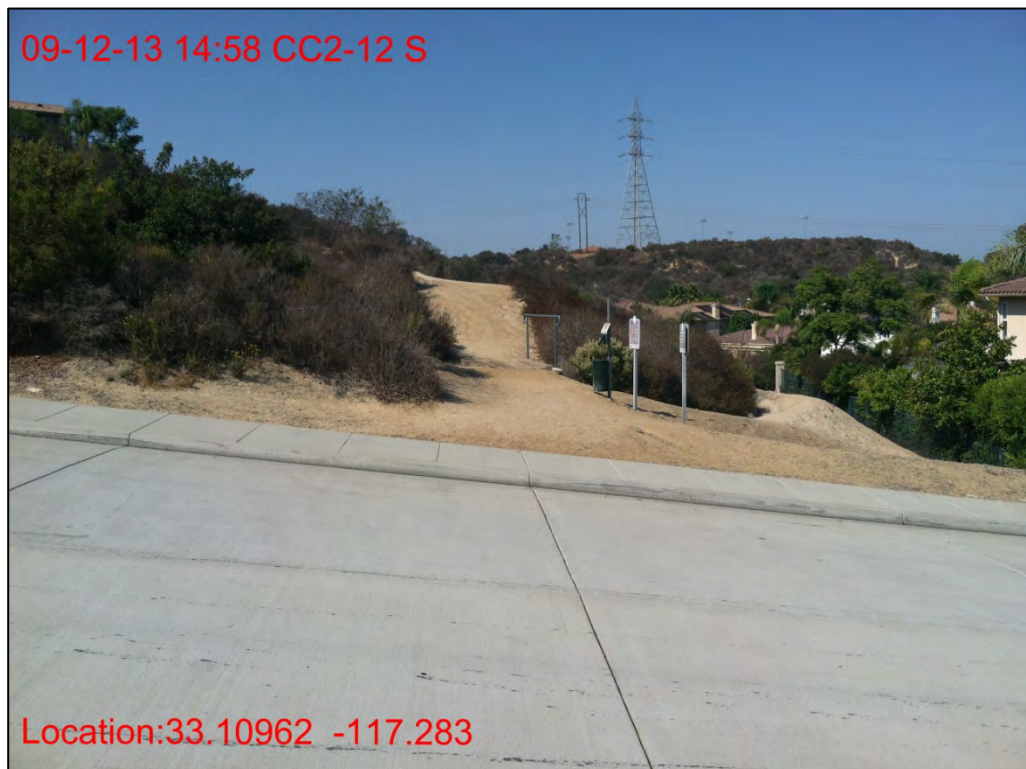
CC2-12, south side, September 2013.

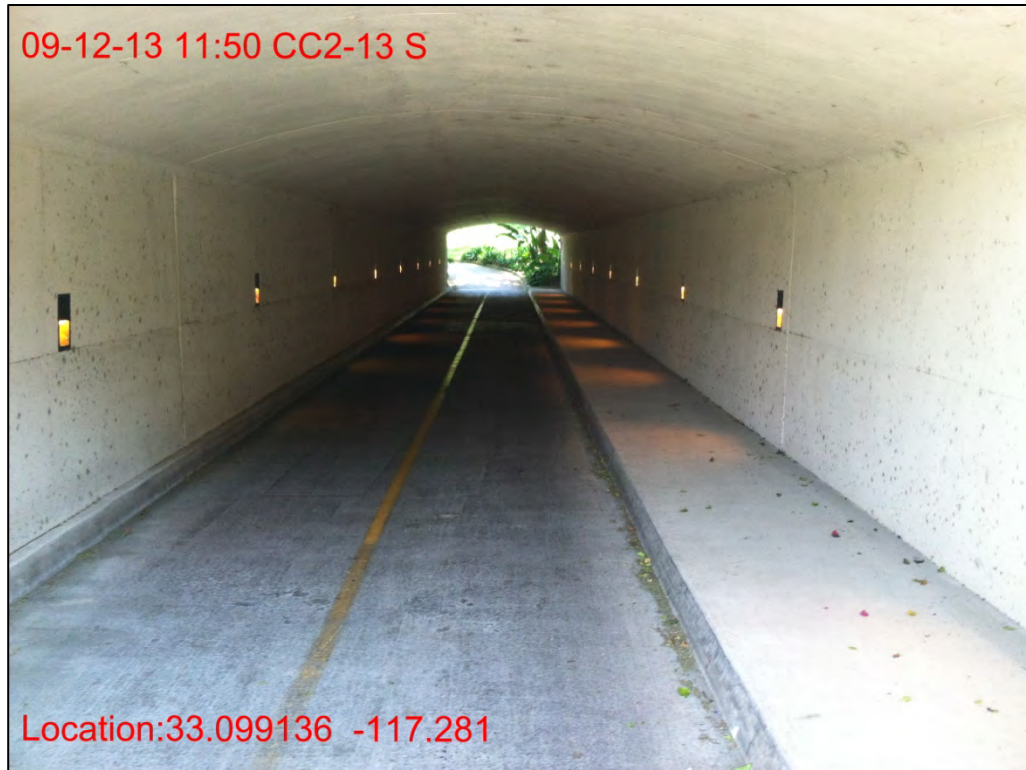
CC2-13, south side facing into undercrossing, September 2013.

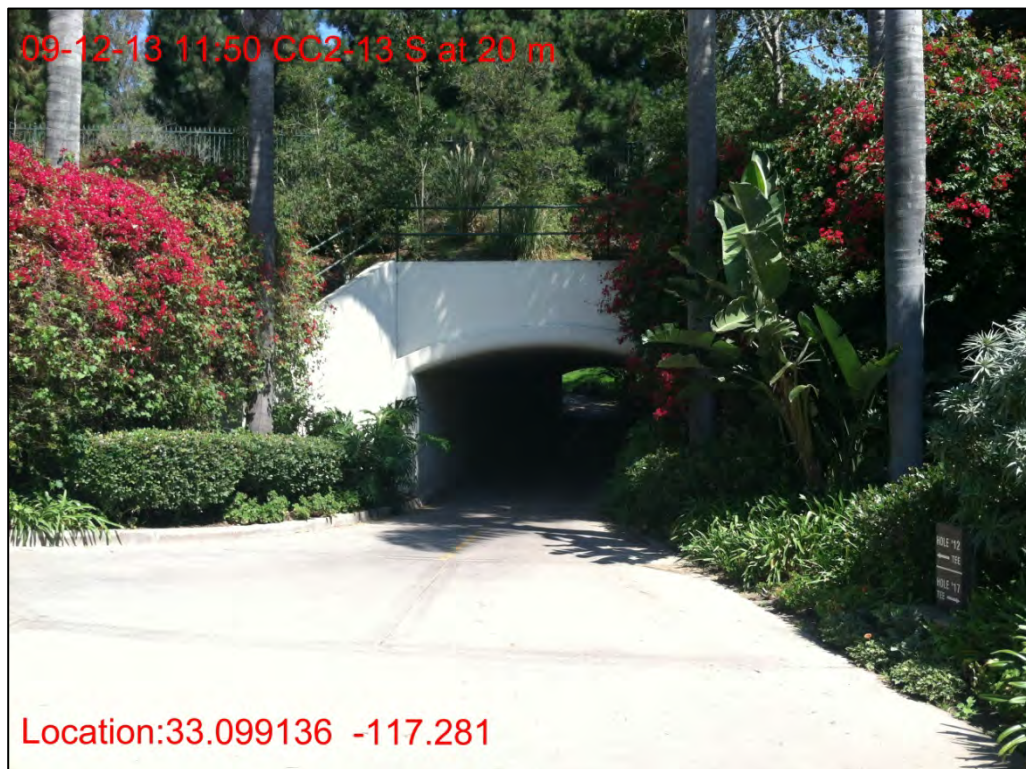
CC2-13, south side at 20 m out, September 2013.

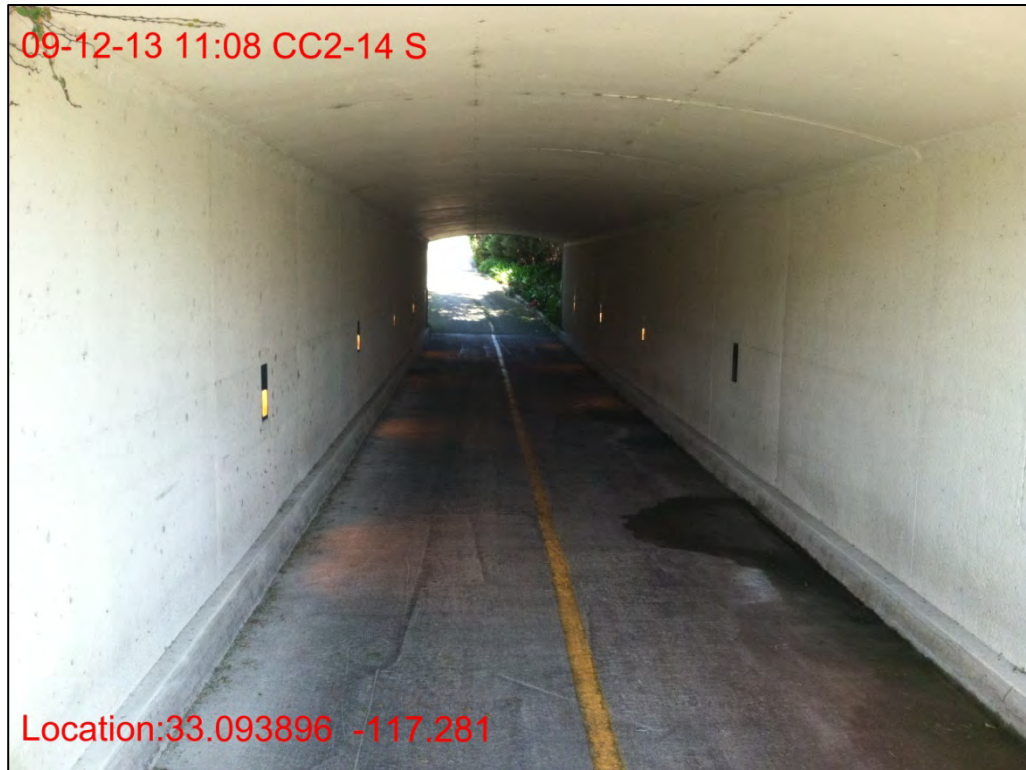
CC2-14, south side facing into undercrossing, September 2013.

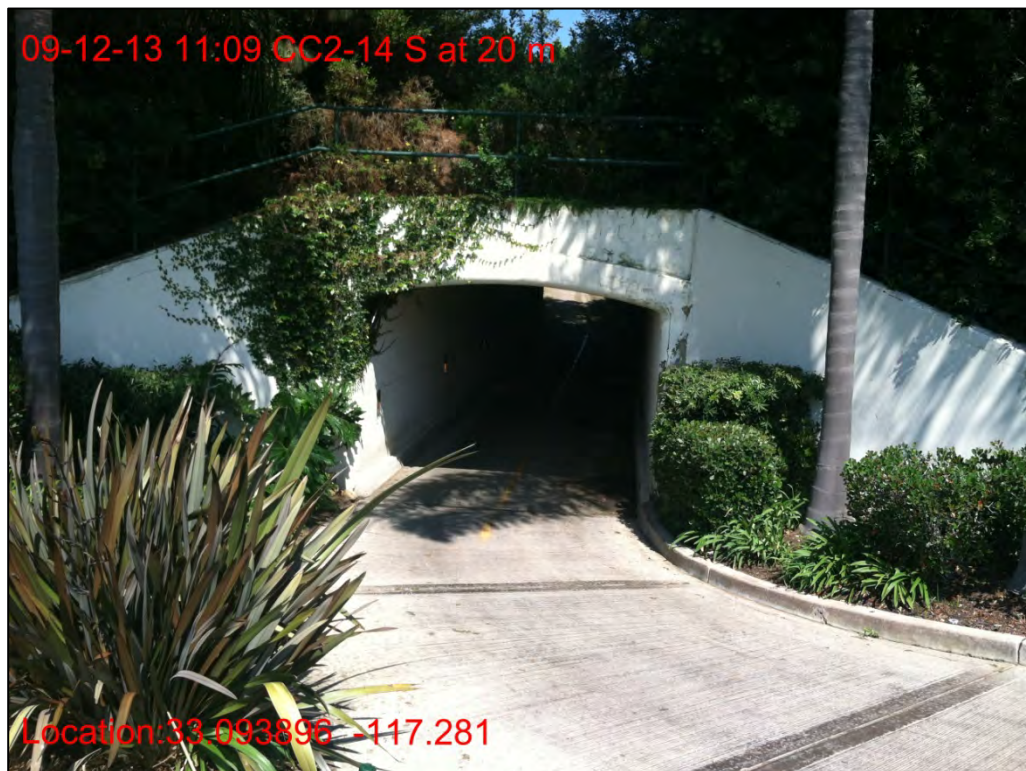
CC2-14, south side at 20 m out, September 2013.
