# City of Carlsbad Wildlife Movement Analysis Final Report

Local Assistance Grant Agreement No.  
P1282107

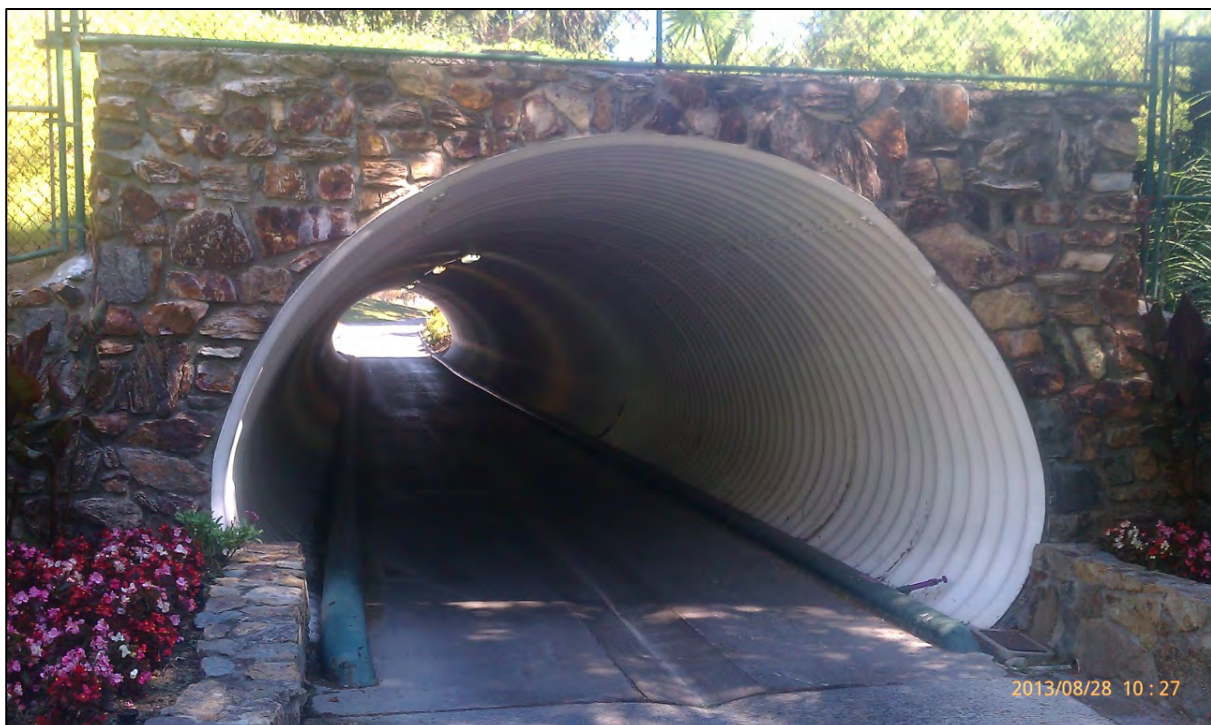
CC3-1 south side facing north, golf cart path entrance, October 2013.

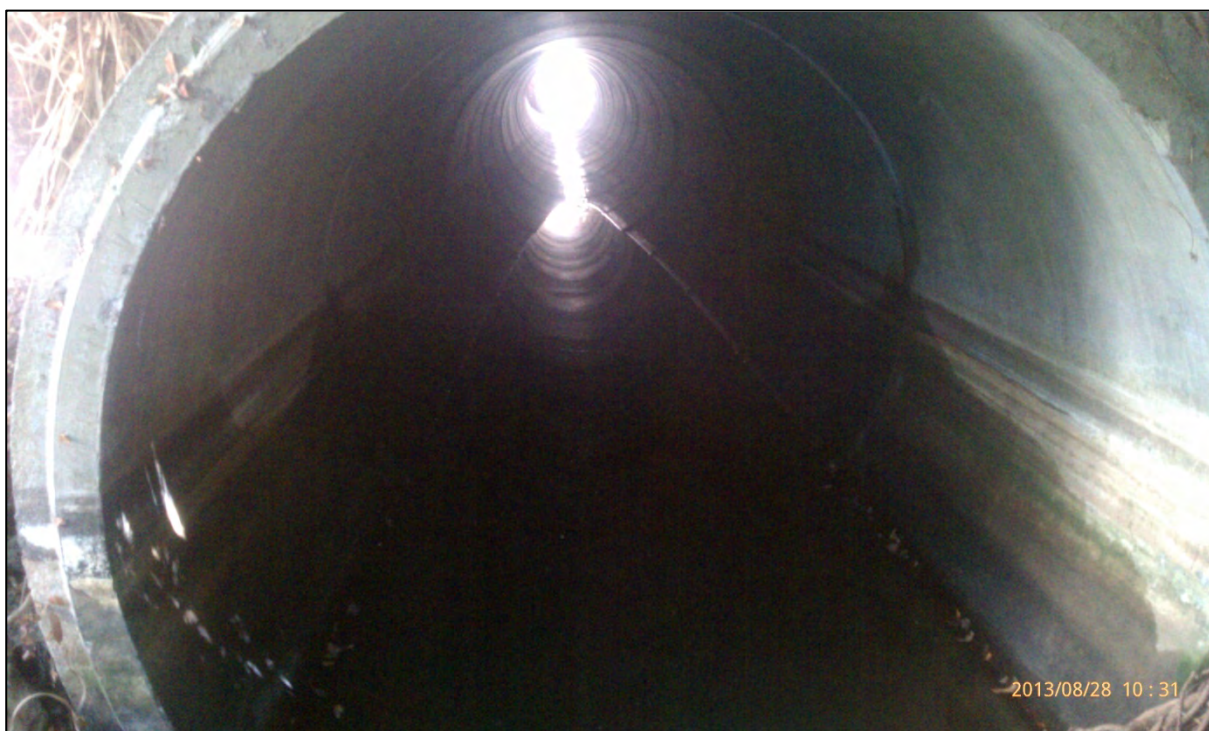
CC3-1 south entrance looking north, alternate route through pipe, October 2013.

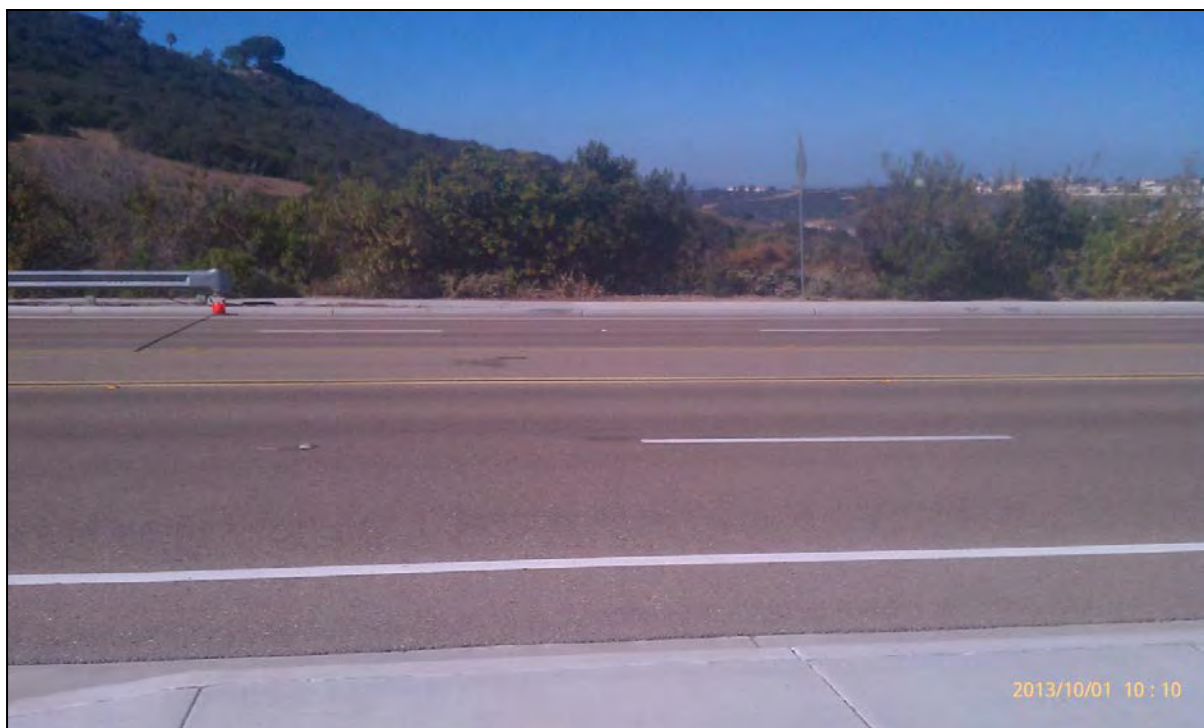
CC3-3a, at-grade crossing, east side looking west, October 2013.

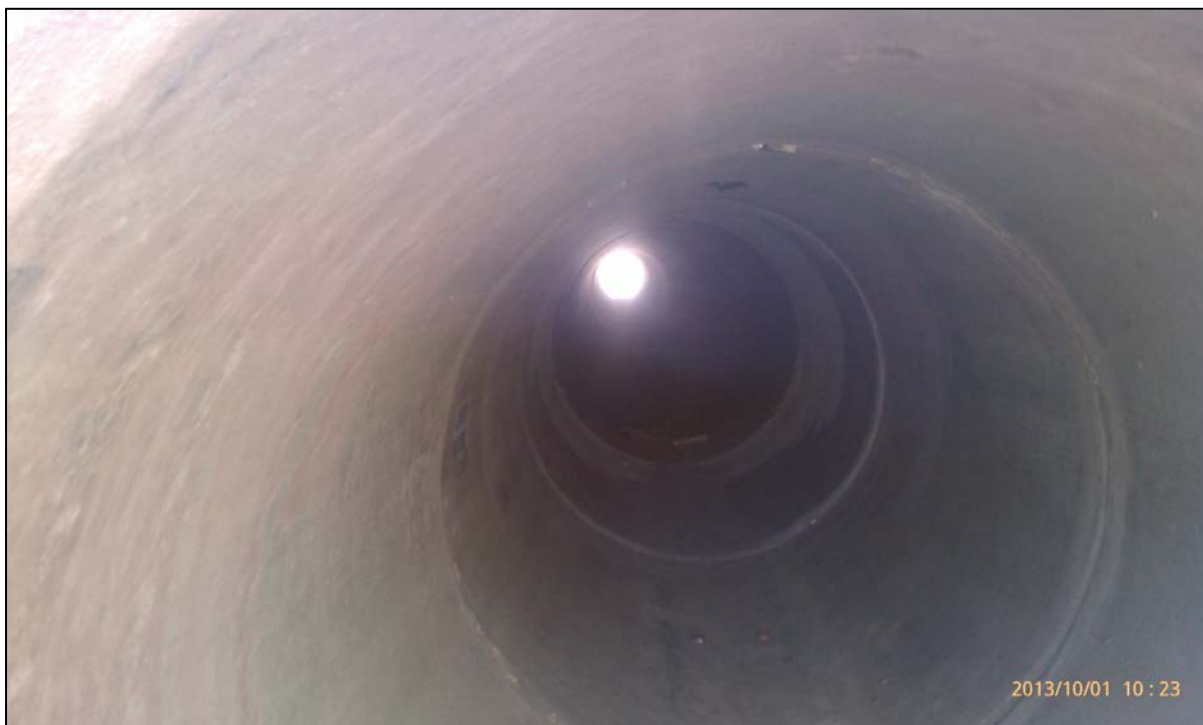
CC3-3b, north side entrance facing toward undercrossing showing long, narrow pipe, Oct 2013.

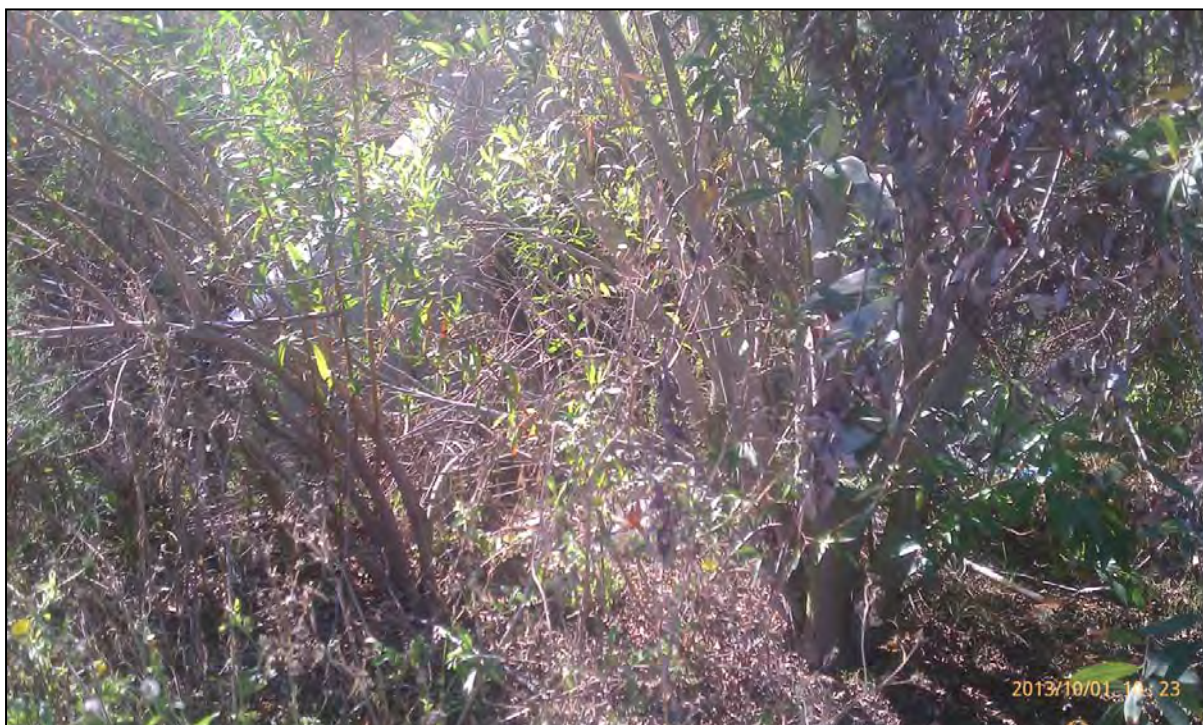
CC3-3b, north side looking south, showing that entrance is blocked by vegetation, October 2013.

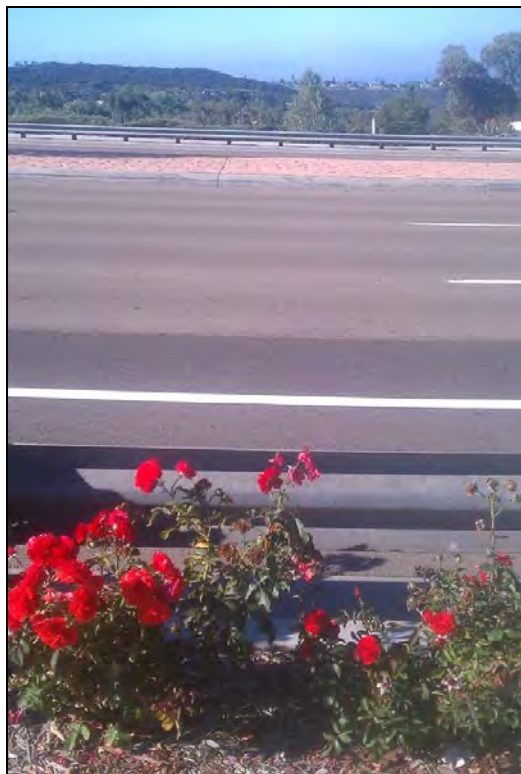
CC3-4, east side looking west, October 2013.

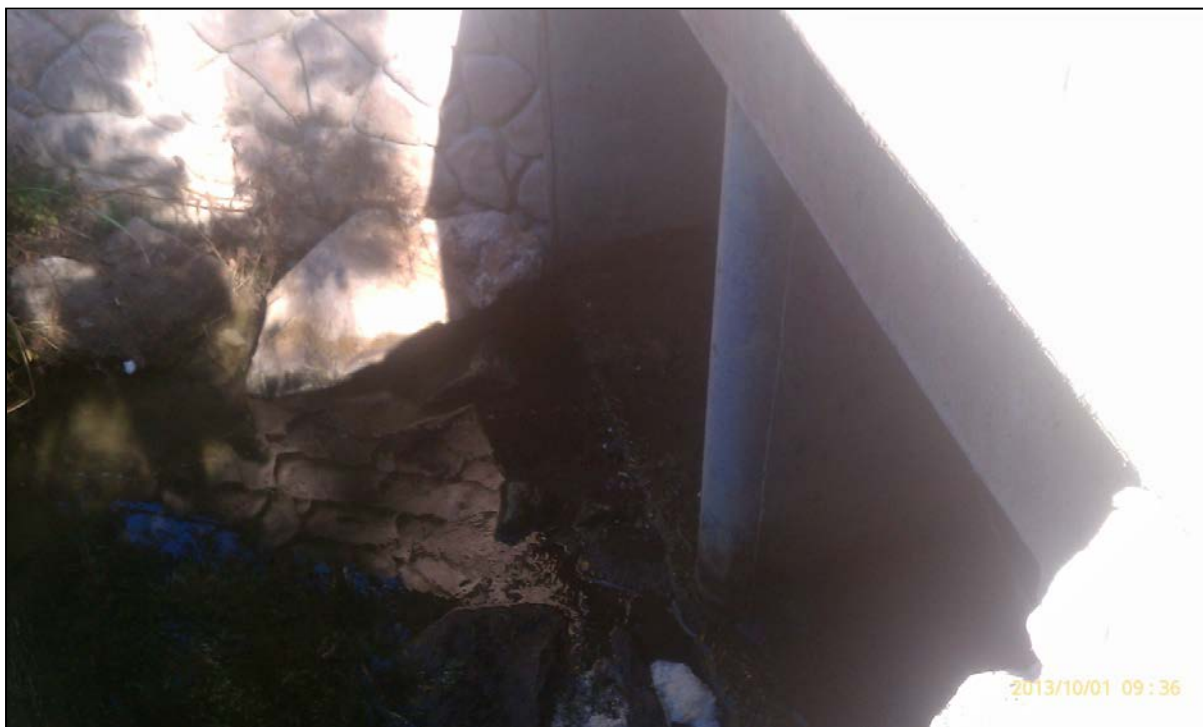
CC3-4, west side outlet from spillway, October 2013.

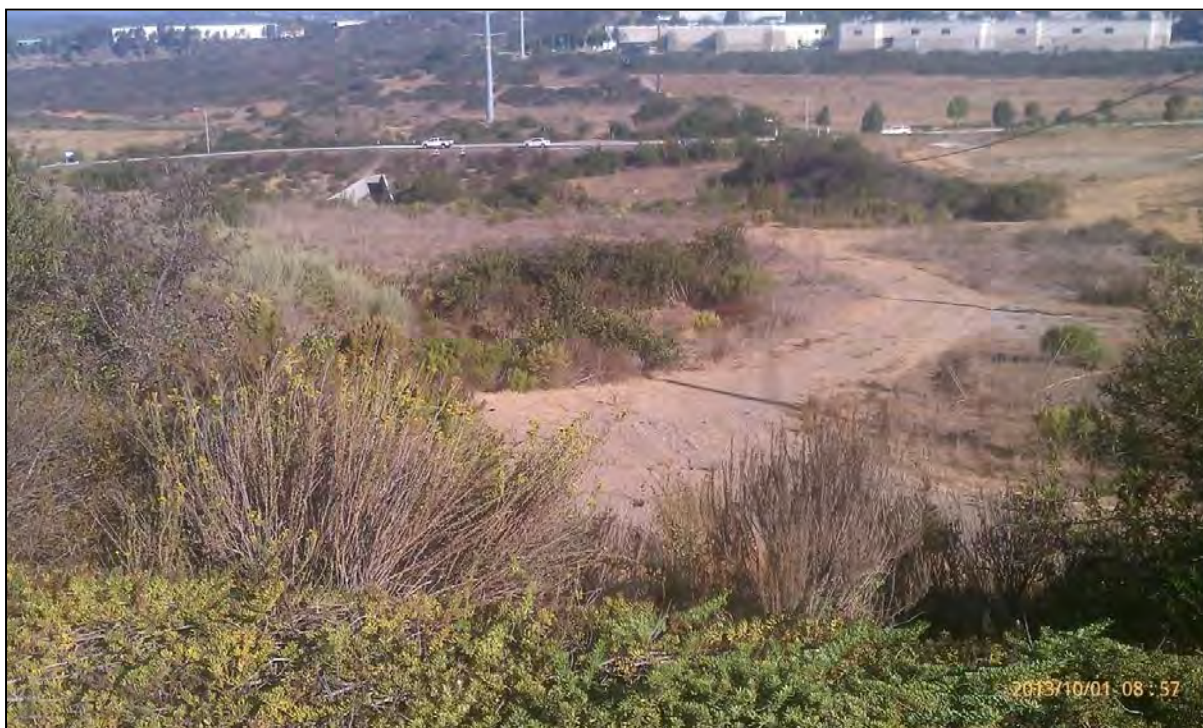
CC3-5, north side looking north (line of sight to M7-5), October 2013

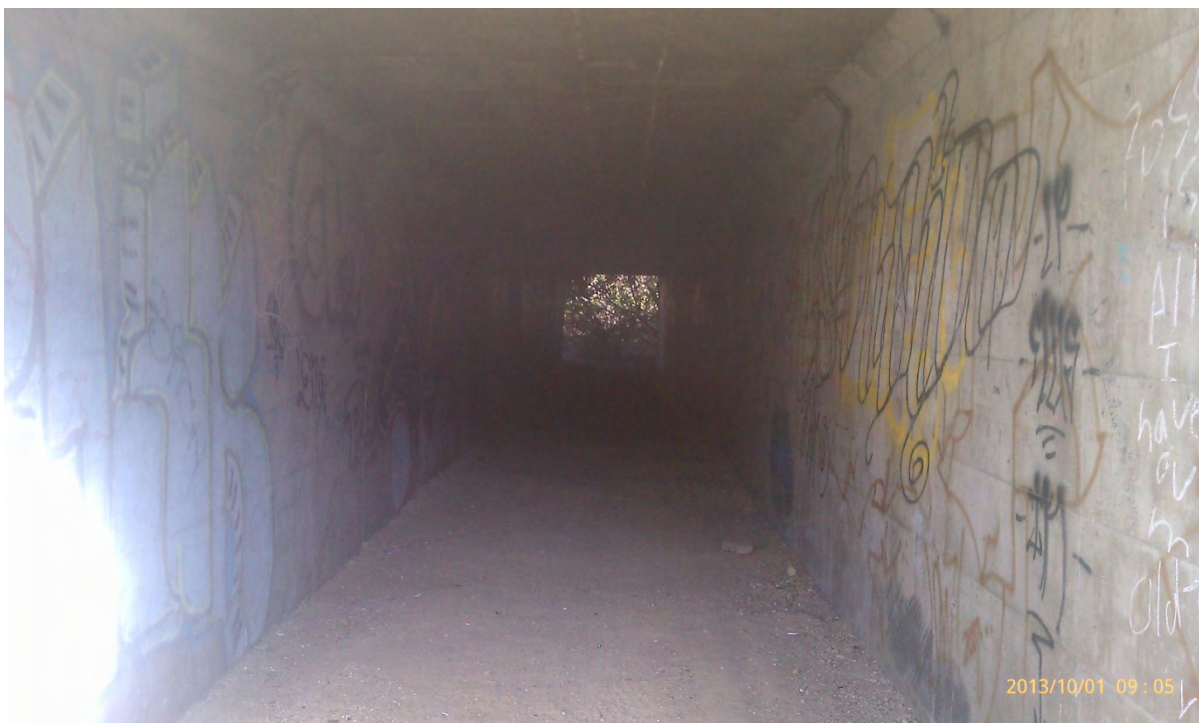
CC3-6. South side looking north from entrance, October 2013

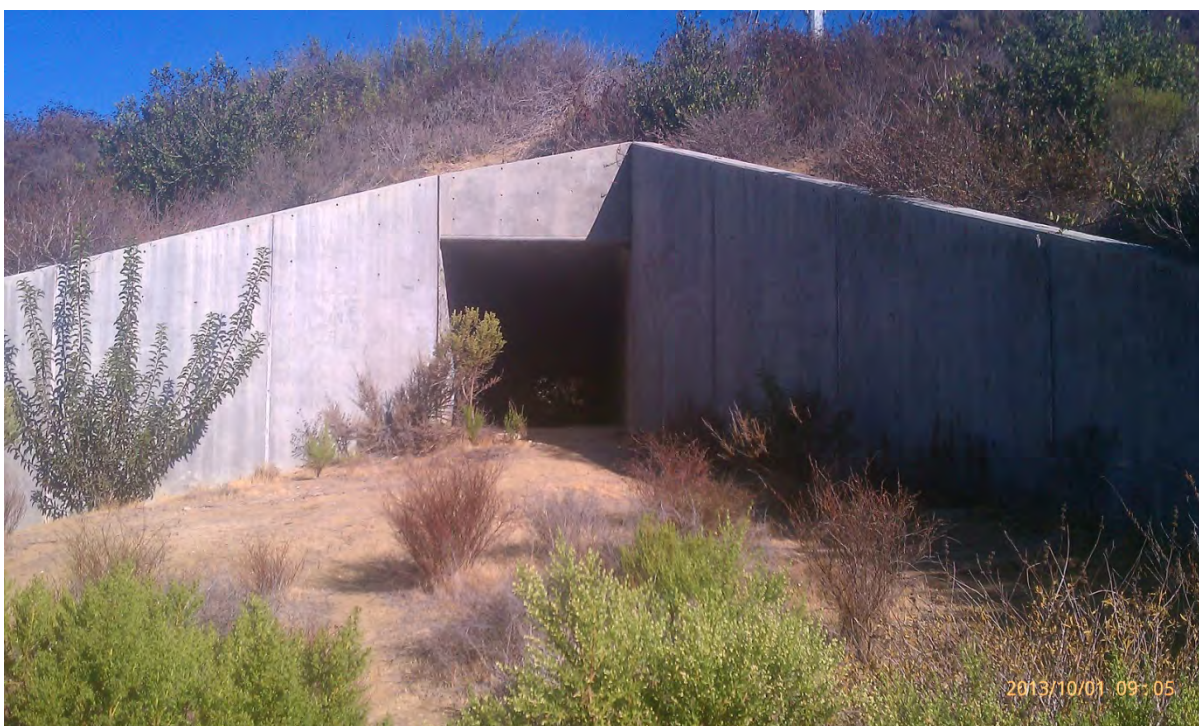
CC3-6. South side looking north from 30 feet out, October, 2013.

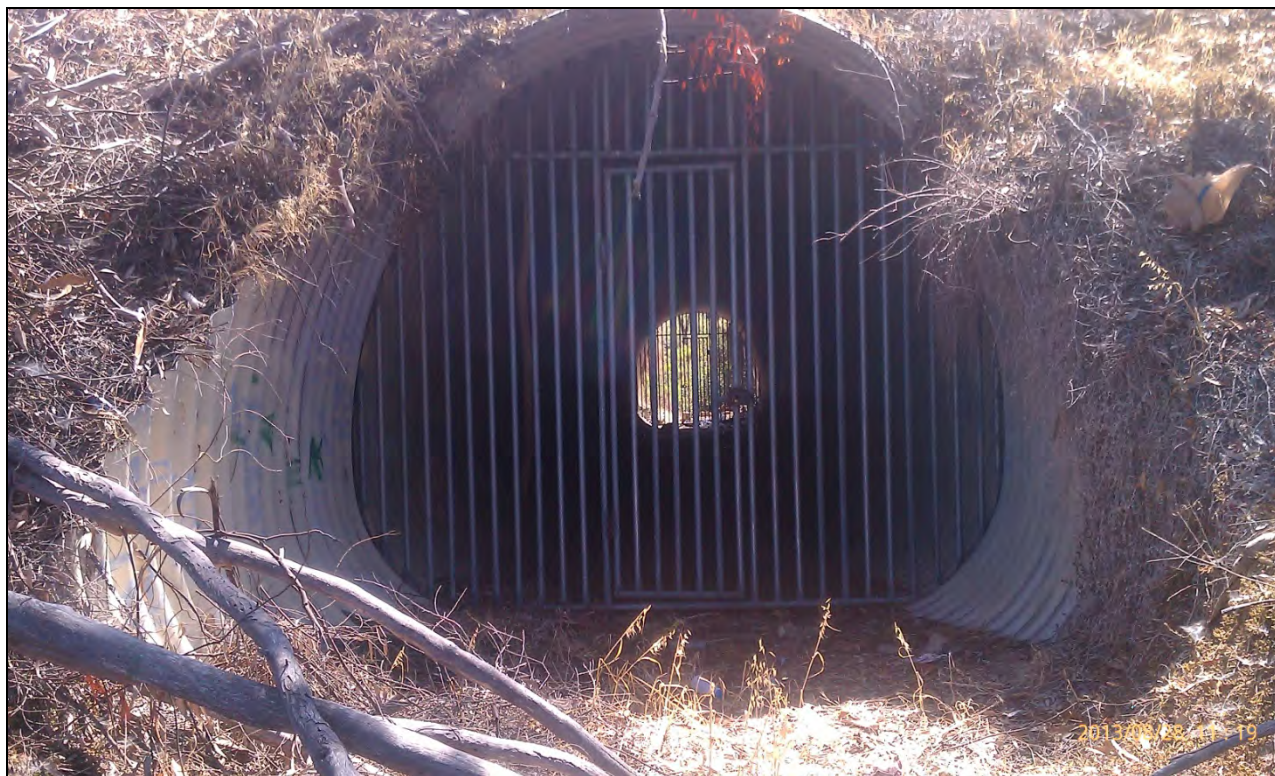
M1-2 – west side facing east, showing locked gate at both ends, August 2013.

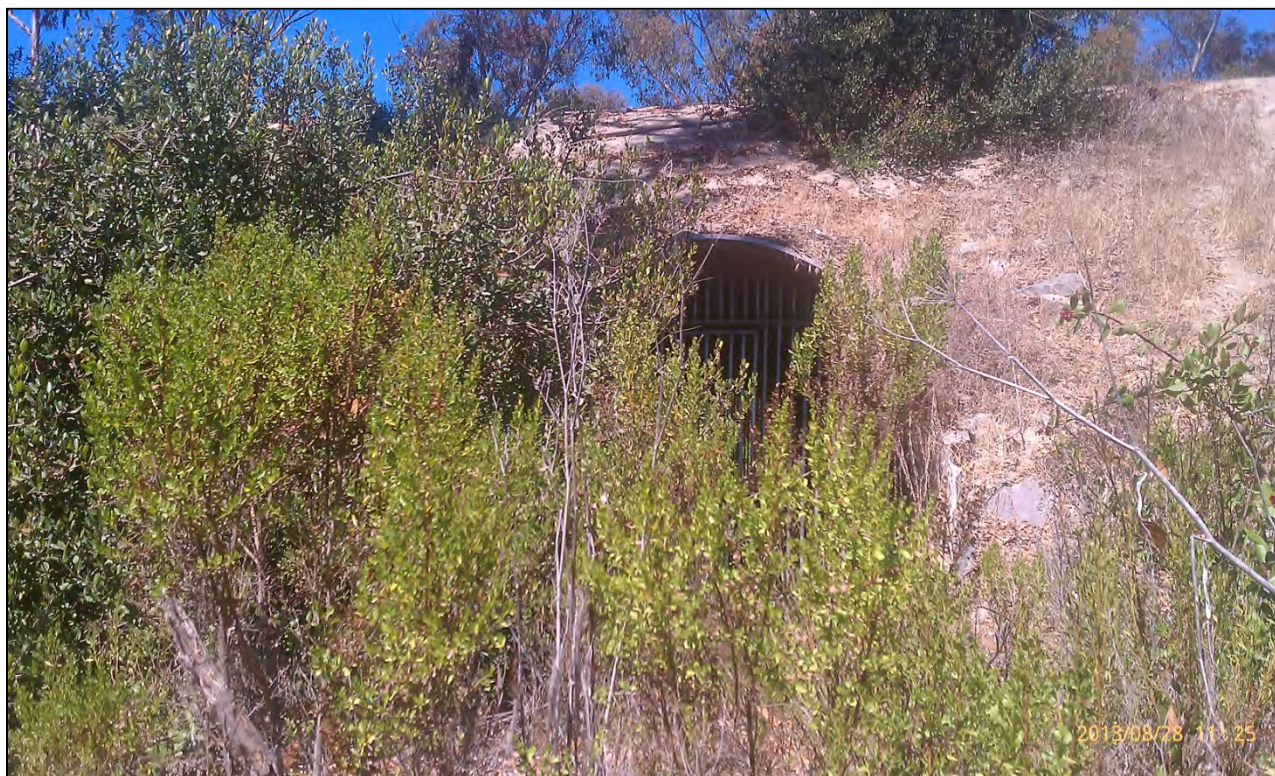
M1-2 east side facing west, August 2013.

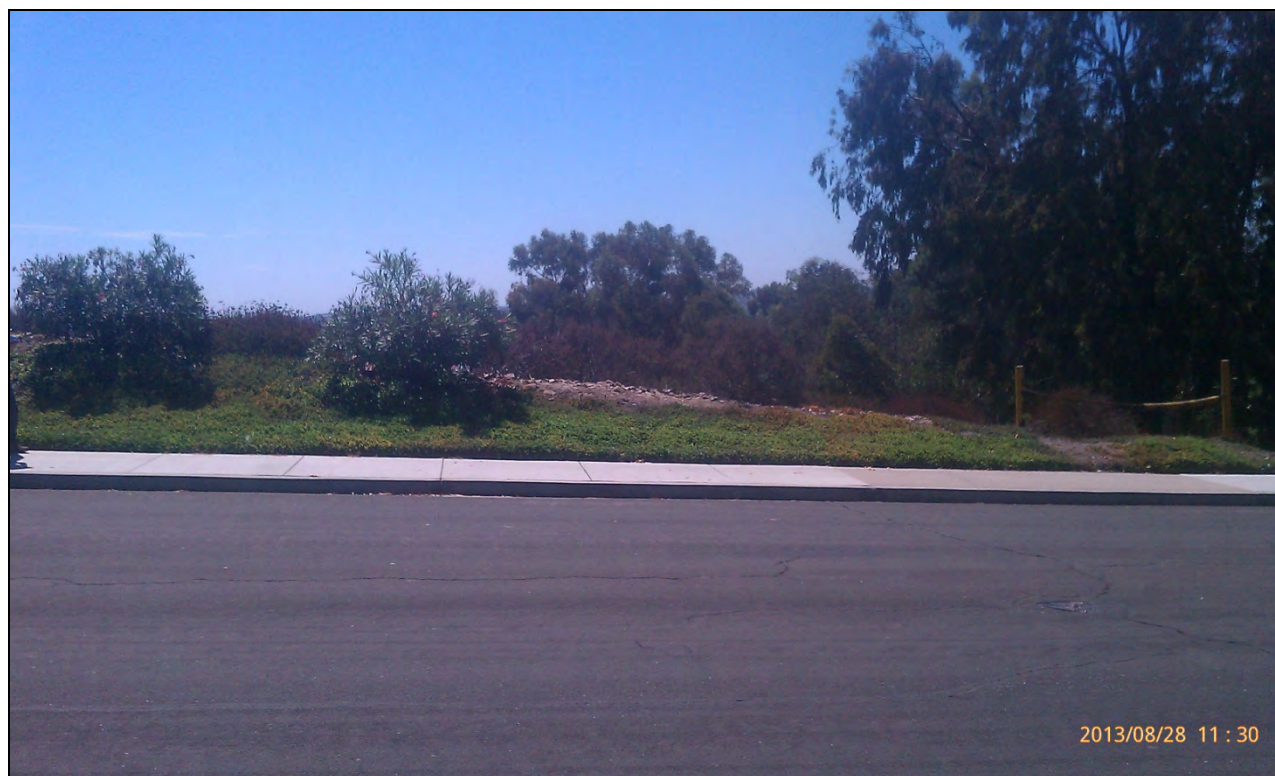
M1-3, at-grade crossing, north side facing south, August 2013.

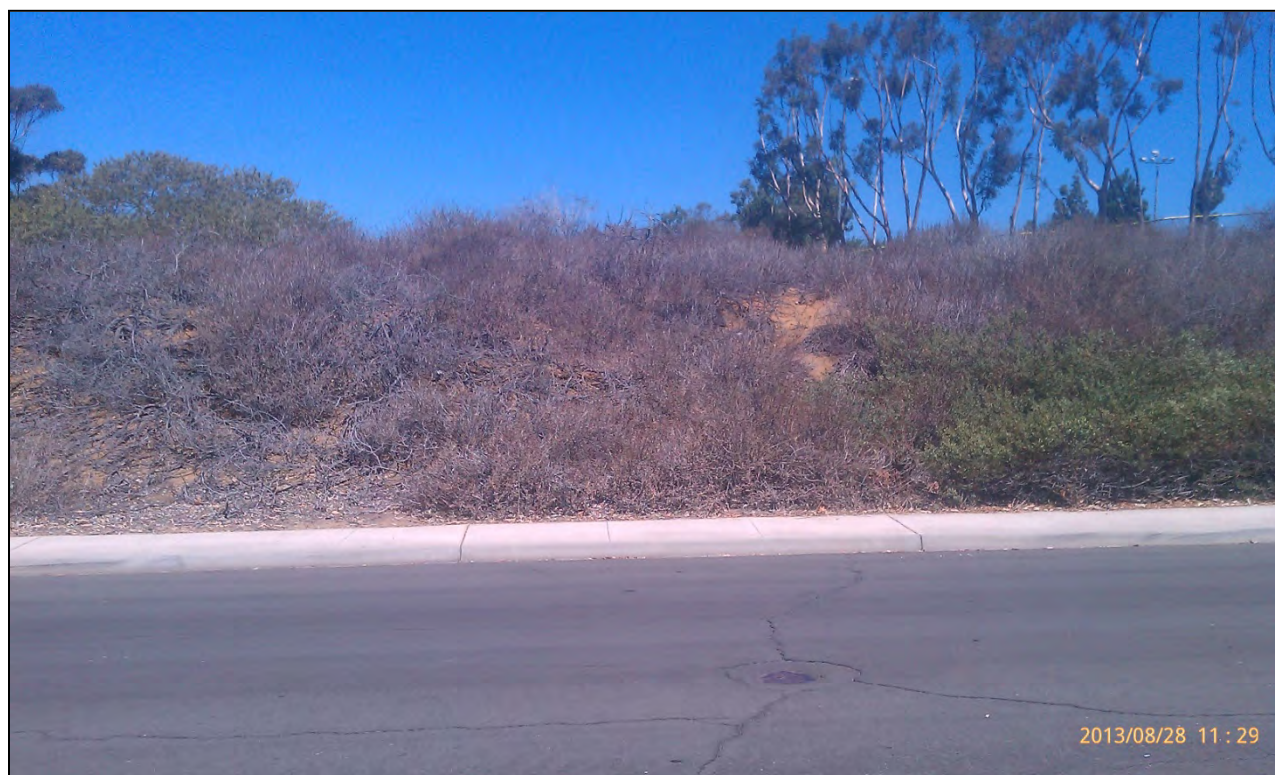
M1-3, south side facing north, August 2013.

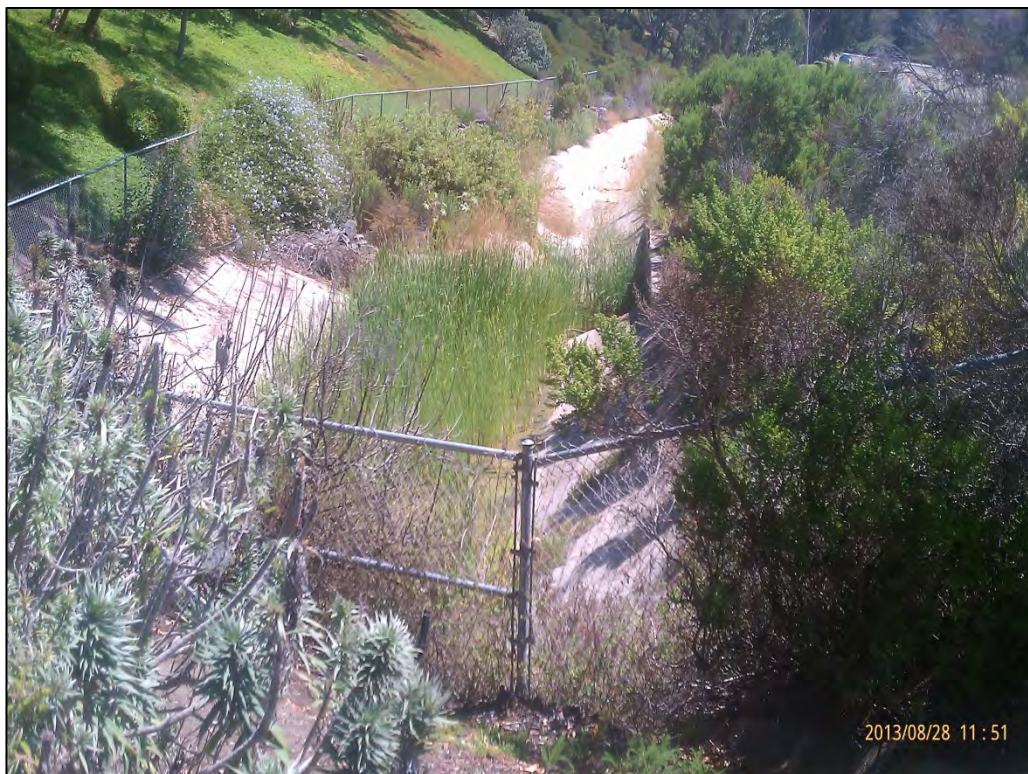
M1-4, looking north from west end, August 2013.

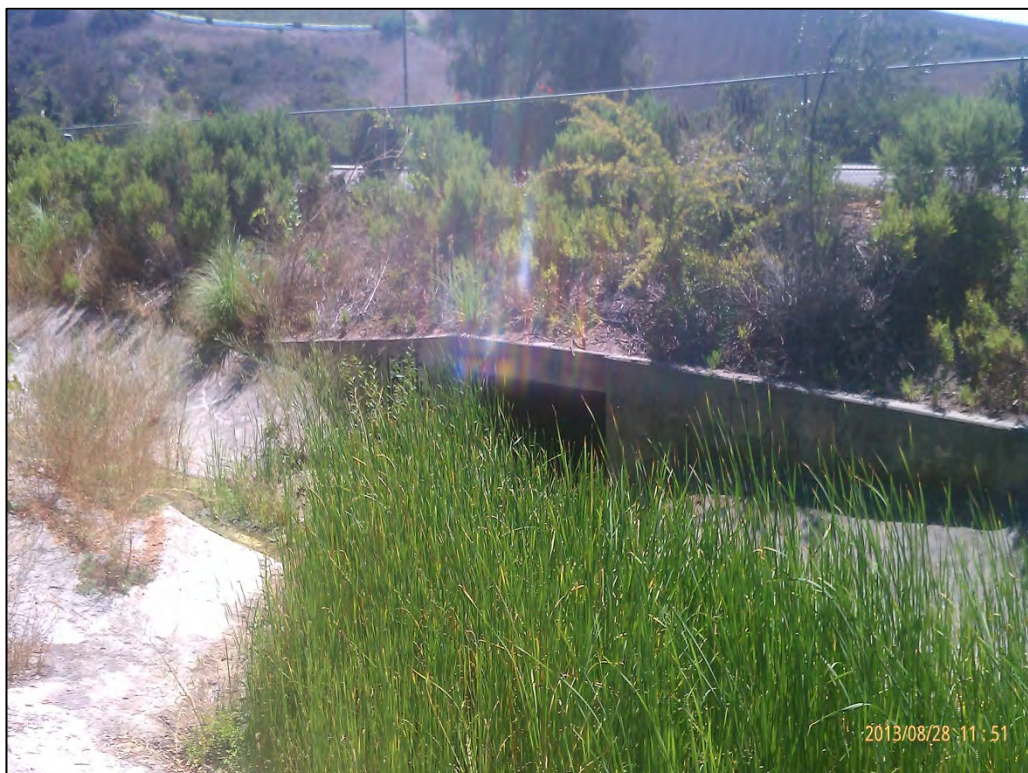
M1-4, looking east from west end, August 2013.

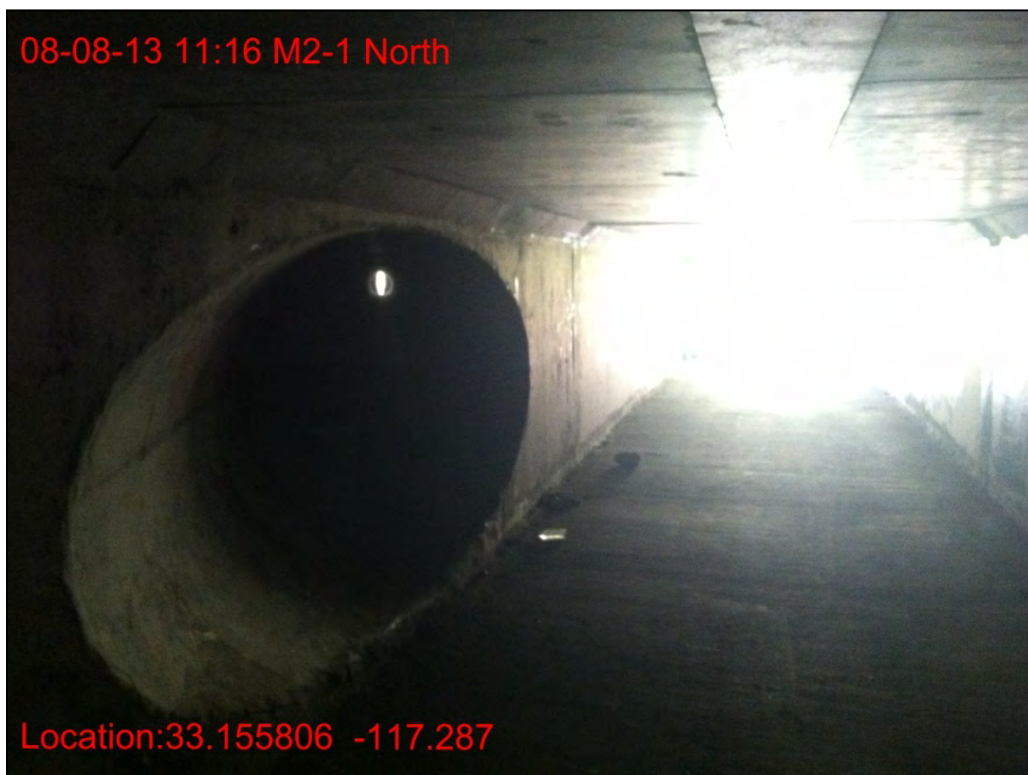
M2-1, north side facing north, showing offshoot pipe, August 2013.

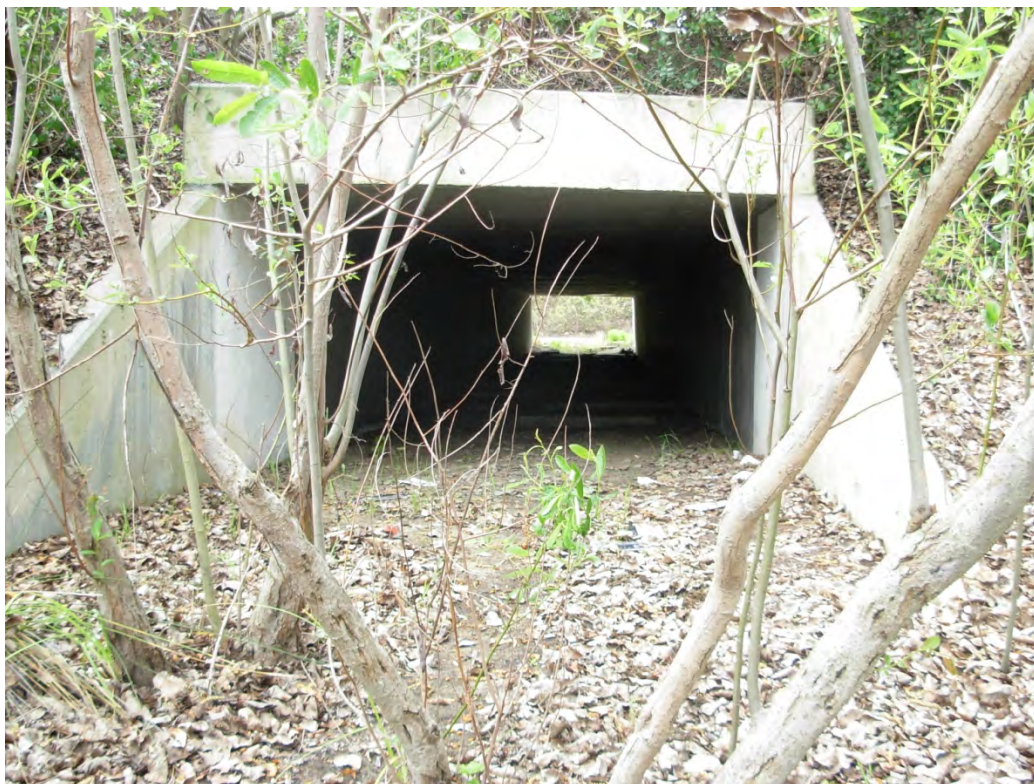
M5-1, looking south from north entrance.

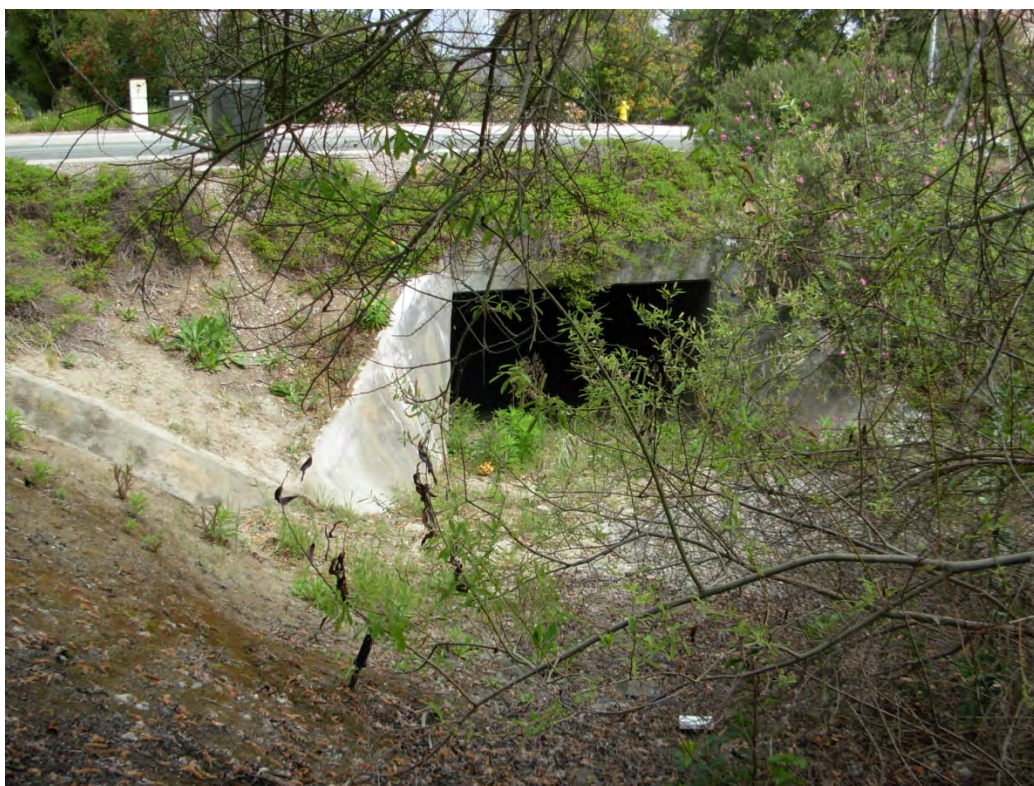
M5-1, looking north at 20 meters from south entrance.

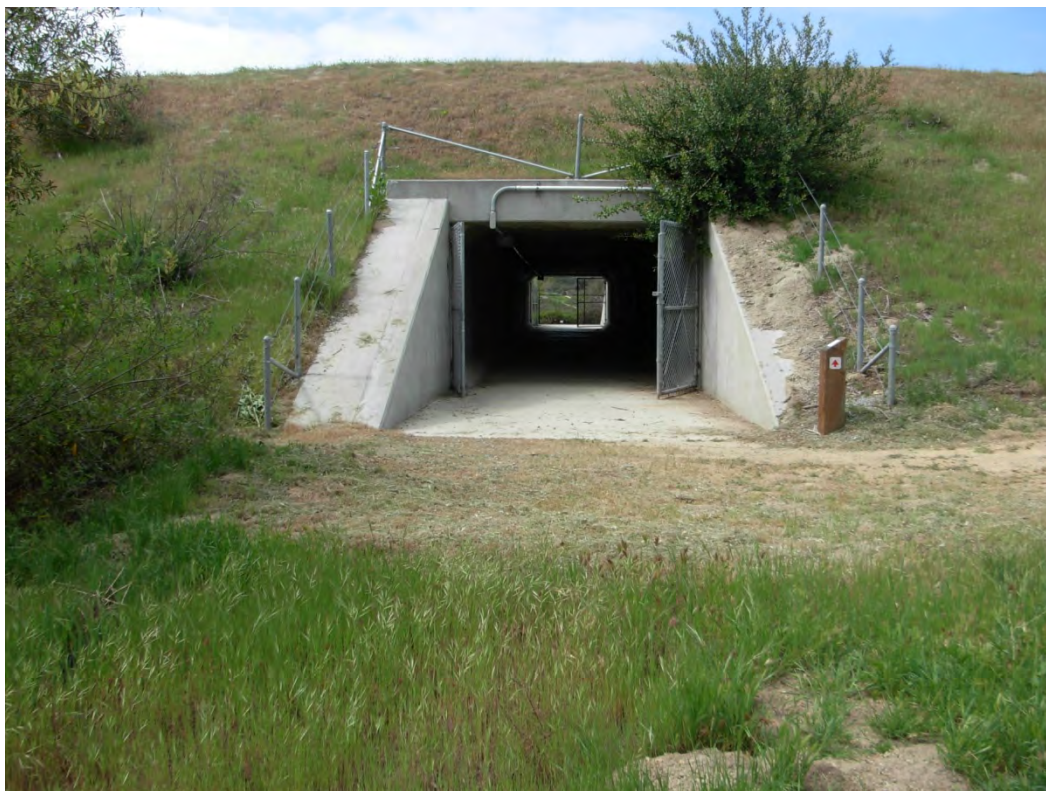
M5-2a, looking south towards north entrance.

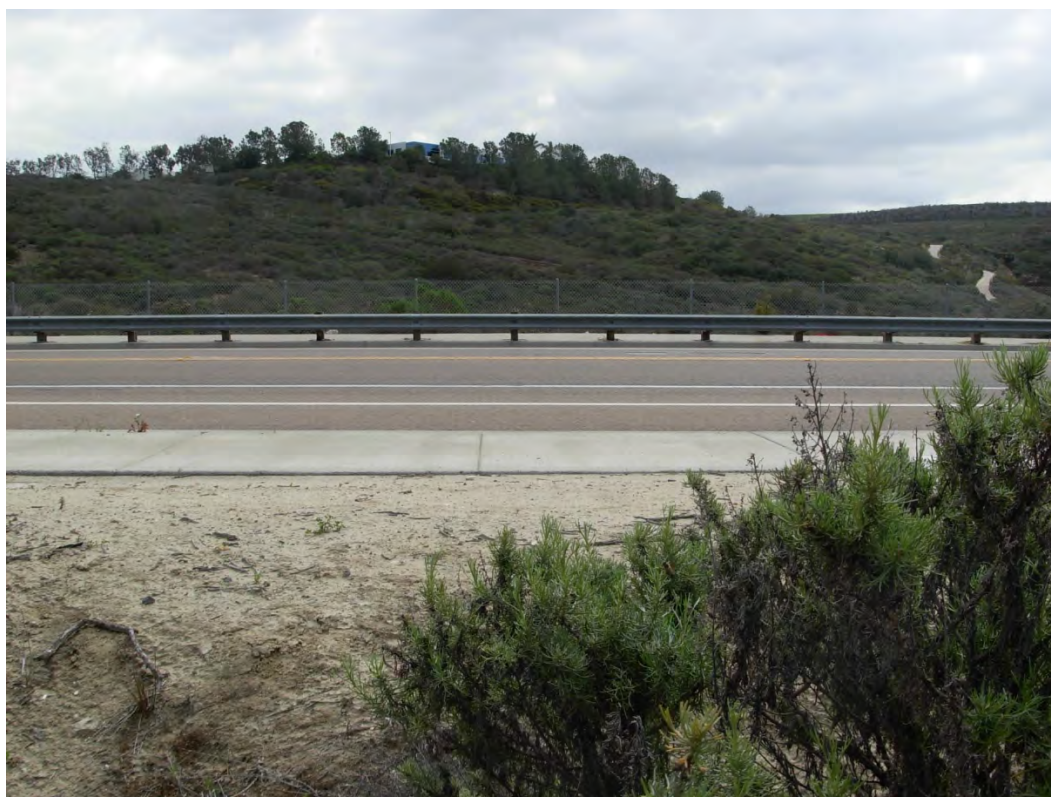
M5-2b, north side looking south.

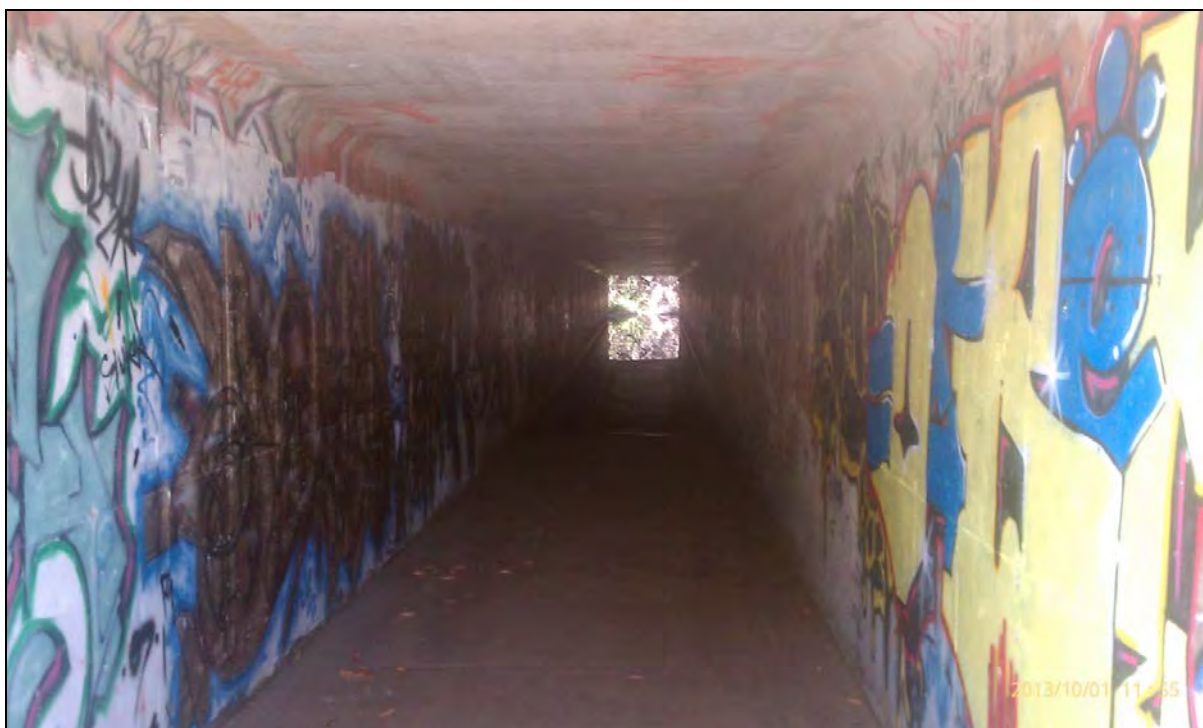
M6-2 east entrance looking west, October 2013.

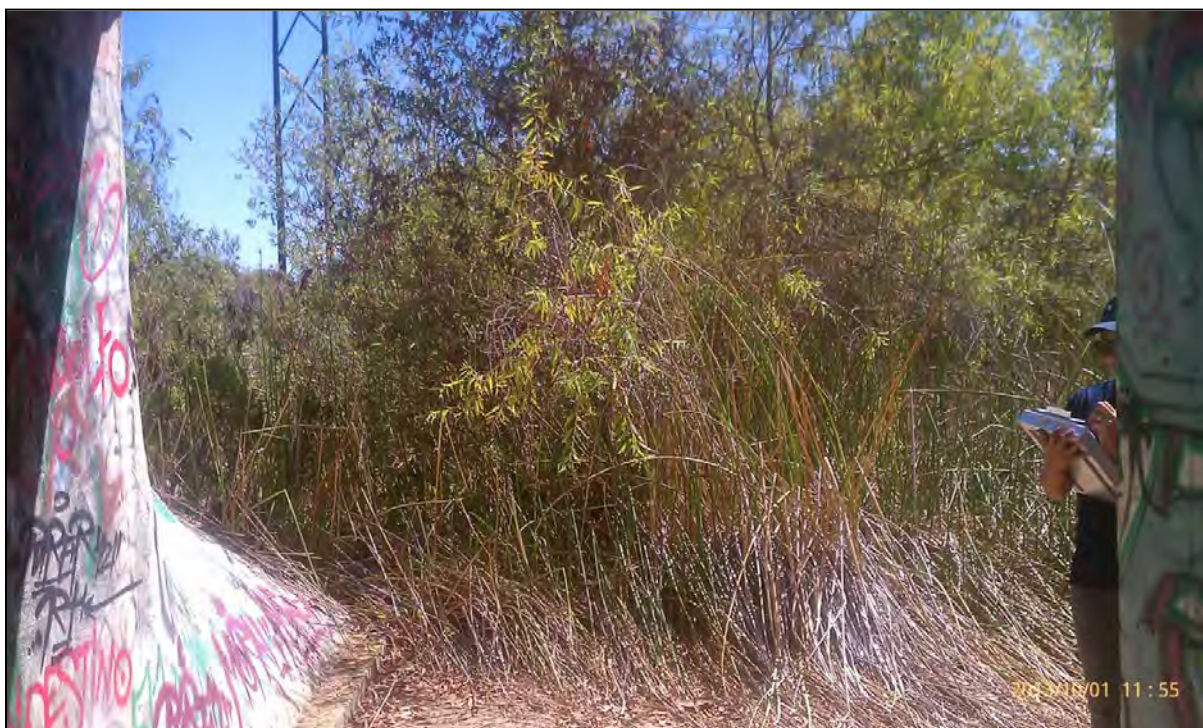
M6-2 east entrance facing east, October 2013.

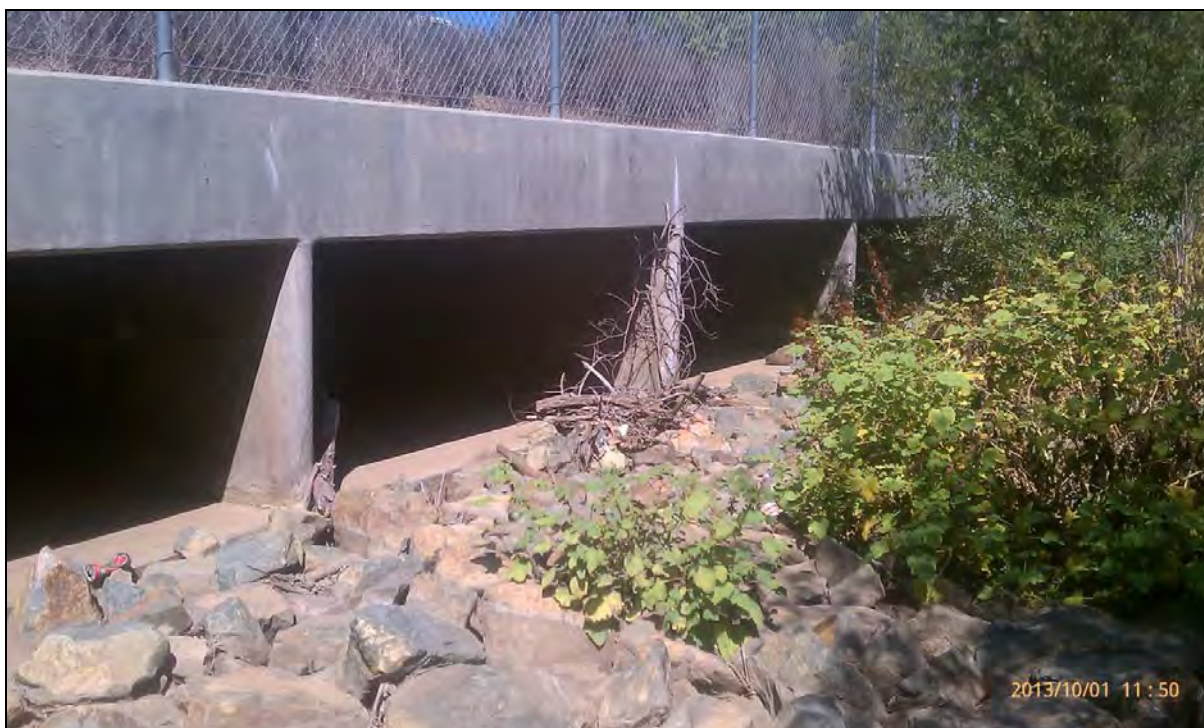
M6-3, west entrance facing southeast at multi-chambered undercrossing, October 2013.

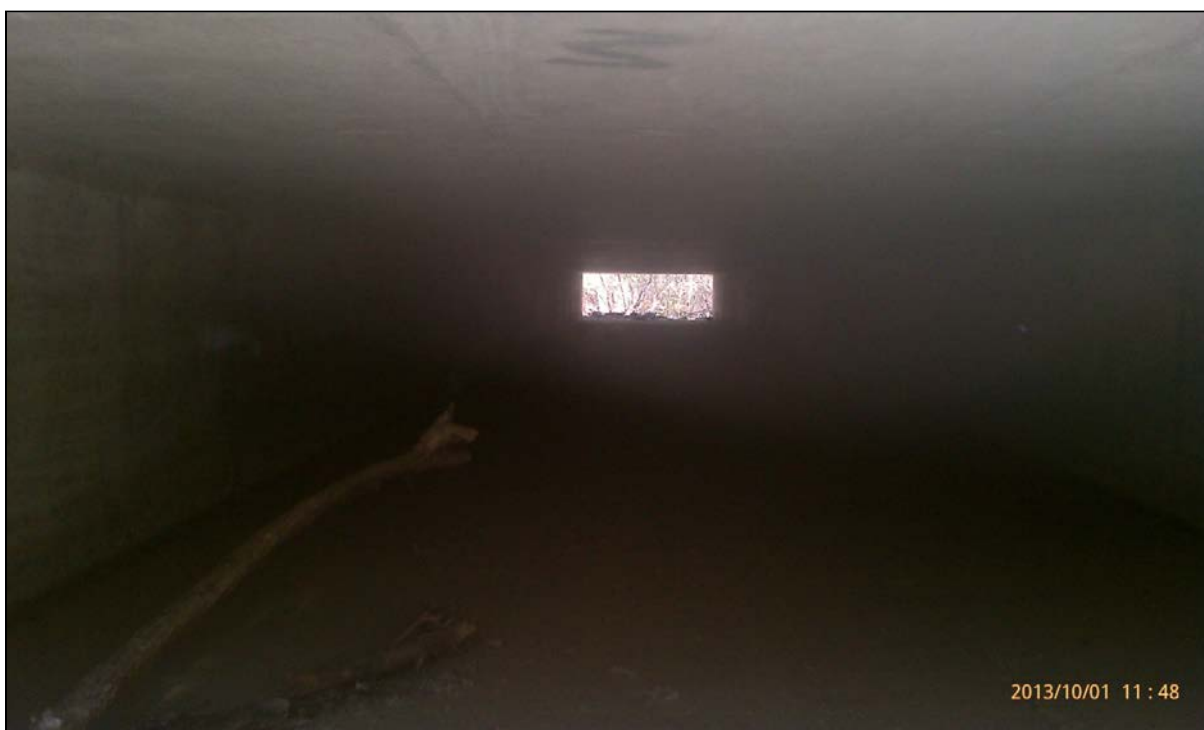
M6-3 east entrance facing toward undercrossing, showing low ceiling, October 2013.

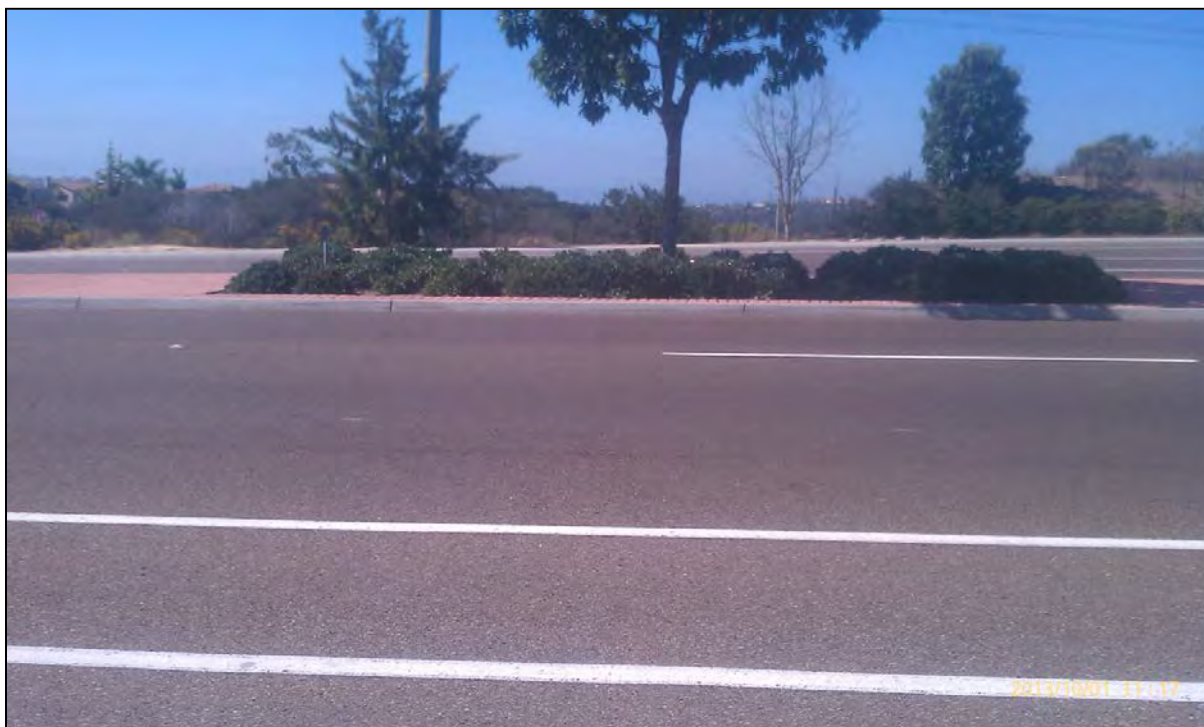
M6-5, at-grade crossing, east side looking west, October 2013
