# City of Carlsbad Wildlife Movement Analysis Final Report

Local Assistance Grant Agreement No.  
P1282107

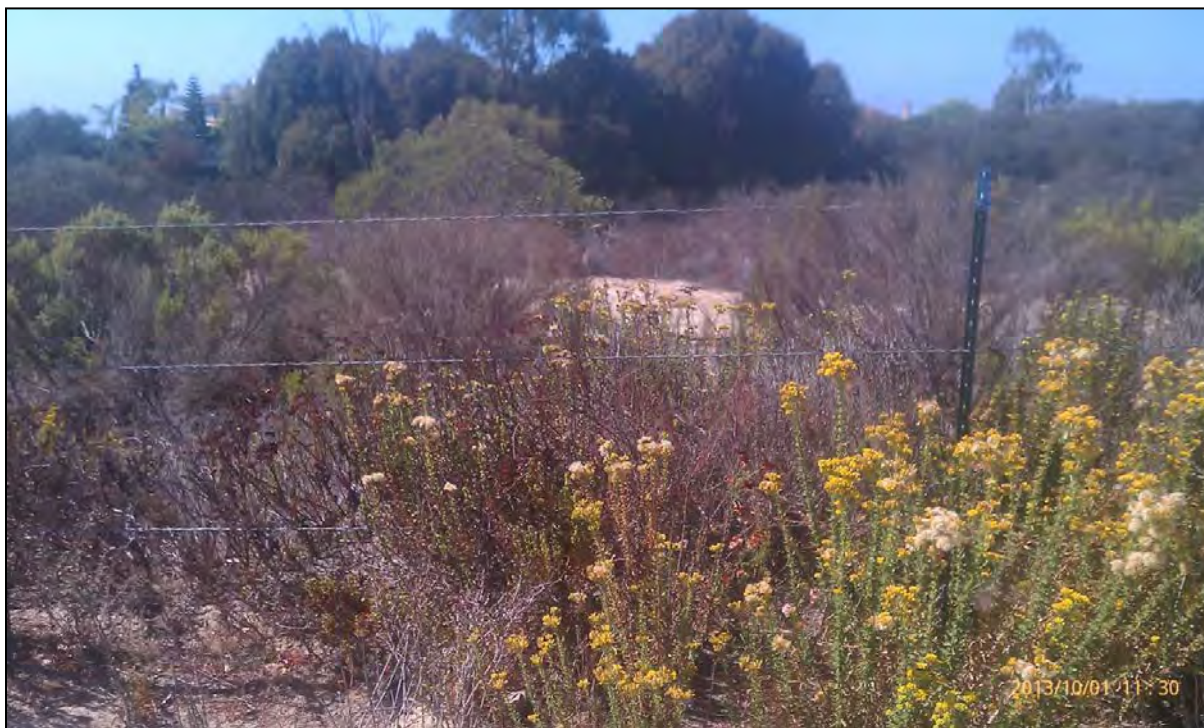
M6-5, west side facing west, showing barbed wire fencing, October 2013.

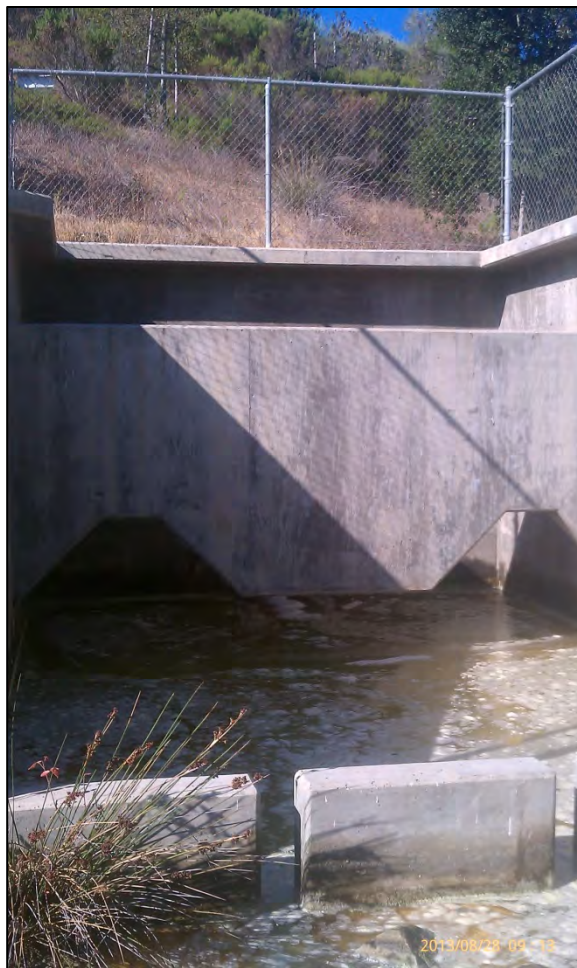
M7-1, north side showing constraints, August 2013.

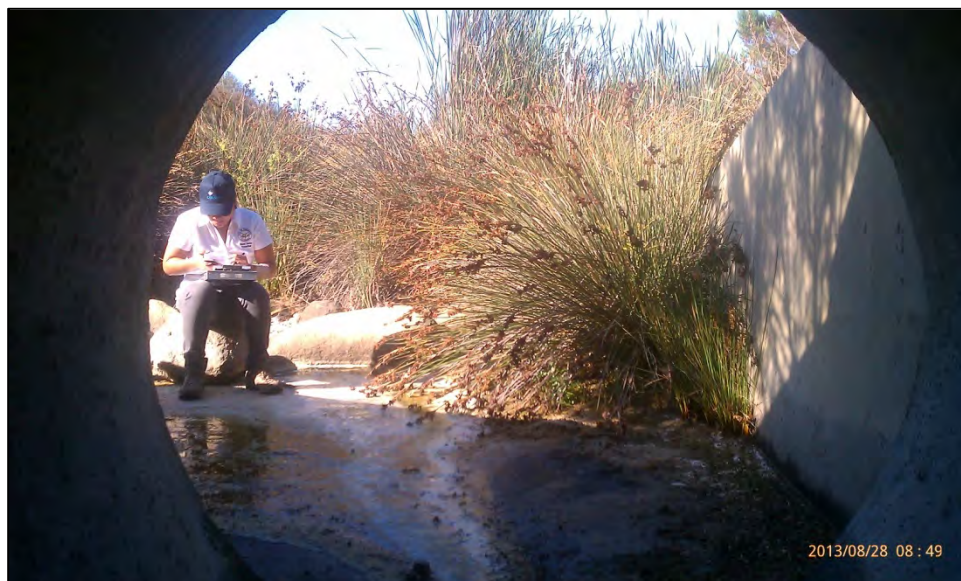
M7-1, south side looking south, August 2013.

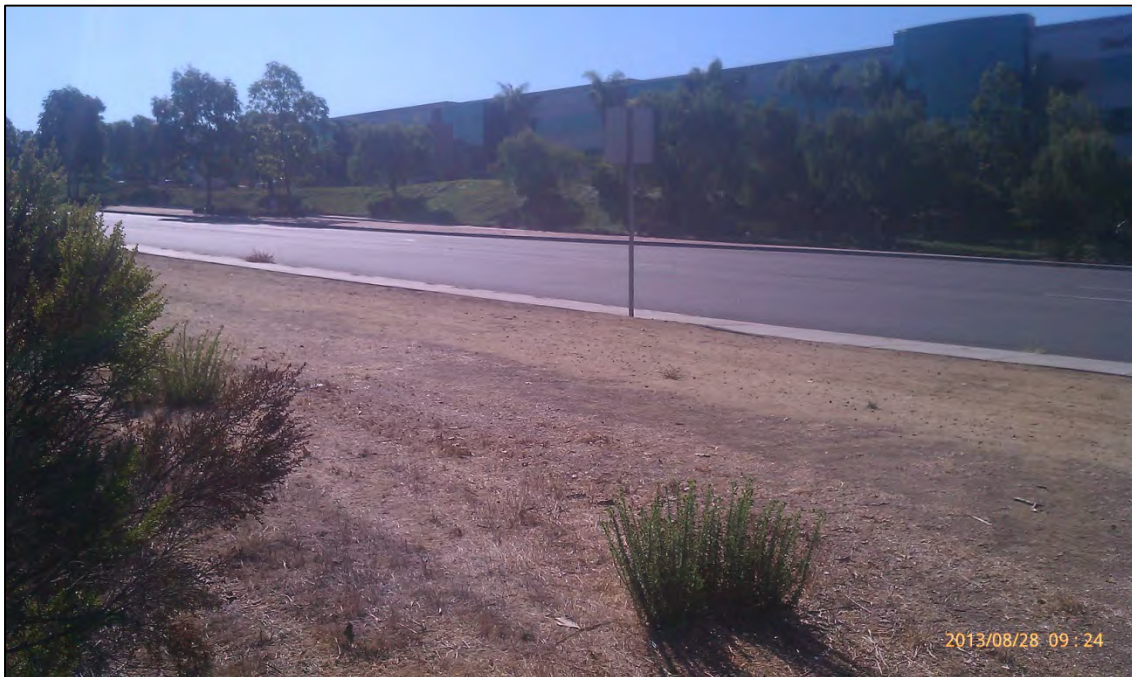
M7-2, at-grade crossing, north side facing southeast, August 2013.

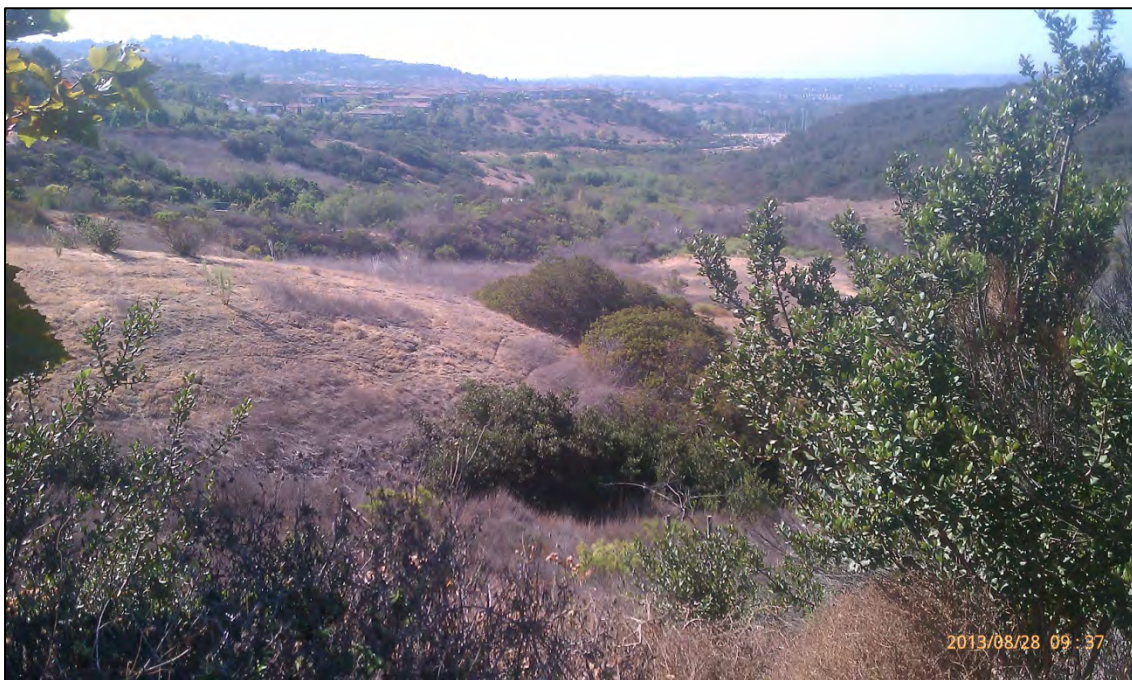
M7-2, north side looking north from habitat edge, August 2013.

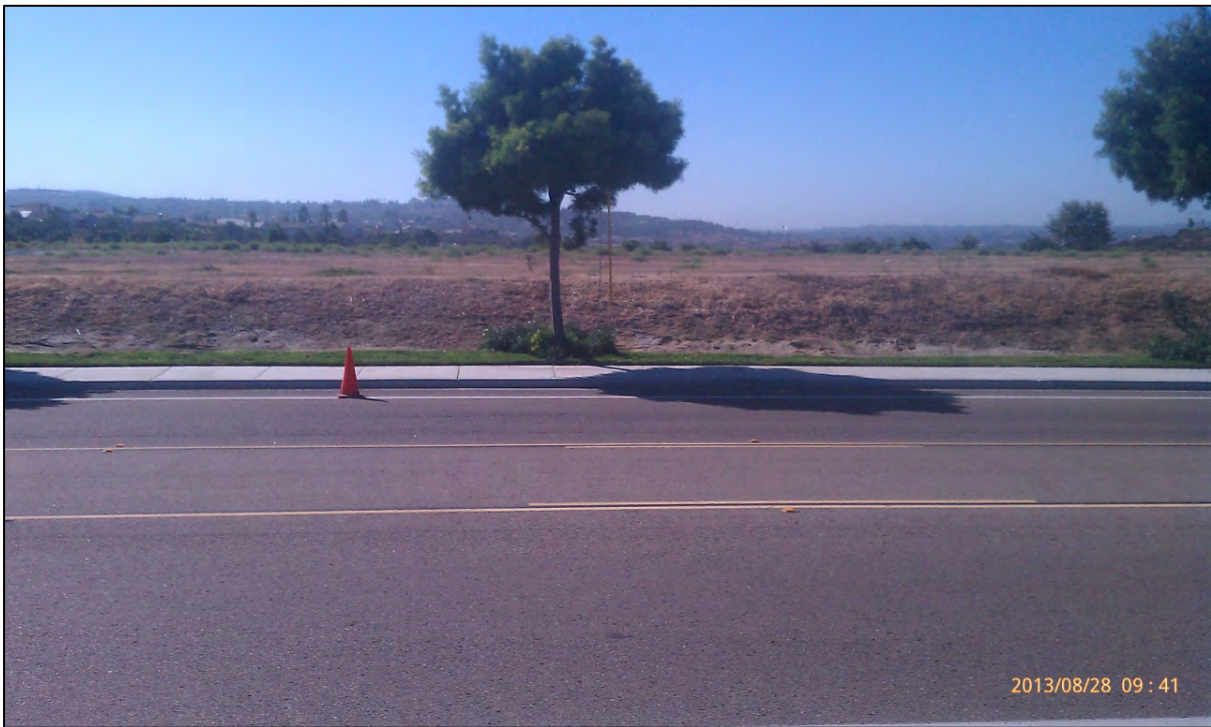
M7-3, at-grade crossing, north side facing south, August 2013.

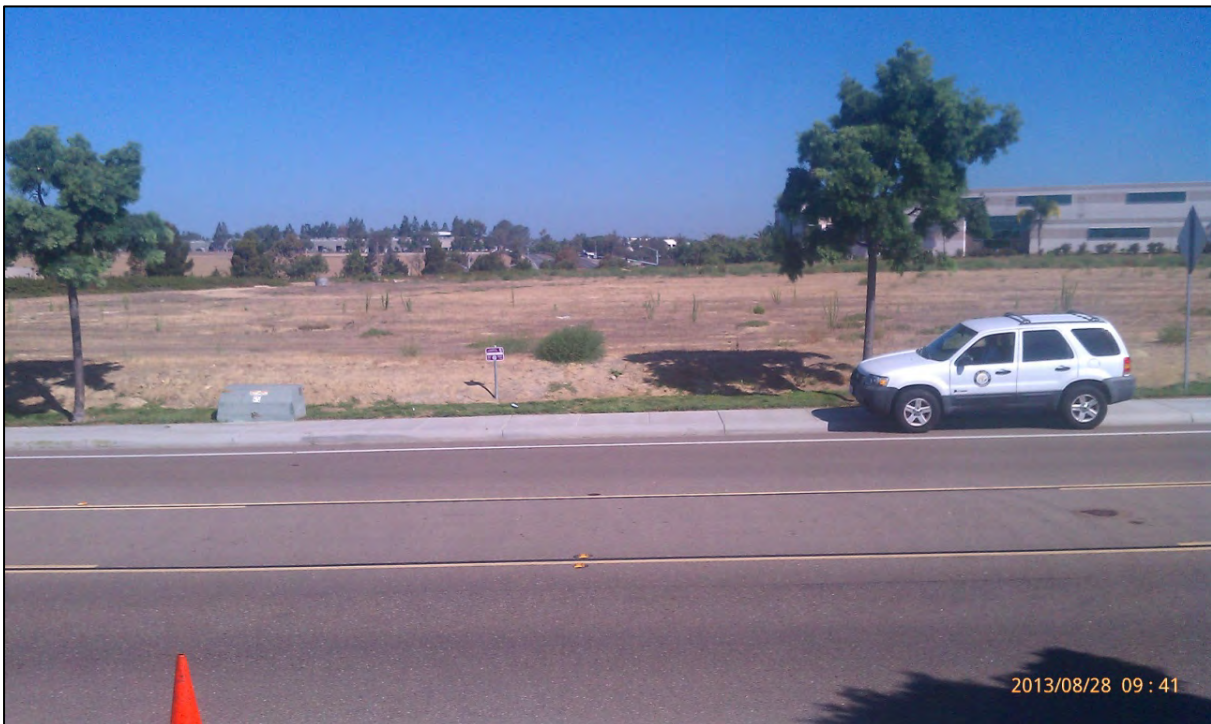
M7-3, at-grade crossing, north side facing south, August 2013.

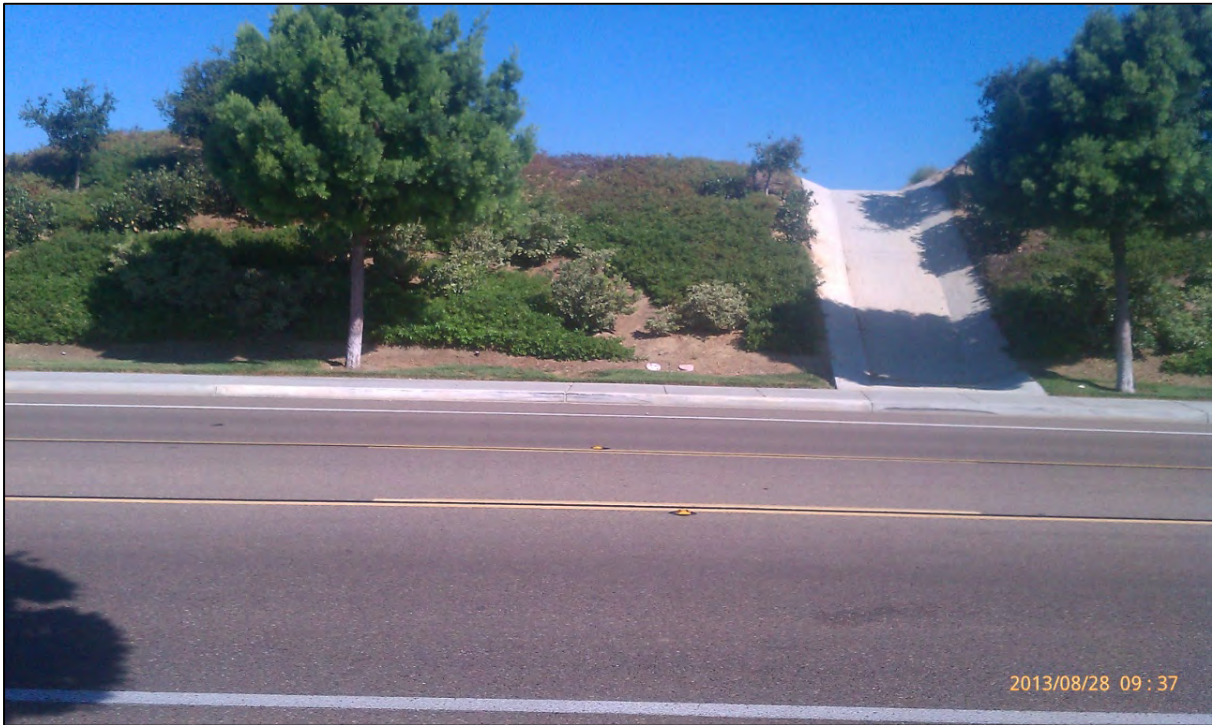
M7-4, at-grade crossing, south side looking north, August 2013

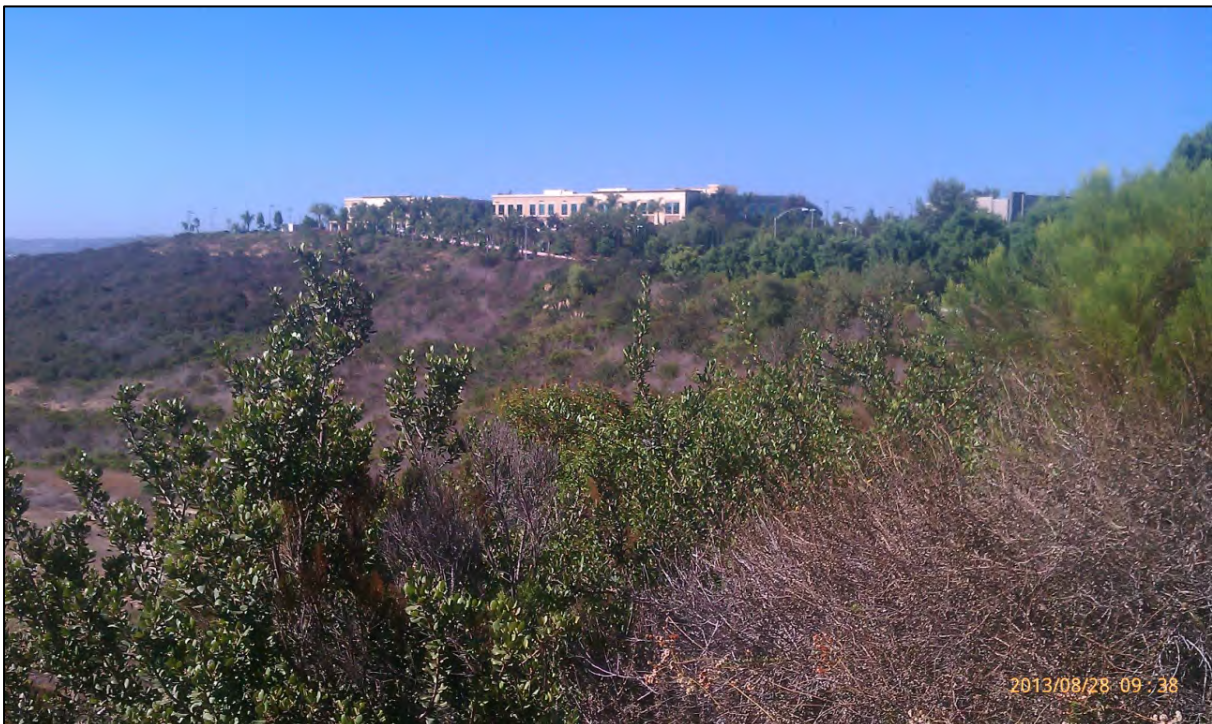
M7-4, south side facing south, August 2013.

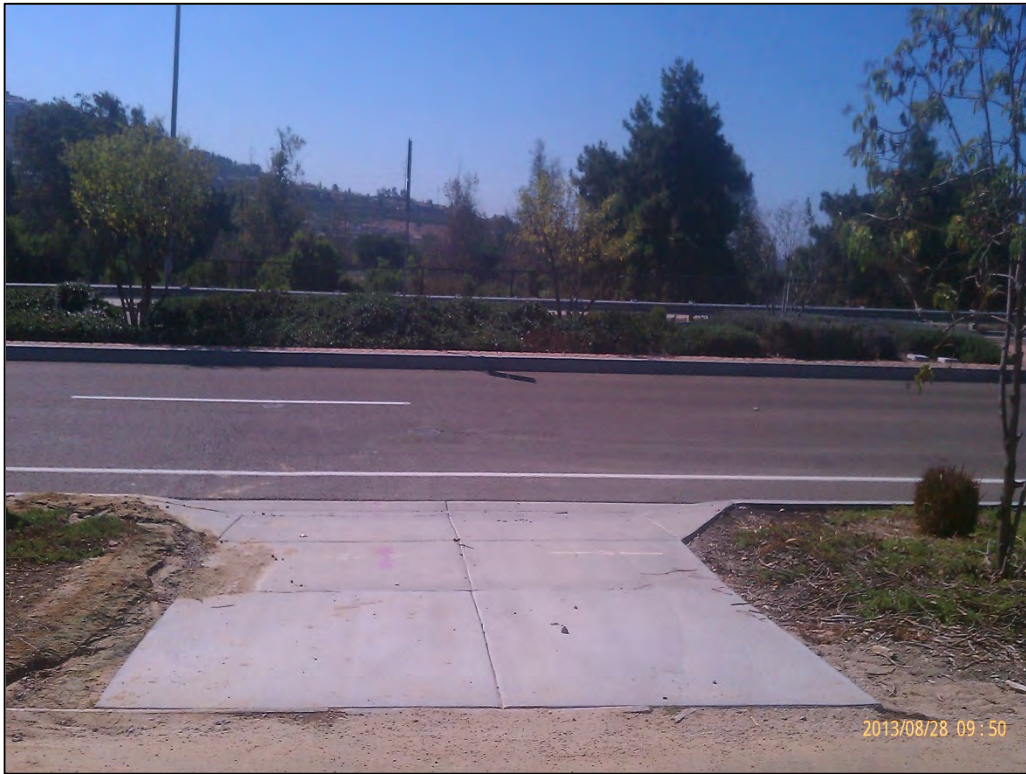
M7-5, looking south from north side, August 2013.

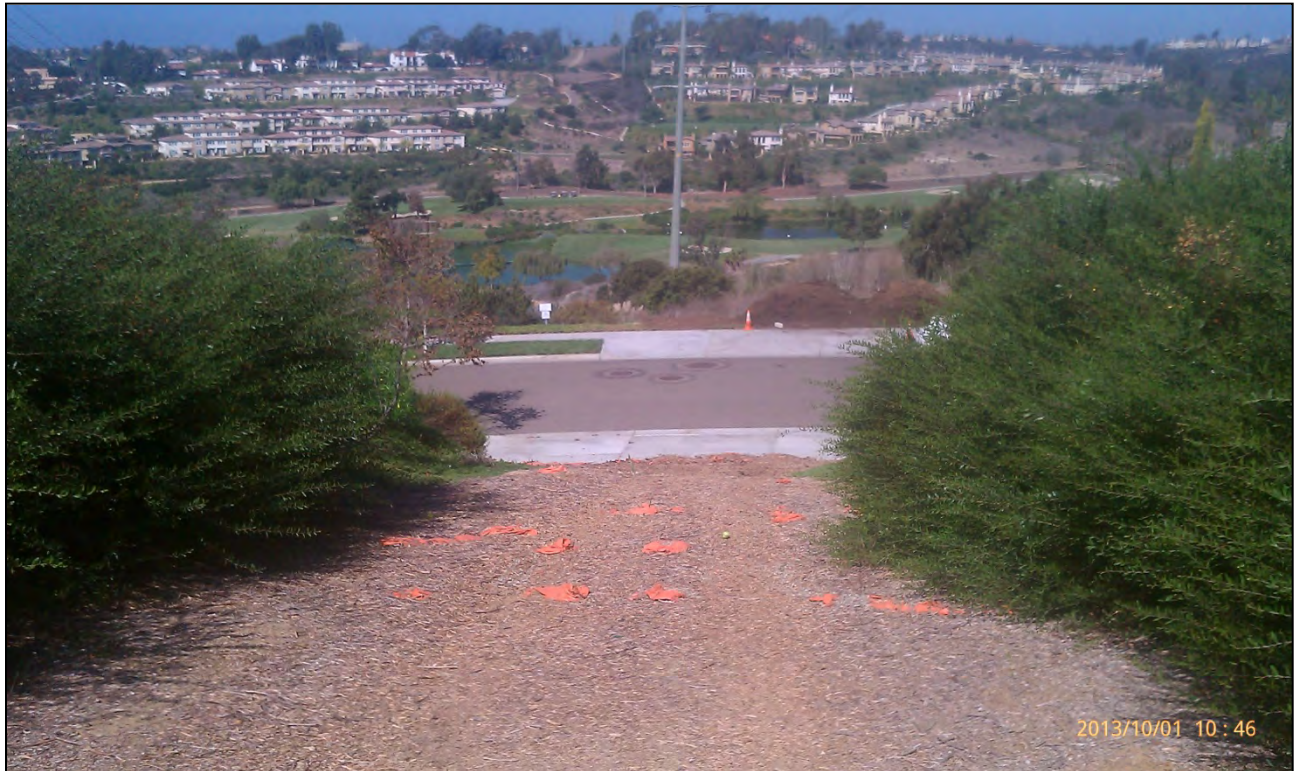
M8-1, at-grade crossing east side facing west from 40 feet away, October 2013.

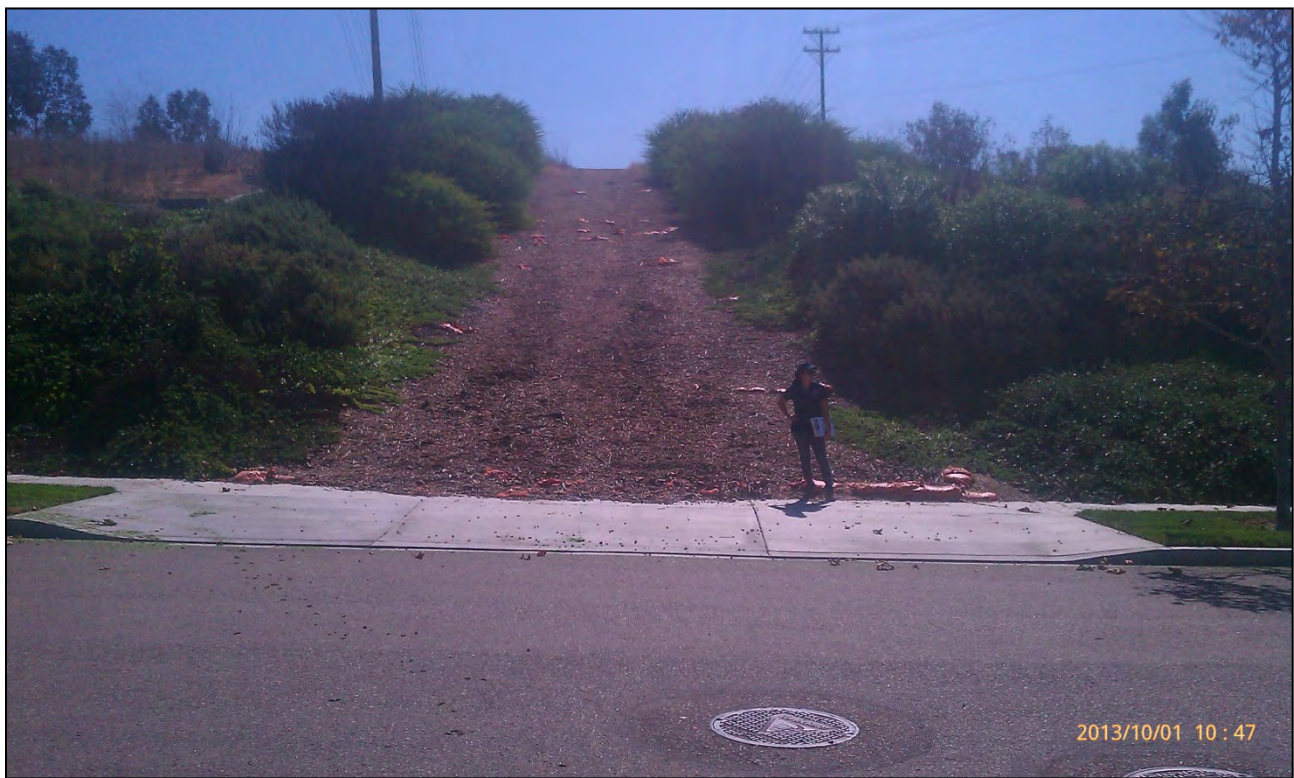
M8-1, west side looking east, October 2013.

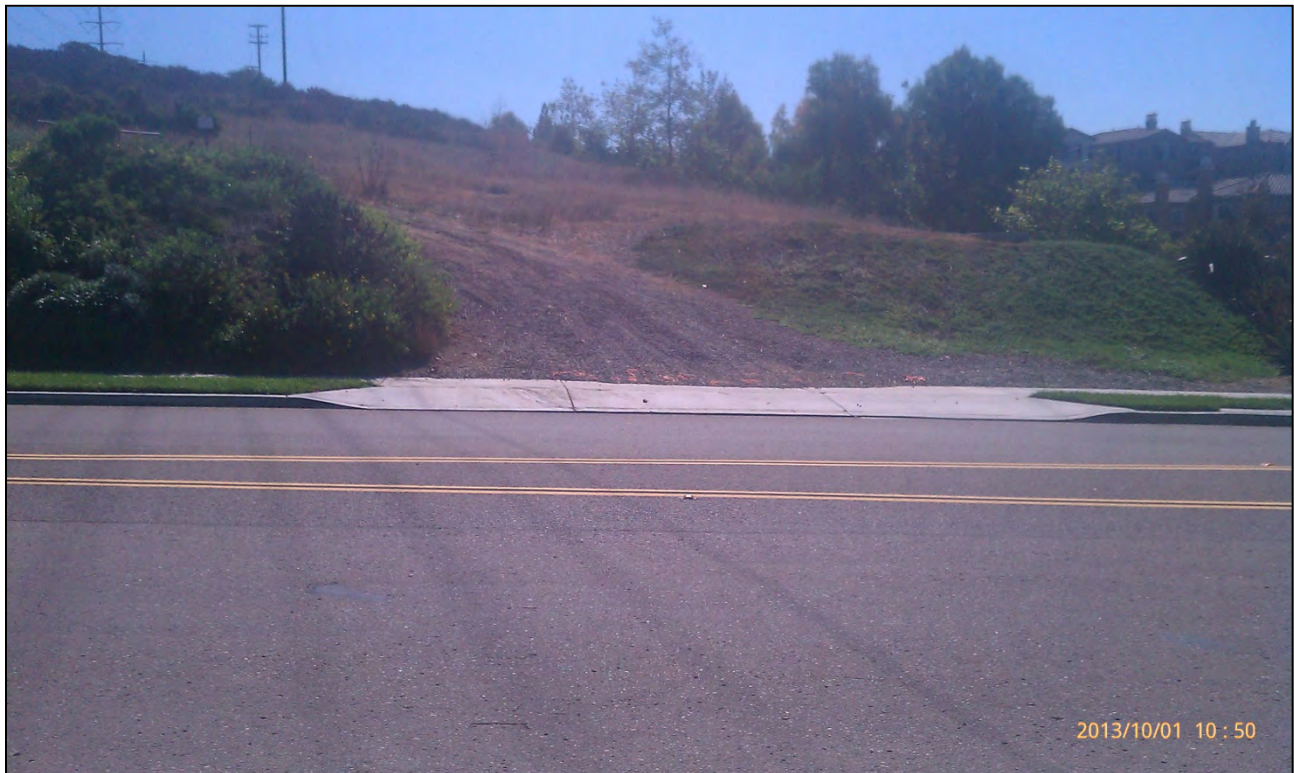
M8-2, at-grade crossing west side facing east, October 2013.

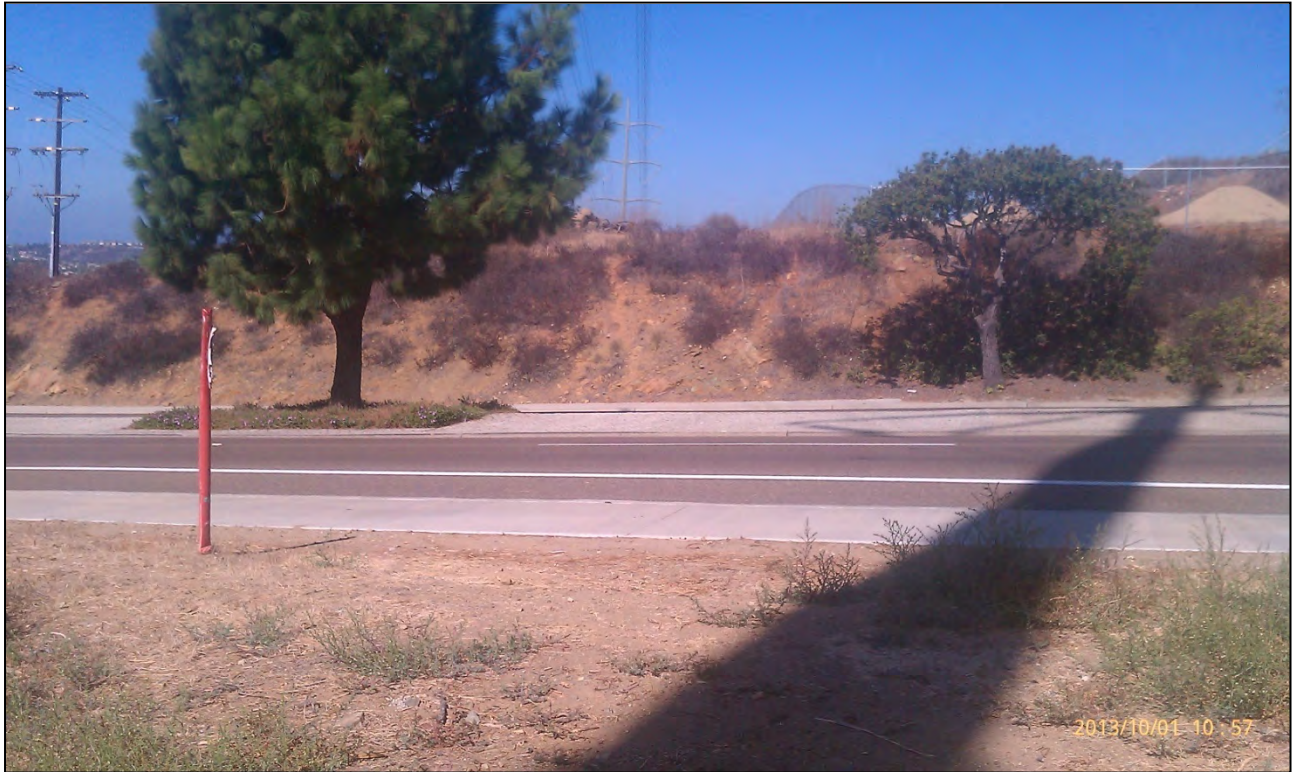
M8-3, east side looking west, October, 2013.

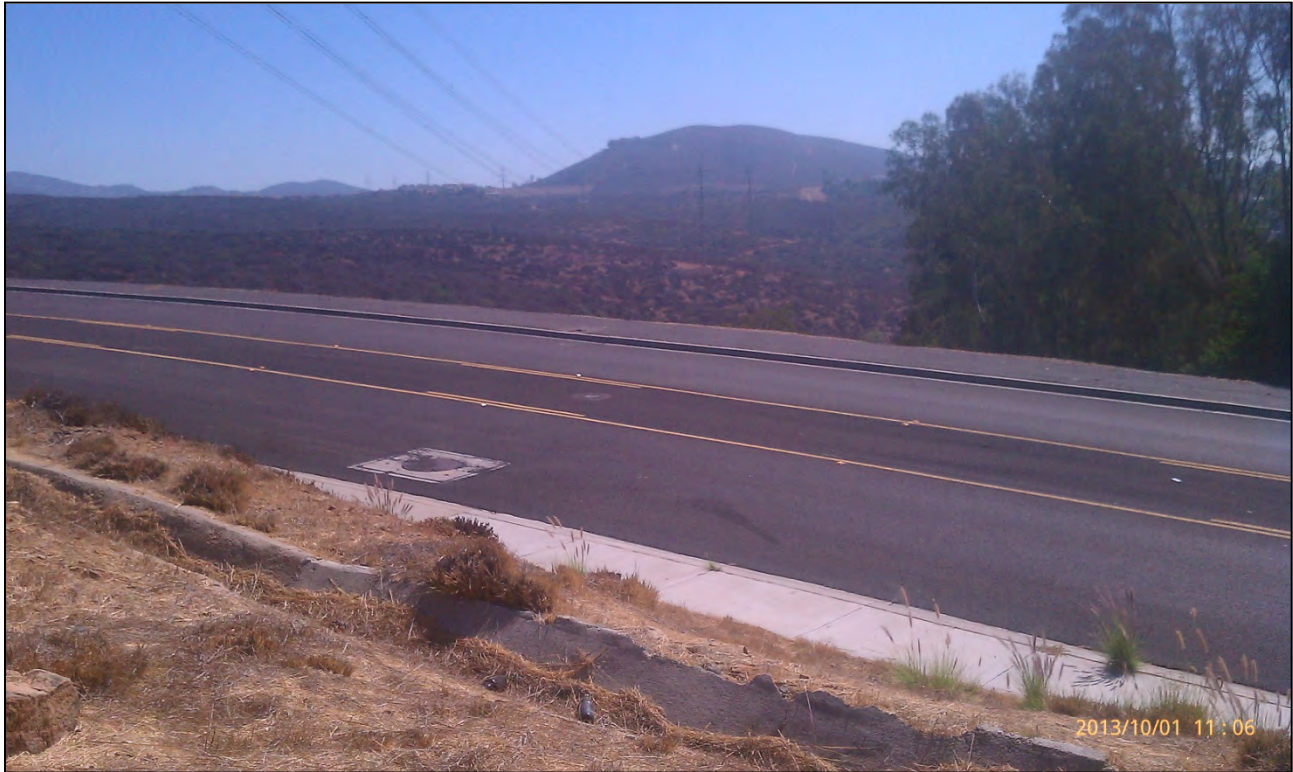
M8-4, at-grade crossing, west side looking east from top of slope, October 2013.

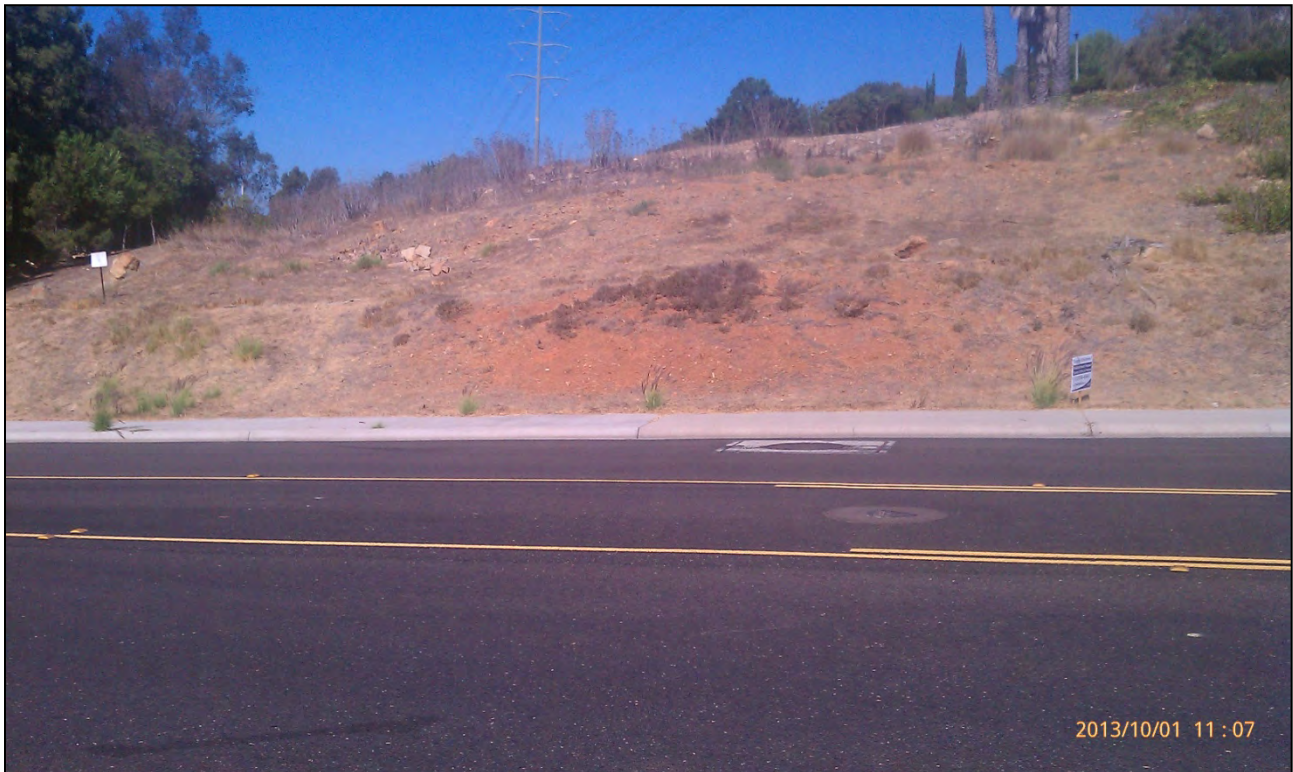
M8-4, east side looking west, October 2013.

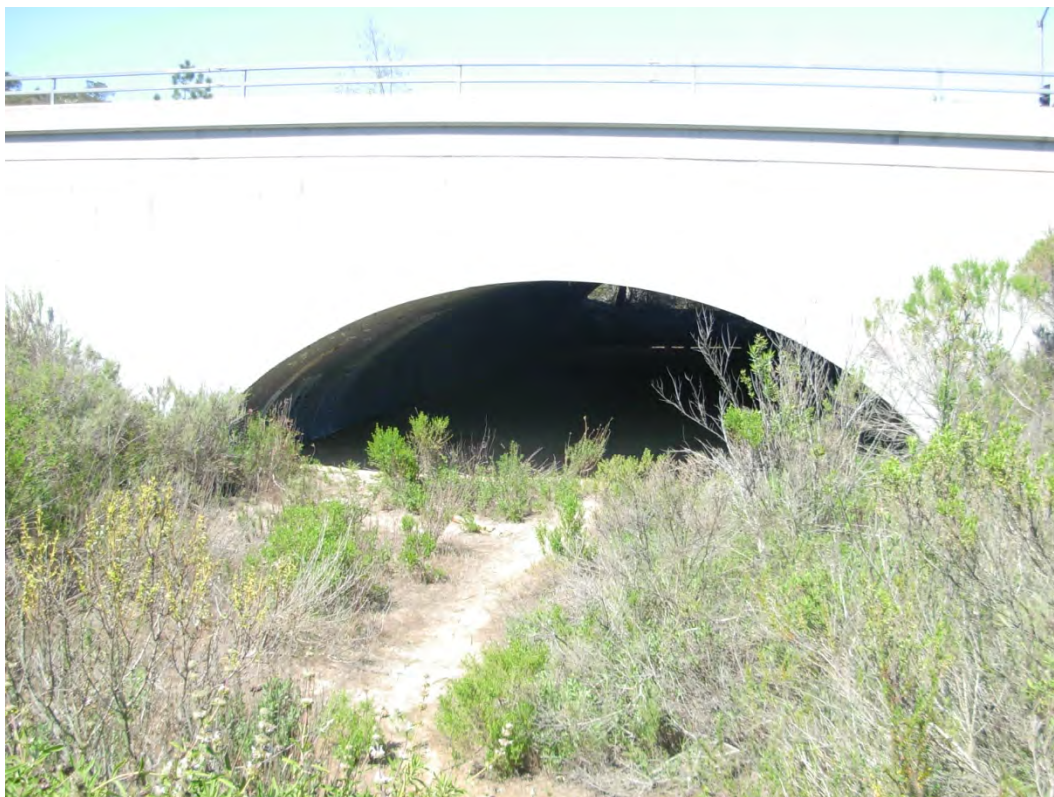
M10-1, south entrance looking north at 20 meters.

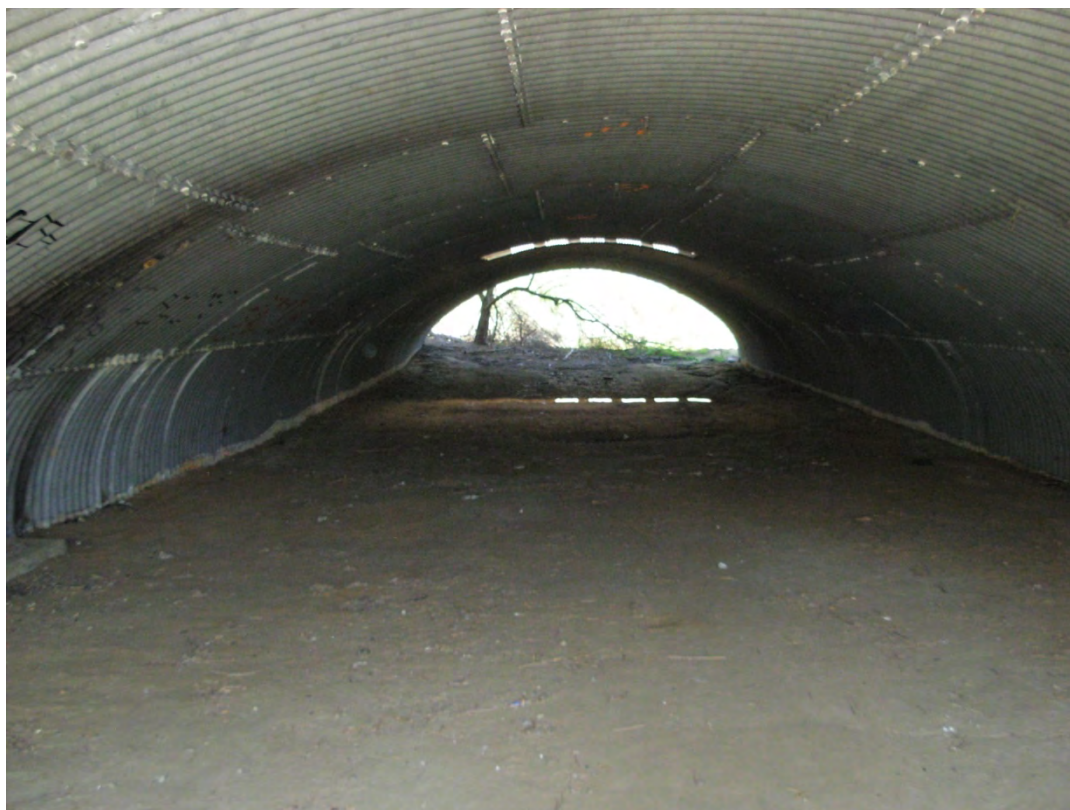
M10-1, looking north from interior.

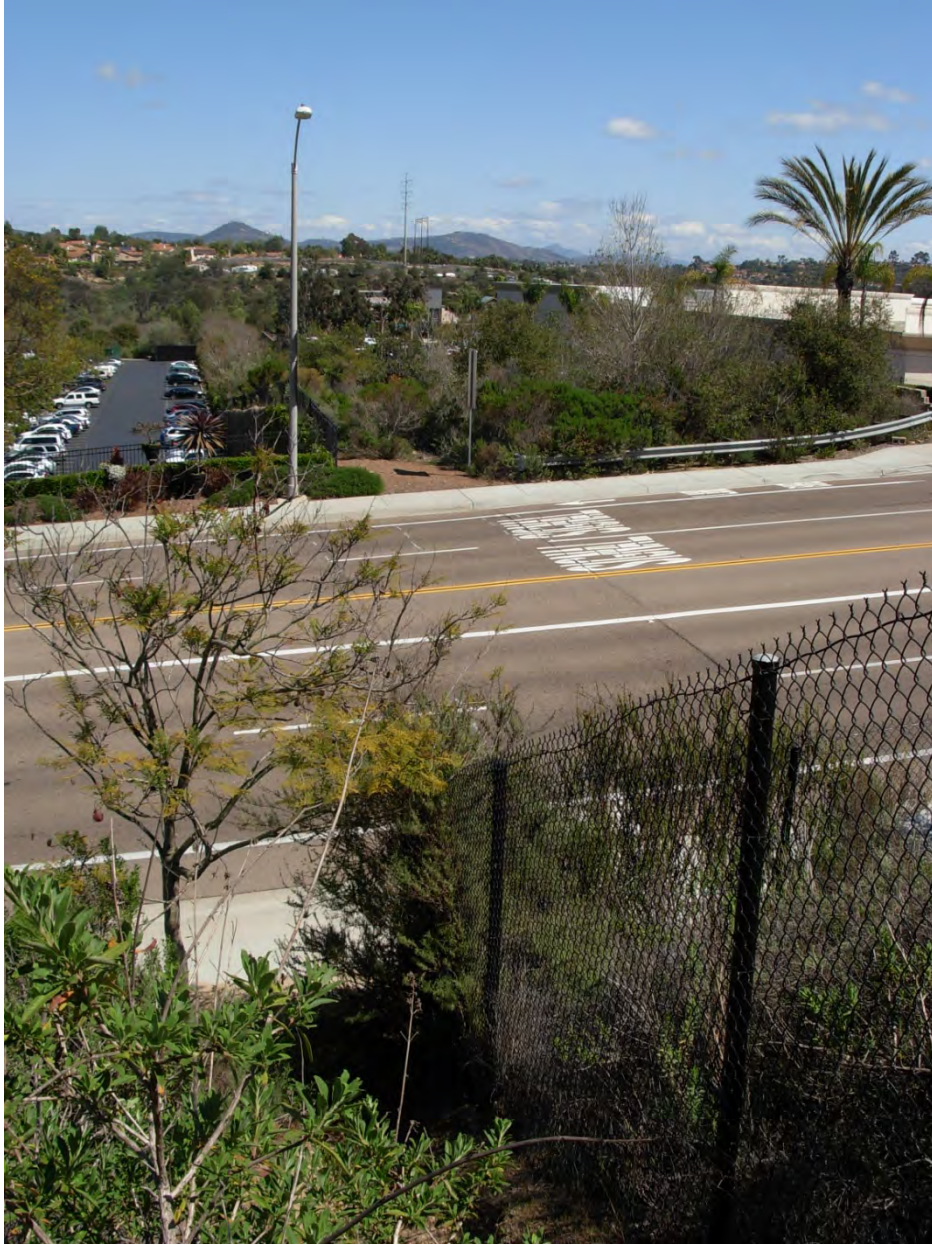
M11-1, west side looking east.

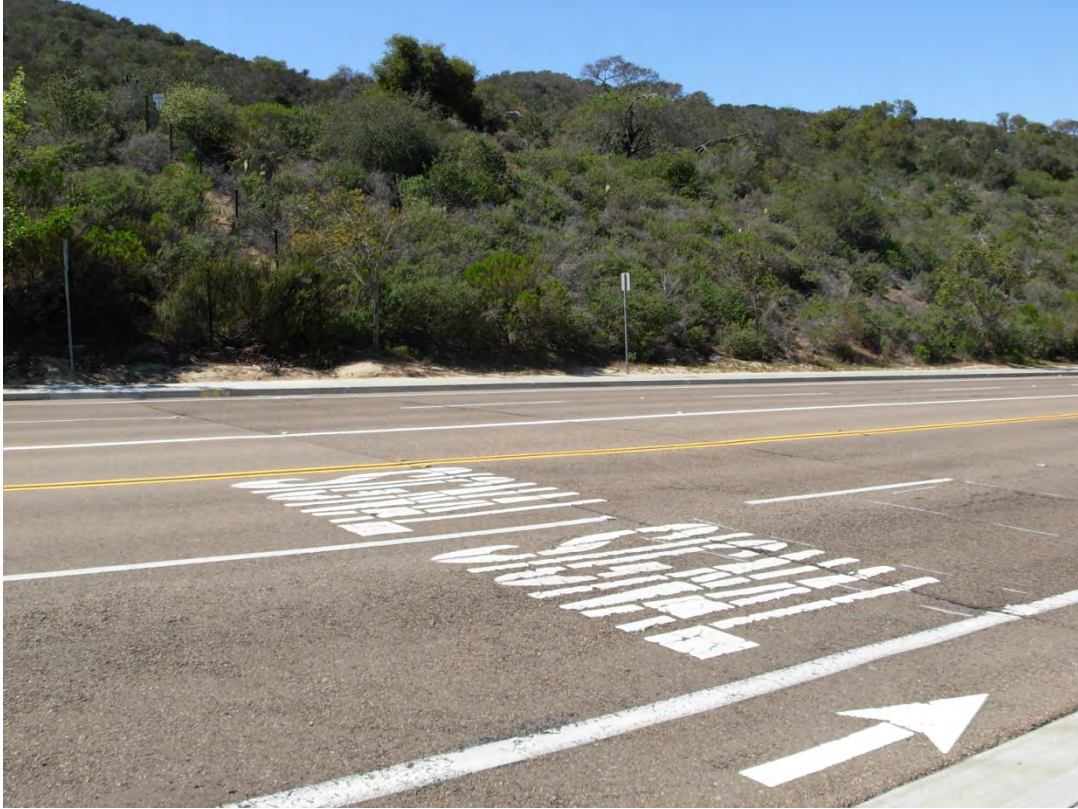
M11-1, east side looking west

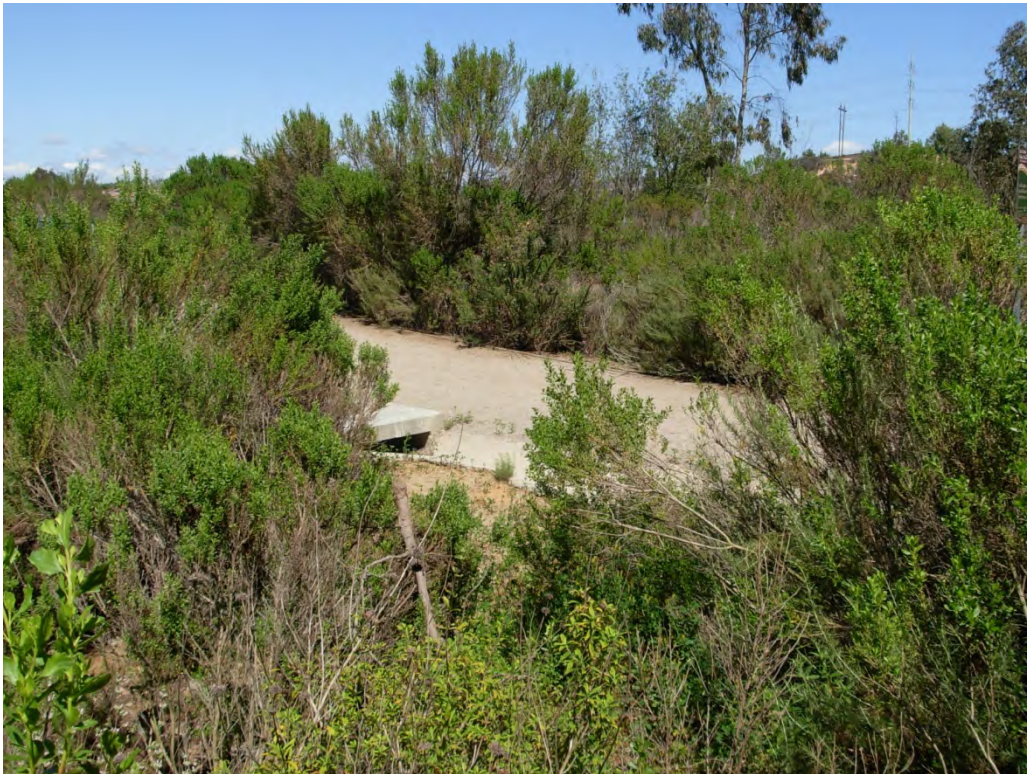
M11-2, west side looking northeast.
